CONTENTS

ACCIDENT

Synopsis

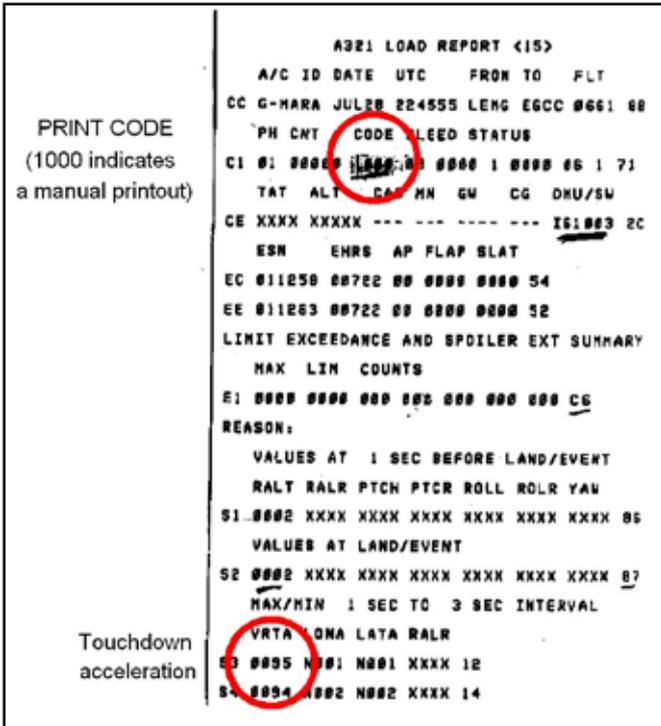
Figure 2

A structural exceedence report, termed LOAD <15>, was introduced following a hard landing of an A320 aircraft on 3 March 1994. Following that hard landing, the aircraft flew another three flights before problems with landing gear retraction, were discovered. Examination revealed the left gear had suffered a fracture of the upper diaphragm tube and the right gear had an ovalised upper diaphragm tube. Had the landing parameter limits been exceeded, a LOAD <15> report³ would have been available on G-MARA after the accident.

Teledyne Controls DMU G-MARA post-landing manually generated LOAD <15> report

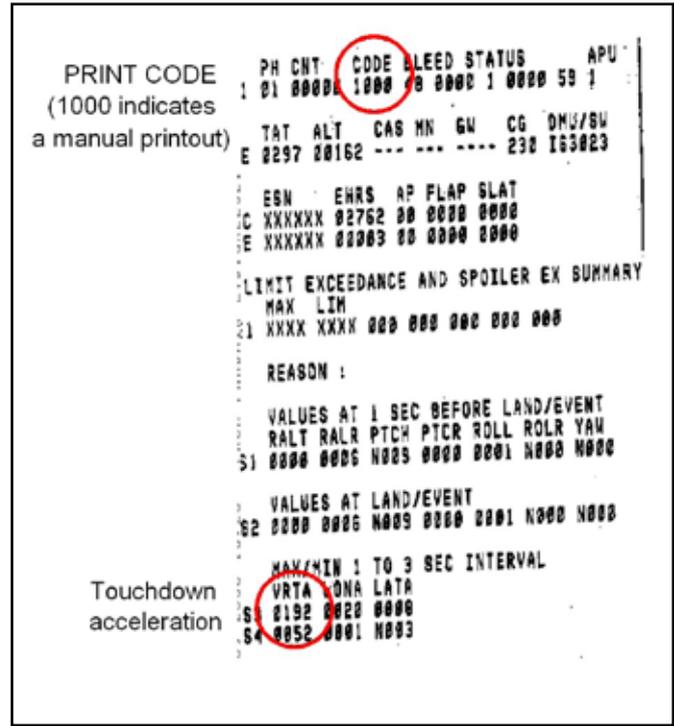
Figure 3

Sagem Avionics DMU Post-landing manually generated LOAD <15> report

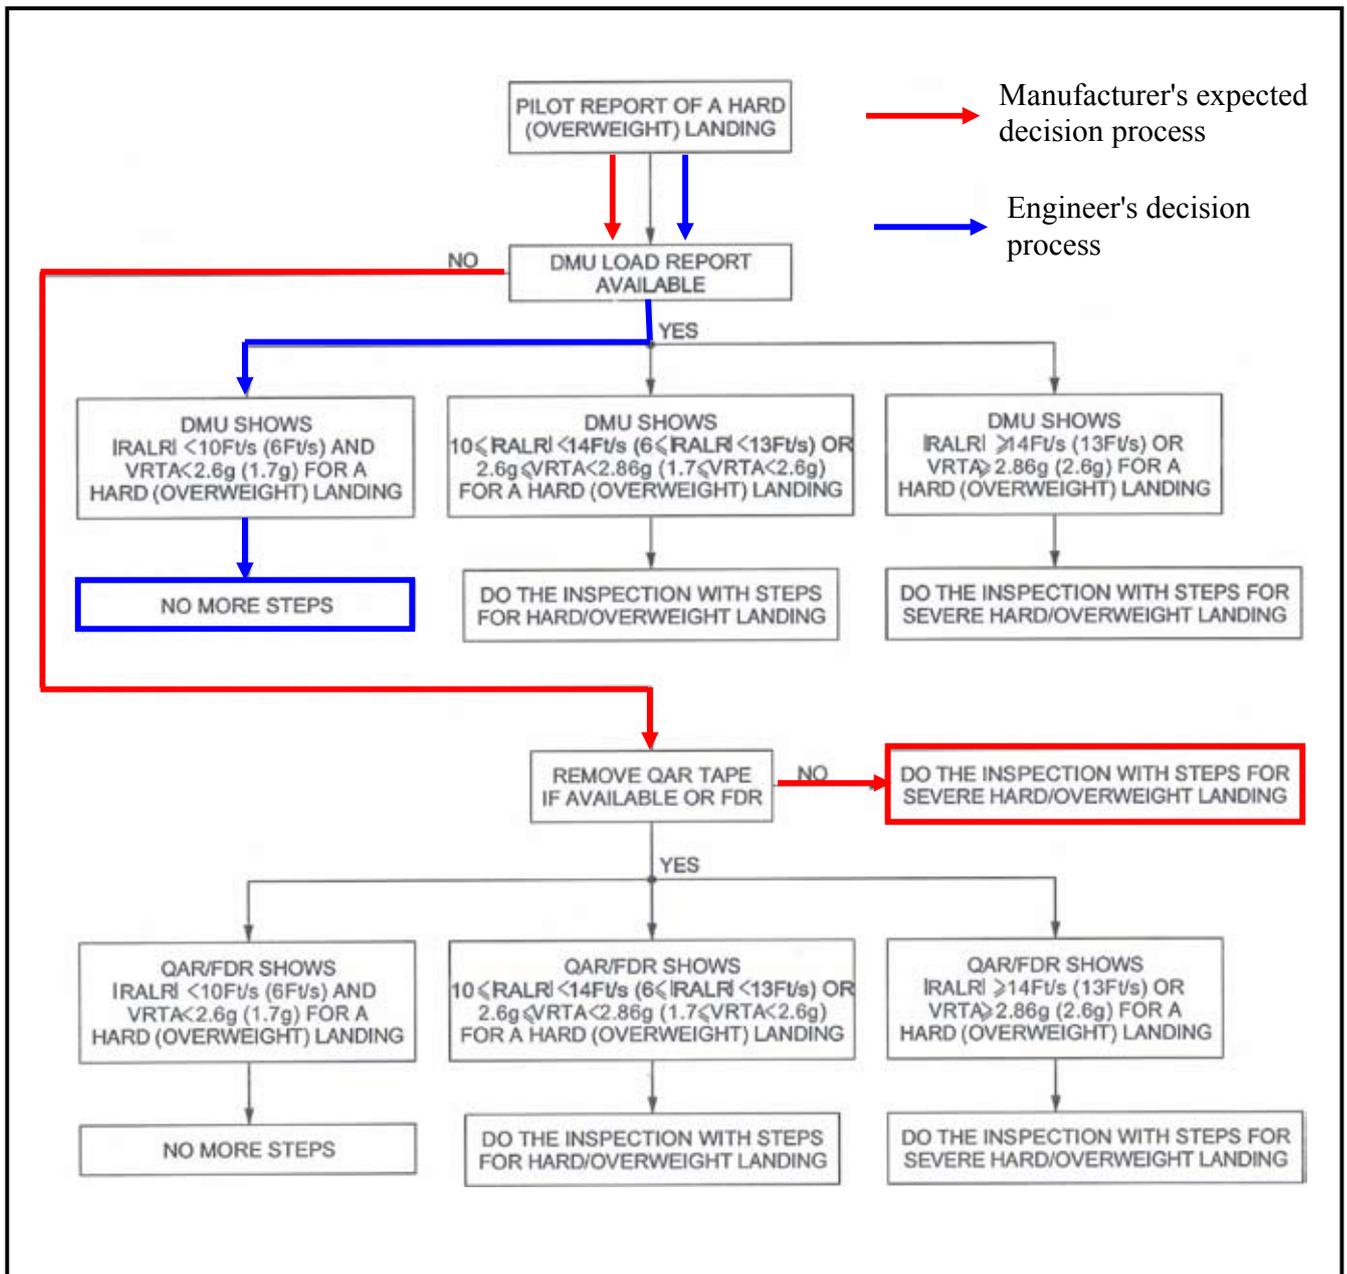
Figure 6

On arrival, after the G-MARA flight crew reported the suspected hard landing to the engineer, he followed the AMM process to determine the level of inspection required using the inspection flow chart, Figure 6. The aircraft manufacturer's intended decision making process and that of the engineer's, is illustrated.

was expected to be NO, as a DMU LOAD <15> report was not produced. This answer would lead to the next decision:

Flow chart for determining category of hard/overweight landing

This inspection requires extensive checks and includes jacking the aircraft and functional checks of retraction and extension of the landing gear. Had these checks been completed, it is likely that the damage to the nose landing gear would have been found.

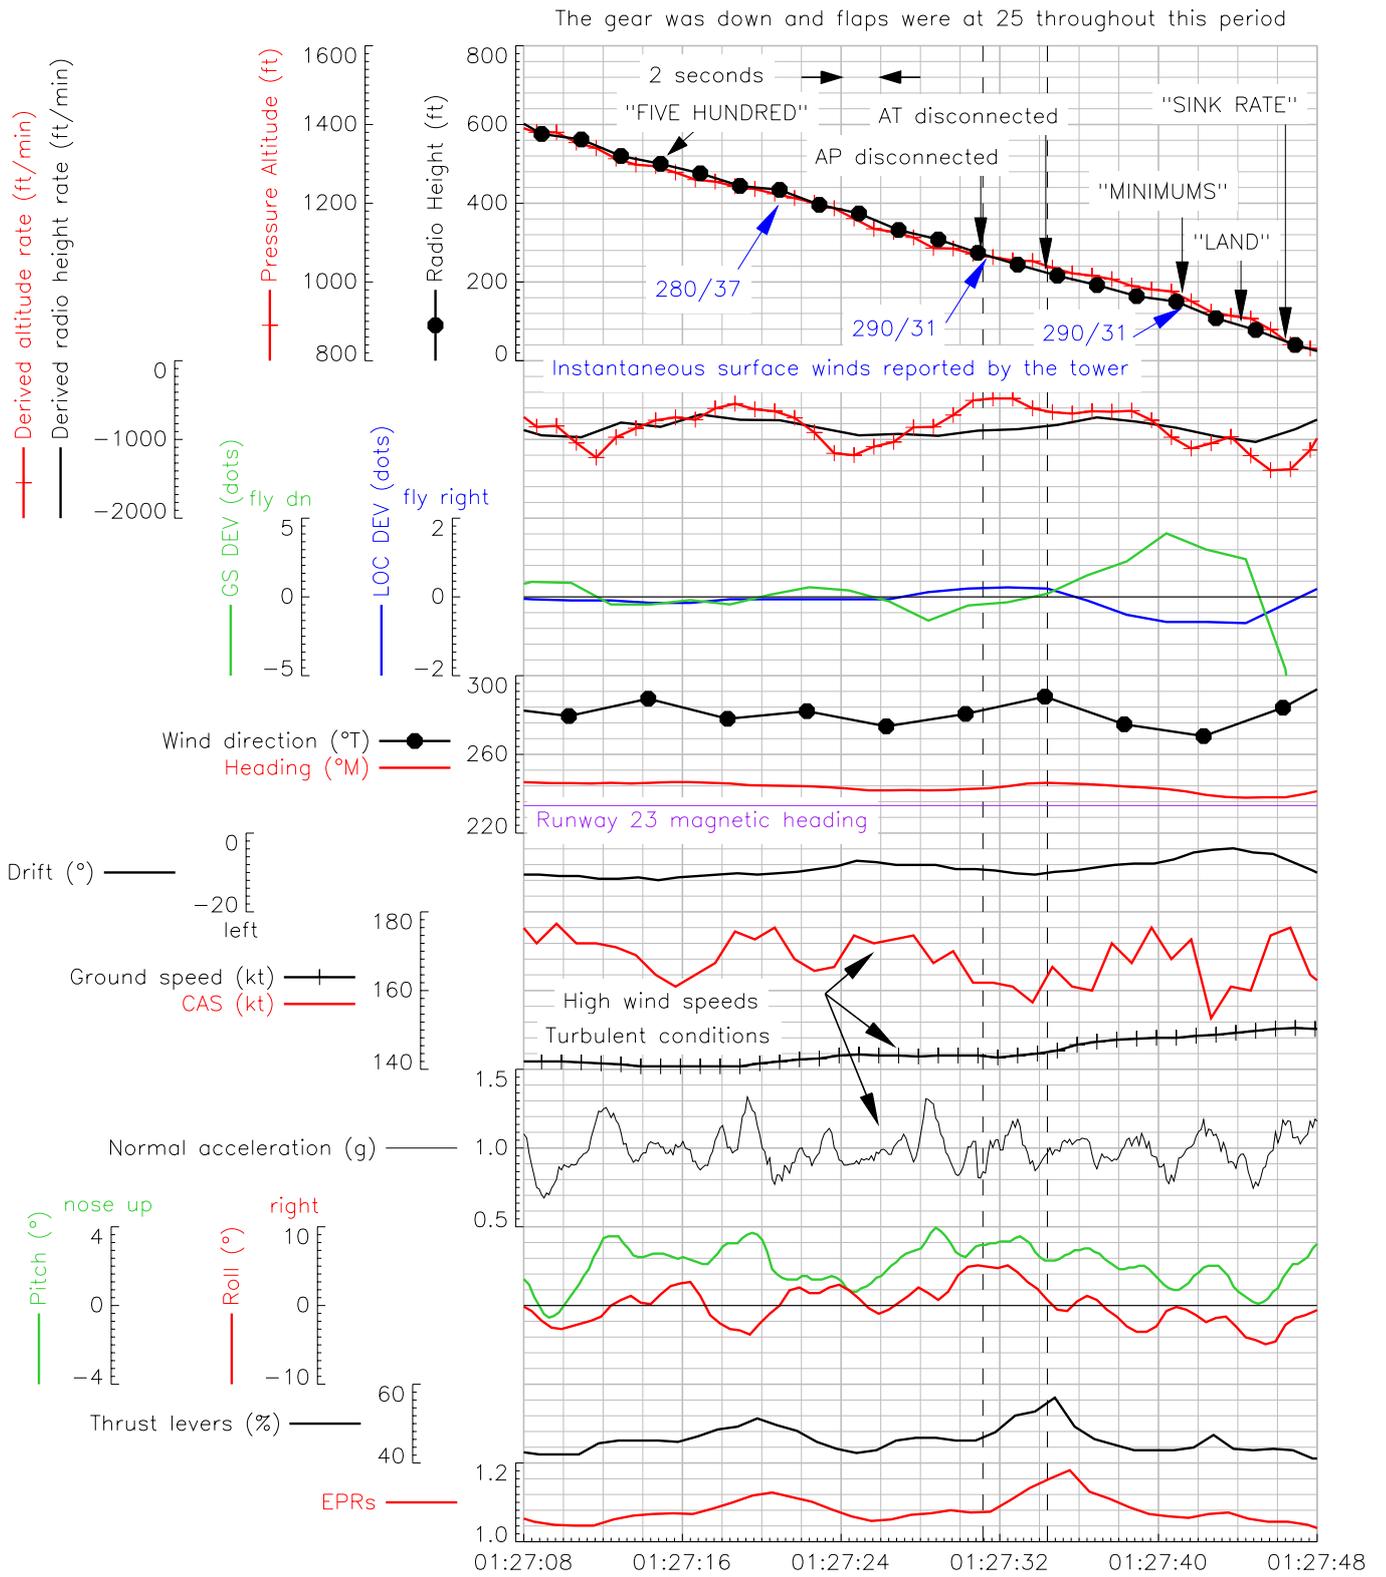
Figures 5 and 6 show the recorded information during the final approach and landing. Of note are the gusty conditions evident in the data. The only wind parameter recorded was the wind direction and this was only recorded once every 4 seconds, which is inadequate for analysis of the prevailing wind conditions.

The aircraft rolled left and the maximum recorded left roll was 6.7°. This did not exceed the nominal 7.5° pod scrape roll limit for the recorded pitch angle but the peak value of roll may not have been recorded and the pod scrape limit would not account for dynamic flexing of the wing. The rollout then stabilised.

Figure 5
 Salient FDR parameters - final approach

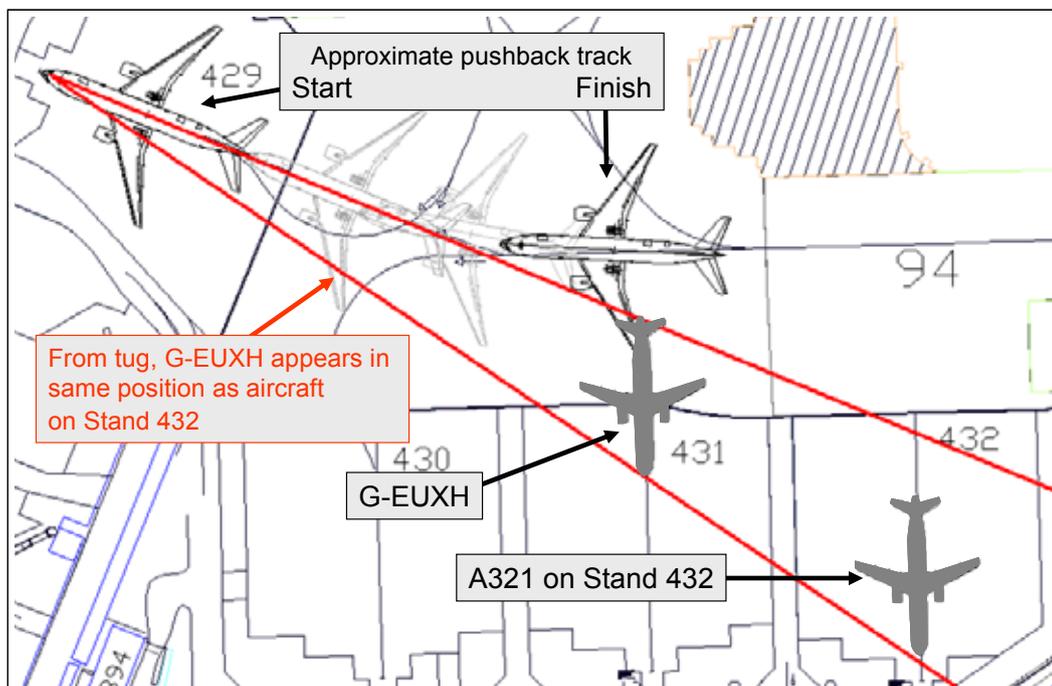
**Figure 5**

At the time of the accident there was an Airbus A321 aircraft, in the operator's livery, parked on Stand 432. This was on the far side of Stand 431 when viewed from the tug position. The ground crew would almost certainly have seen this aircraft earlier, though it would not have been a factor for the pushback. With G-EUXH stopped short of Stand 431, it would have appeared to an observer in the tug cab to be in about the same relative position (albeit closer) as the aircraft on Stand 432, and probably partially obscured the aircraft actually parked there (Figure 5). It is conceivable that one or both of the ground crew had seen G-EUXH from the tug's cab

Relative position of the two Airbus aircraft as viewed from the tug cab

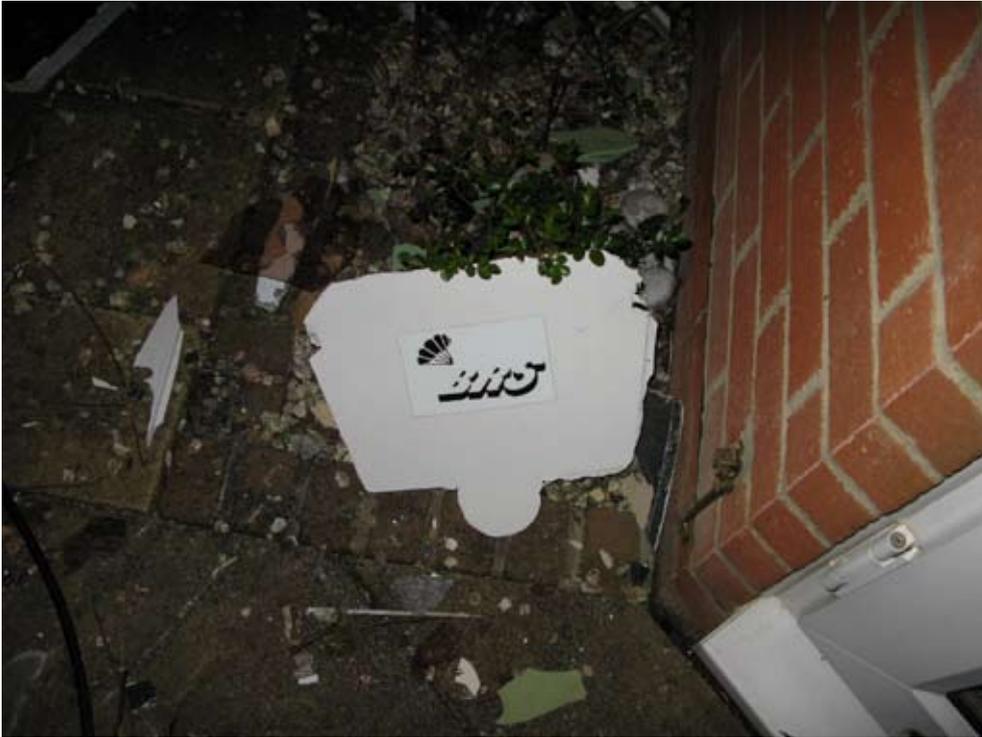
Figure 3. Neither contained any explicit reference to pyrotechnic or projectile hazards. The BRS logo was also displayed on the top surface of the parachute within the compartment, Figure 3.

Figure 2
Parachute compartment cover displaying the BRS placard

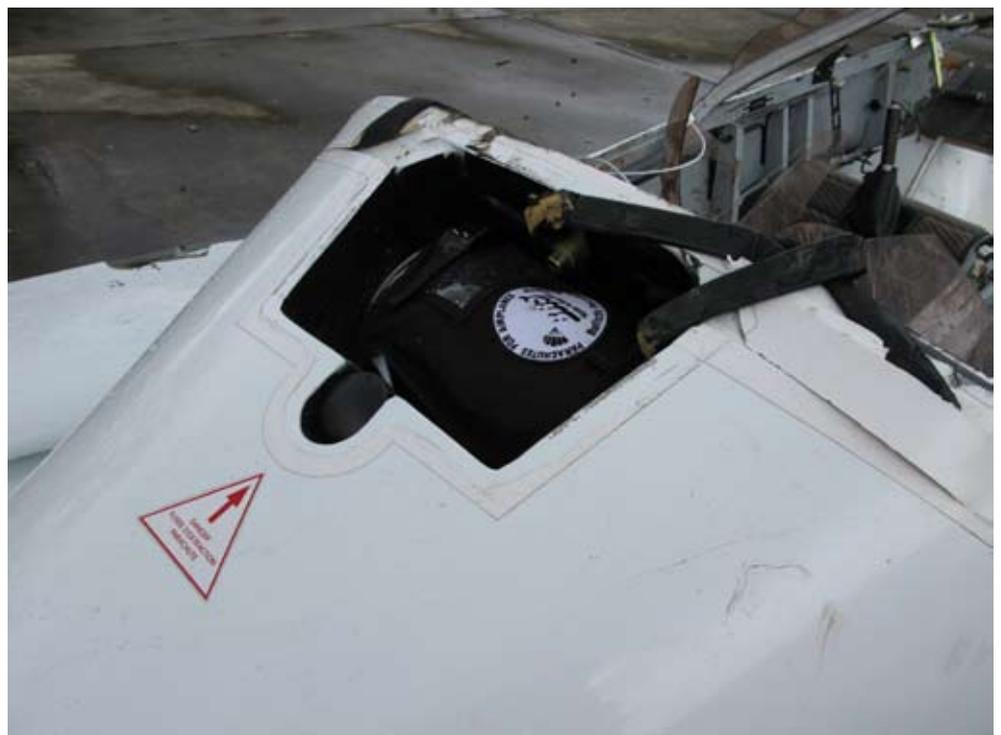
Figure 3
Red warning triangle and BRS placard (displayed on the parachute)
