CONTENTS

COMMERCIAL AIR TRANSPORT

SERIOUS INCIDENT

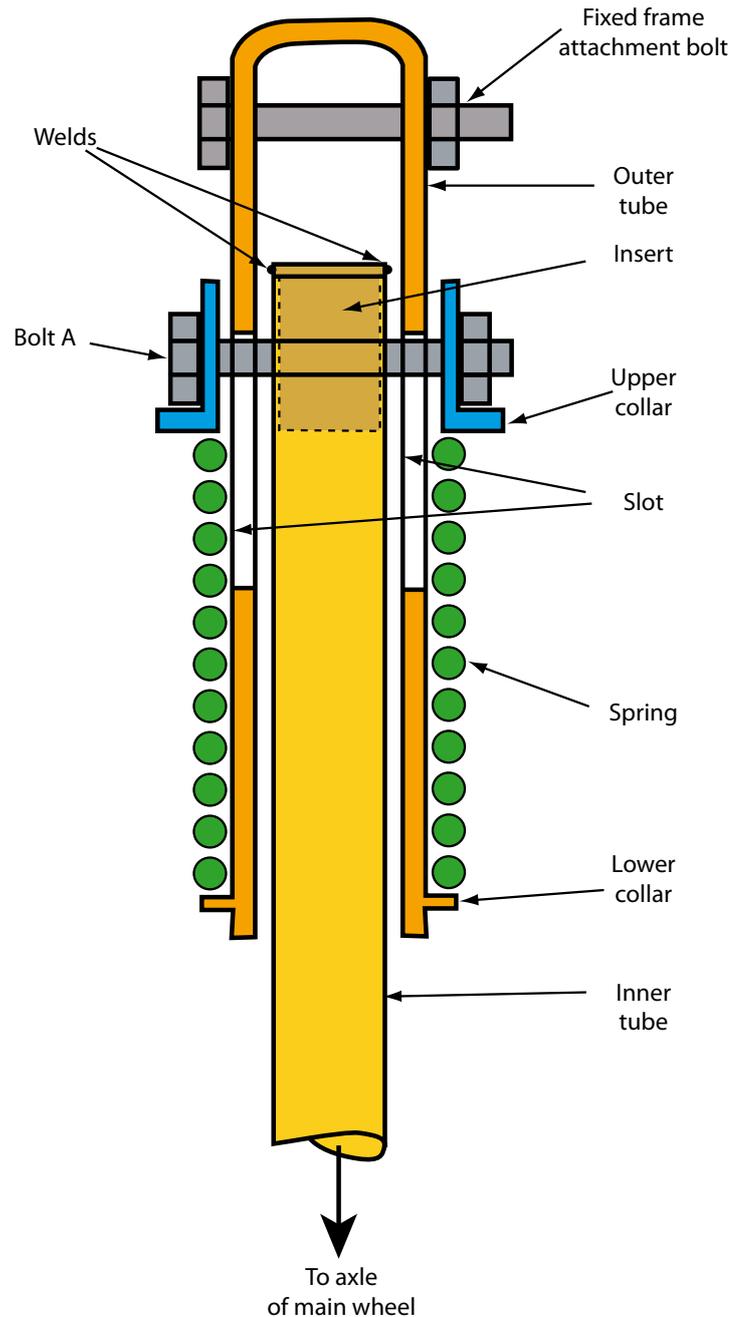
Figure 2

tube which is connected to a fixed frame at the fuselage. See Figure 2. A spring is fitted over the outside of the outer tube and is retained in place by a lower collar welded to the tube and an upper collar which is held in place by Bolt 'A'. Bolt 'A' passes through a slot in the outer tube and a hole in the inner tube and insert. As the landing leg moves outwards, the inner tube moves downwards causing the upper collar to compress the spring. On G-CGAK an insert had been welded in two positions into the end of the inner tube in order to increase the maximum 'tear out' force that the tube could sustain.

The damage to left and right inner tubes was consistent with the aircraft having landed heavily with Bolt 'A' on the right strut bottoming on the end of the slot in the outer tube. This damage could not have been sustained in the firm landing that occurred in March 2011 as it is unlikely that the right cross-strut would have remained intact during the subsequent flights.

Schematic drawing of the cross-strut

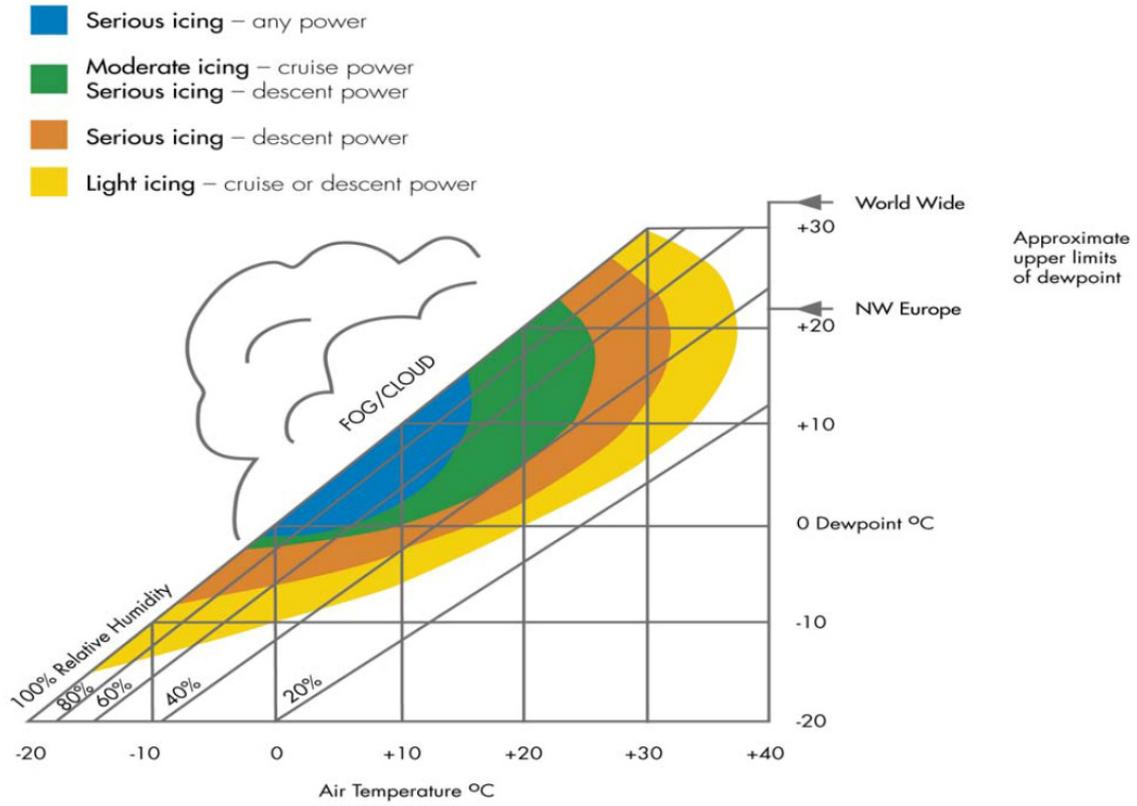
Figure 1
Carburettor icing chart

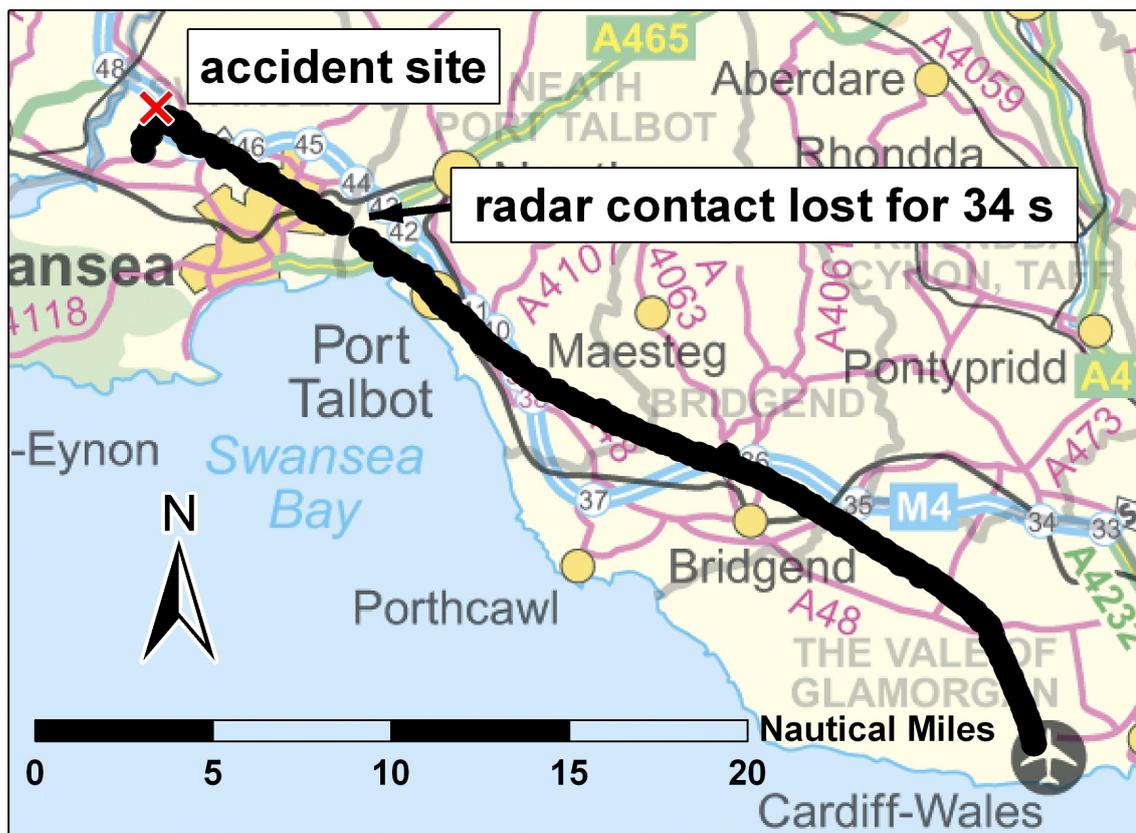
Figure 3 shows the accident track from 1320:49 hrs, north of Cardiff Airport, to 1329:50 hrs, approximately 1 nm south of the accident site. Between 1323:43 hrs and 1324:19 hrs radar contact was lost. This loss of contact was probably due to the aircraft's altitude reducing briefly to a level that placed it out of line of sight of the radar head.

Radar track of G-ASXY and position of accident site
