CONTENTS

SPECIAL BULLETINS

Eurocopter EC225 LP Super Puma	G-REDU	18-Feb-09	1
Eurocopter AS332L2 Super Puma	G-REDL	01-Apr-09	5

ACCIDENT

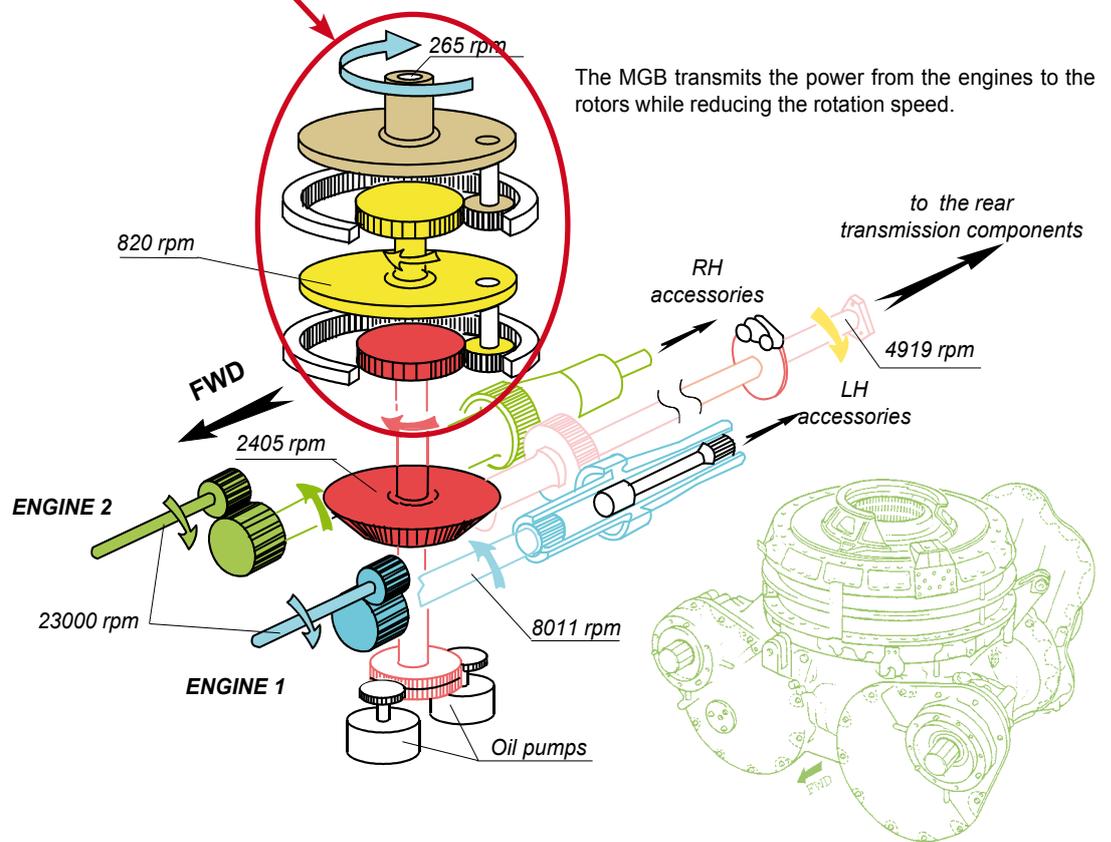
Figure 1
Schematic of the Main Rotor Gearbox

The MGB transmits the power from the engines to the rotors while reducing the rotation speed.

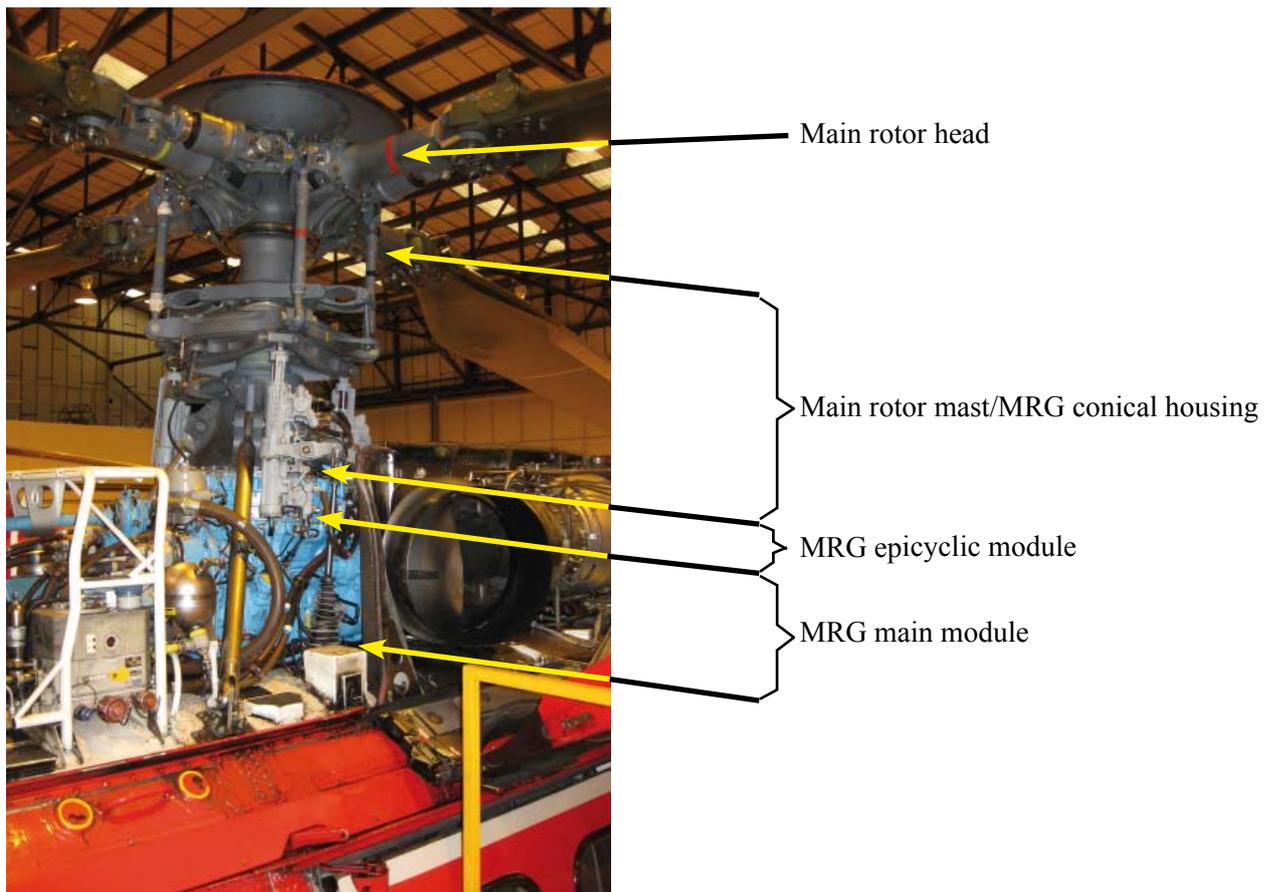
Figure 3

The epicyclic module is located between the main module and the main rotor mast conical housing, Figure 3. The ring gear for both stages is integral with the circular housing. The MRG is fitted with three magnetic chip detector plugs. One is located in the sump area below the main module, one adjacent to the epicyclic gearbox module and one in the main rotor conical housing. These are designed to detect and retain any chips of magnetic material shed, for example, from the gears or their bearings. The sump magnetic plug provides a warning to the flight crew should a chip be detected, whilst the plug adjacent to the epicyclic stages provides evidence of chip detection to the HUMS system, when the aircraft is equipped with such a system, which was the case with G-REDL. The magnetic plug in the conical housing is

MRG installation

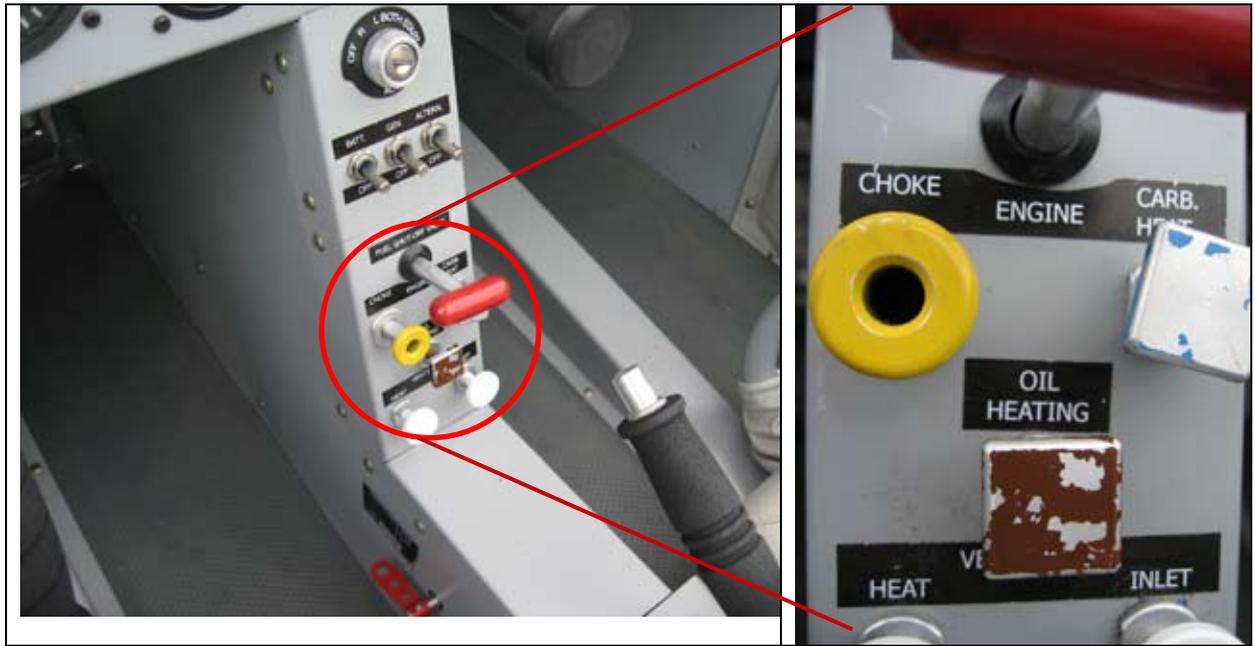
The choke control has a cylindrical yellow knob and the carburettor heat has a square blue knob. Both controls have a similar action: pulling the knob selects the system ON and turning the knob to the right locks it in the ON position.

The choke and carburettor heat controls are situated close together on the centre panel extension (Figure 1).

Figure 1
Ancillary engine controls (similar aircraft)

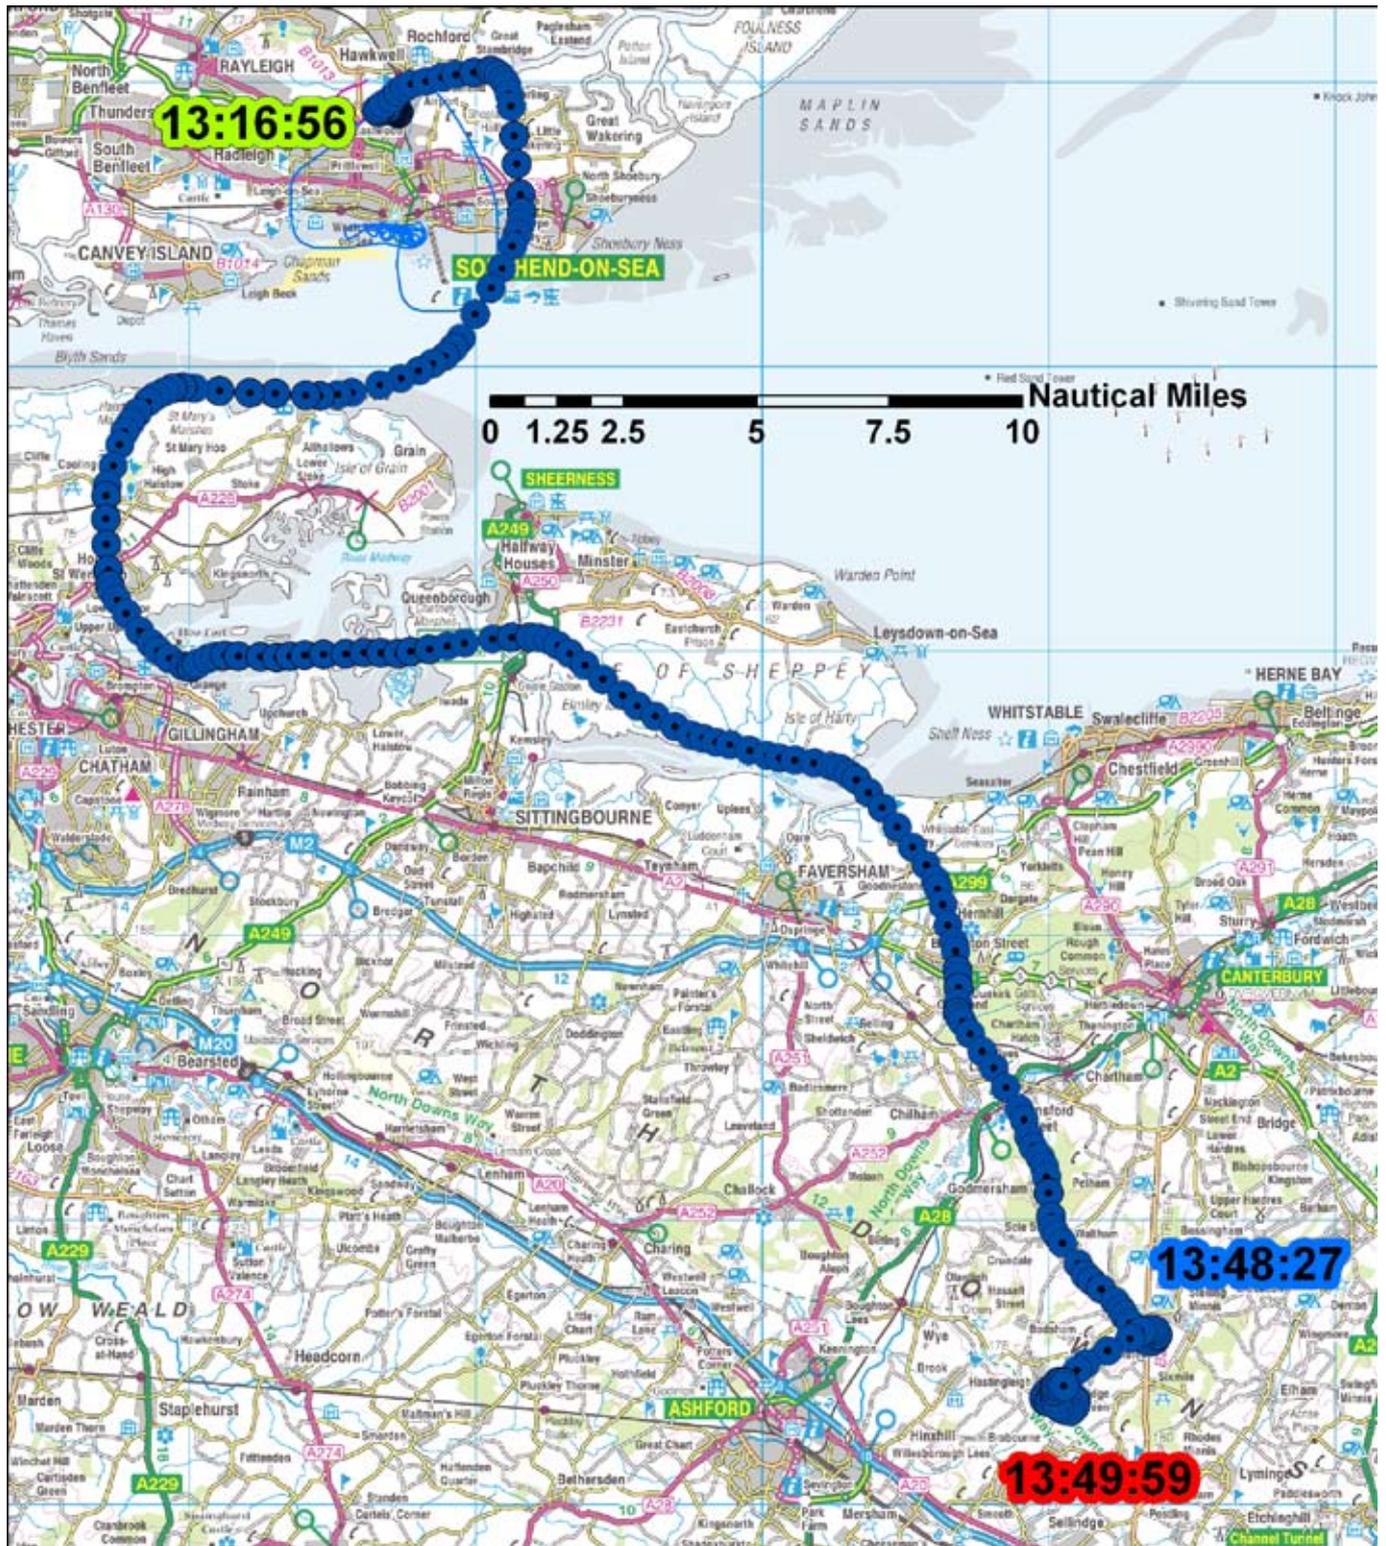
Figure 2

No radar data was available for the accident flight; however, the pilot was using a Garmin GPS Pilot III that recorded position and time, but no height information. Processing of this data allowed the average ground speed between recorded points to be calculated, ie, based on the horizontal straight-line distance between successive points. The accident track is illustrated in Figure 2.

Garmin GPS Pilot III final logged track for G-IIEX

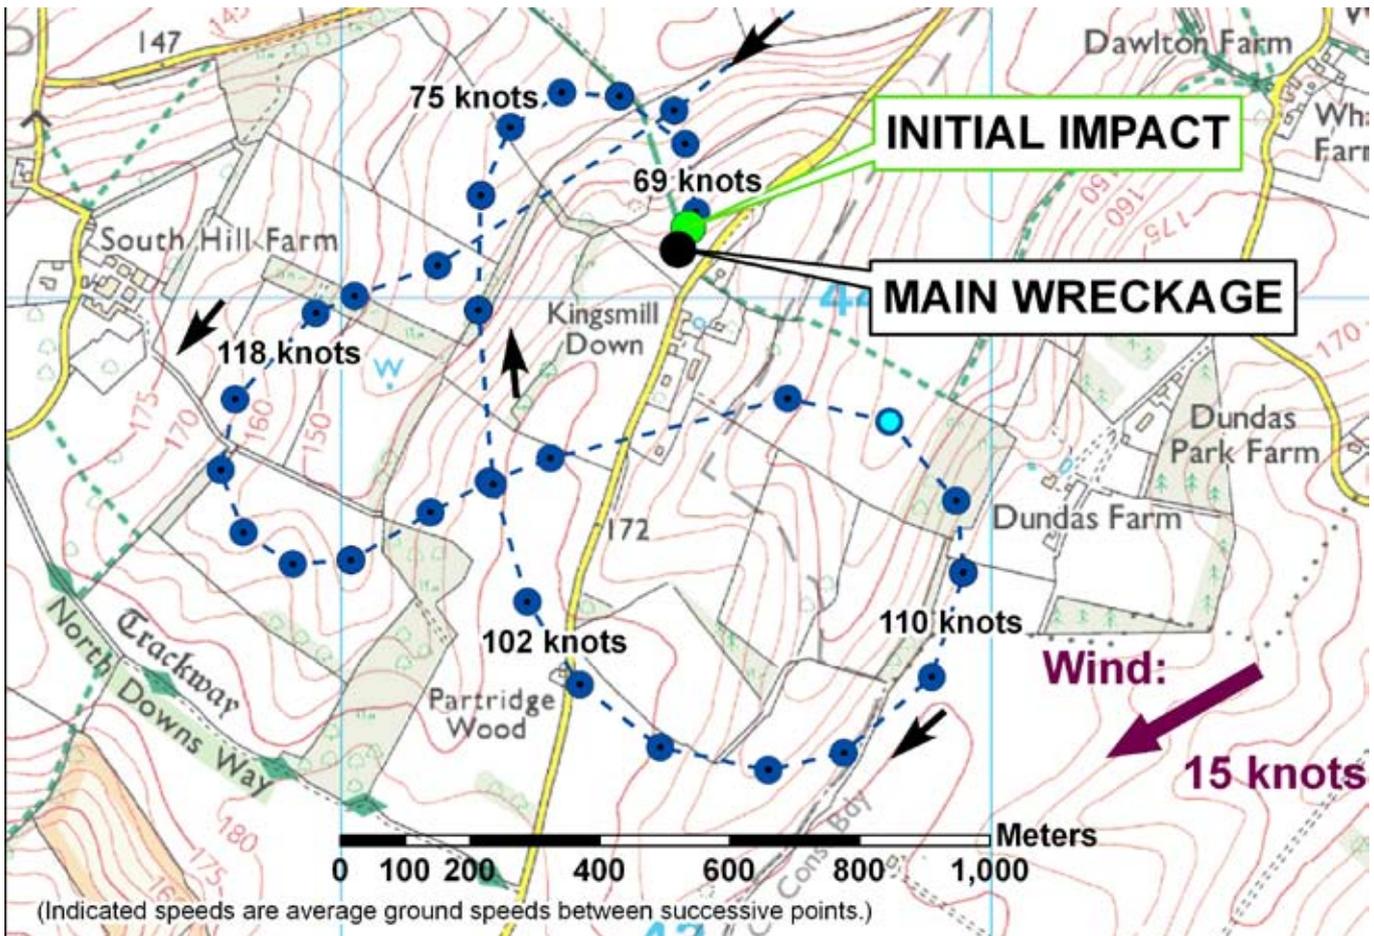
Figure 3 illustrates the last minute of the aircraft's track, together with the position of the initial ground-impact mark and main wreckage. The last two points recorded on the GPS unit were three seconds apart, suggesting an average ground speed of 69 kt between these points, and the last GPS point, initial ground-impact mark and main wreckage lie on a line with a track of 208°.

Figure 3 also shows the direction and strength of the wind taken from the Met Office aftercast, which illustrates a large tailwind component of the wind along the track from the last GPS point to the wreckage. The effect of such a tailwind with a groundspeed of 69 kt results in an airspeed of 56 kt.

G-IIEX precautionary landing track

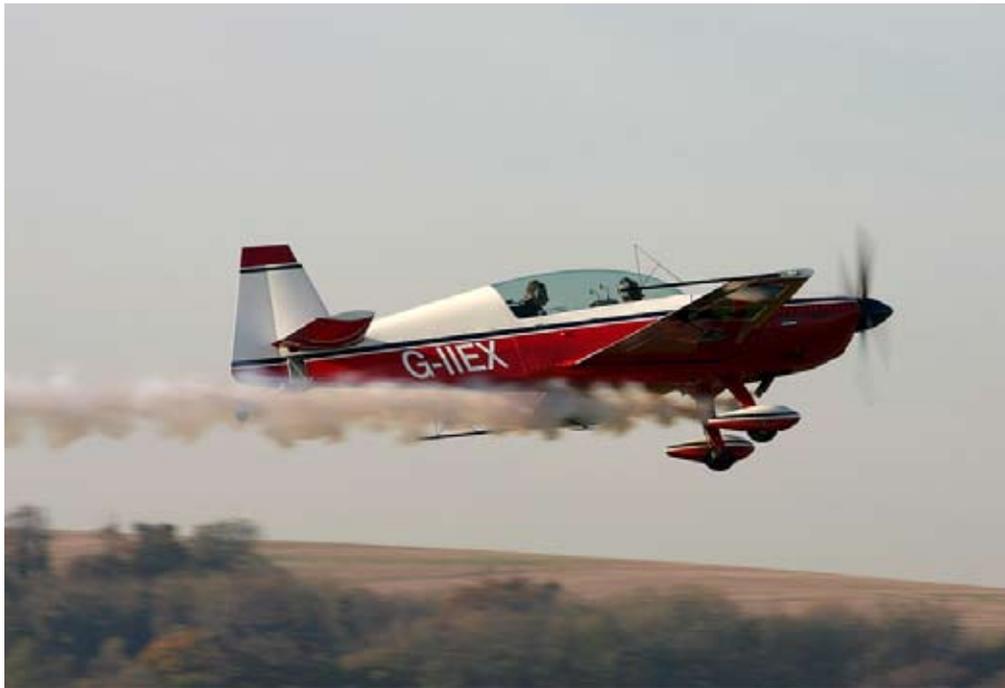
Figure 4

The Extra 300/L is a single-engine low-winged monoplane, designed to be fully aerobatic, Figure 4. It is qualified for manoeuvre load factors of $\pm 10g$. The aircraft is powered by a 300 shp piston engine driving a four-bladed constant-speed wooden propeller. The fuselage is constructed of a tubular steel frame covered with aluminium and fabric fairings; the wings are of

Configuration of G-IIEX

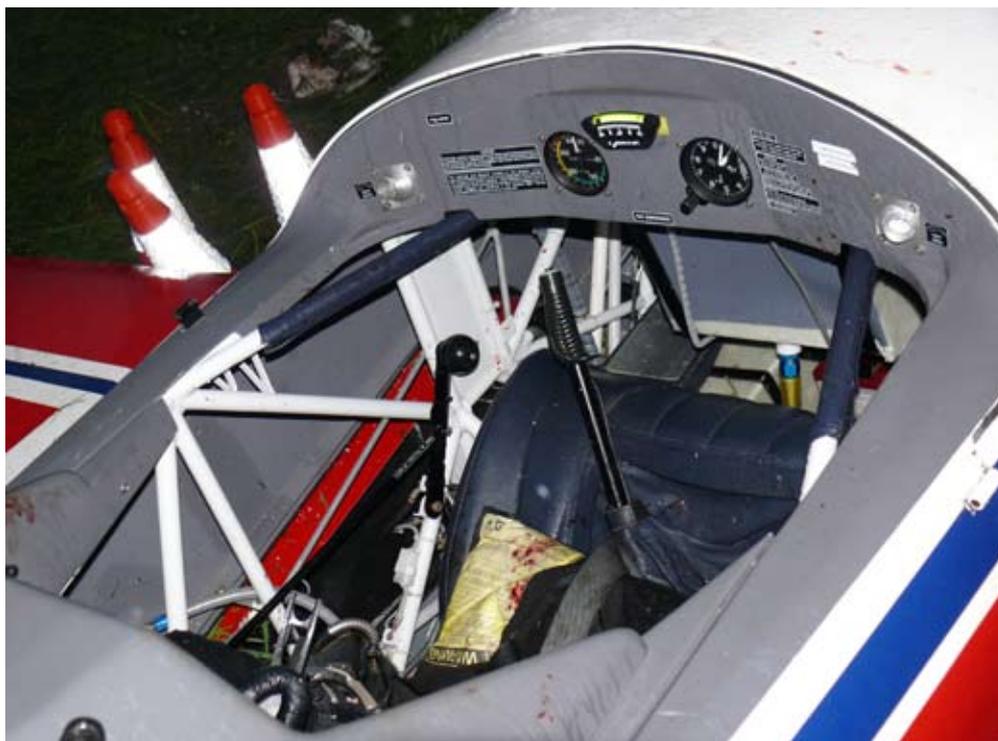
compressed under the occupant's weight, this would not be regarded as substantial. The rear cockpit seat is upright; the front cockpit seat is reclined by approximately 20°. In both cockpits, the underside of the seat pan is separated from the structure and various systems by several inches. A seven-point Sutton harness (aerobatic-type, with broad-straps) is fitted at each seat position. The fuselage framework intrudes into the cockpits in the form of a diagonal horizontal steel bracing tube in the upper part of each cockpit forward corner, angled inwards from aft to forward and spanning between the cockpit coaming and the instrument panel area, Figures 5 and 6. These tubes are sheathed in thin leather.

Figure 5
G-IIEX front cockpit

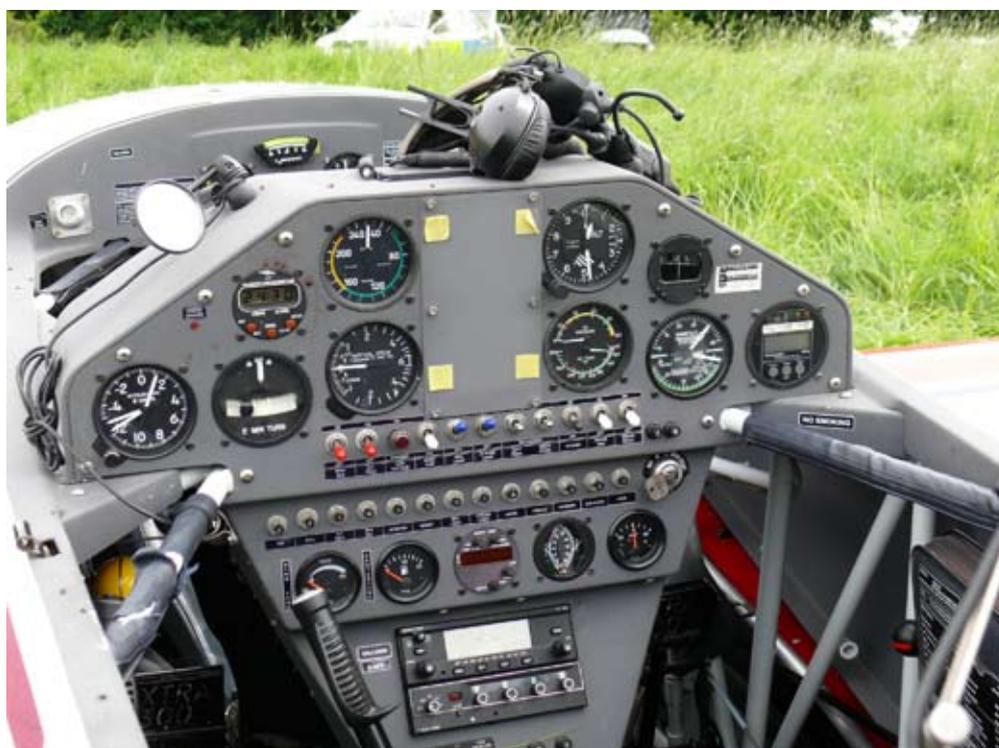
Figure 6
G-IIEX rear cockpit
