CONTENTS

SPECIAL BULLETINS

COMMERCIAL AIR TRANSPORT

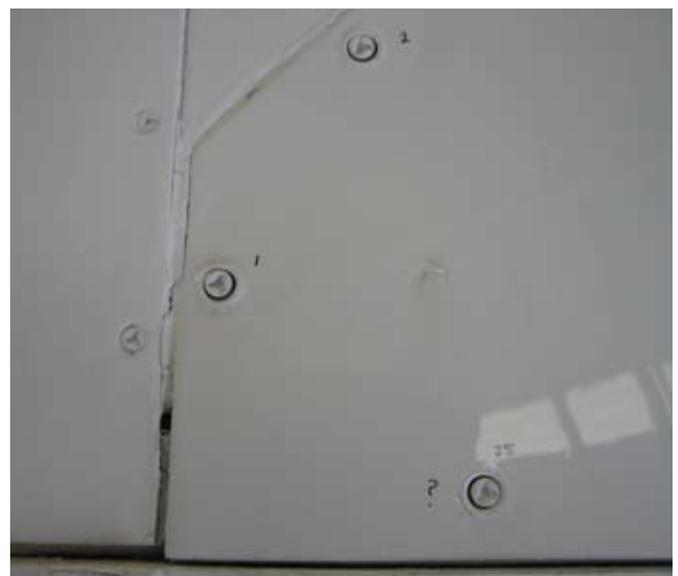
Figure 4

The similar panel on the right wing to fuselage joint was inspected. The grommets and bolts on this panel had all been painted and it was therefore very difficult to inspect the grommets (Figure 4). Four areas of the right panel in the region of grommets were then stripped of paint and it was determined that the flange thickness on these four grommets was less than specification and importantly, there were marks on the grommets consistent with the flanges having been abraded.

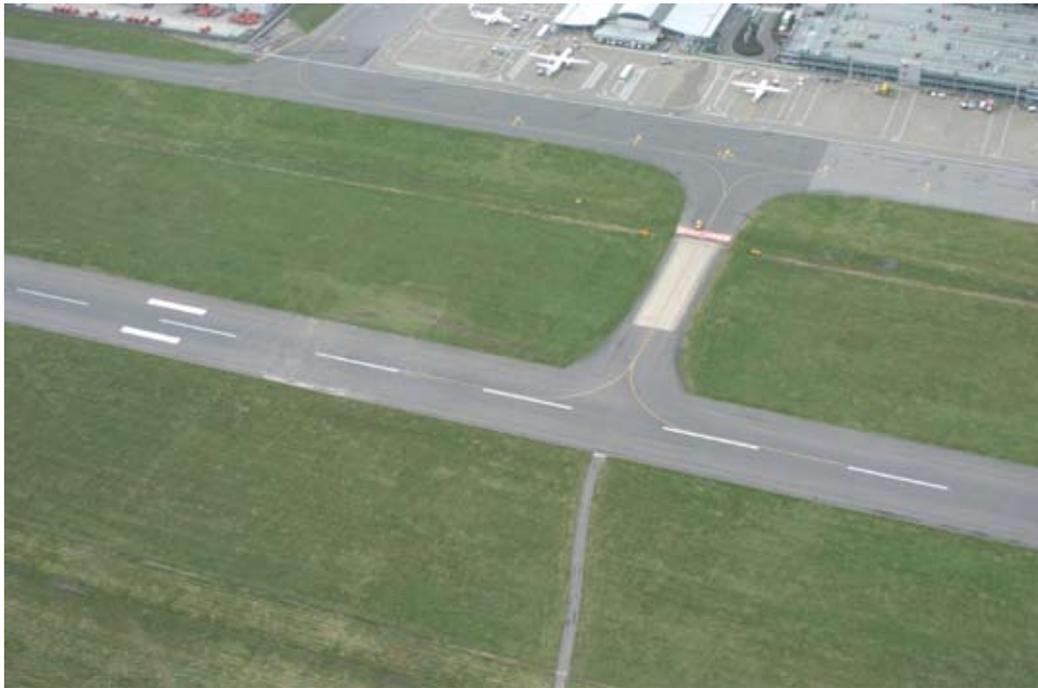
well as trying to steer using the tiller. Despite this the aircraft continued to veer to the right, crossing the mouth of Holding Point B1 (Figure 2 - aerial photograph) and departing the runway onto the grass. The pilots estimated the speed to be about 20 kts on leaving the runway, at which point the co-pilot cancelled the reverse thrust, and the aircraft came to a halt.

Holding point B1, Runway 20

Figure 2 is an aerial photograph of the location in which the tyre marks are visible. In Figure 3 it can be seen that the marks from the nosewheels are closer to the marks of the right mainwheels than to the marks of the left mainwheels, indicating that the aircraft was ‘skidding’ slightly to the left. The marks from both the inboard and outboard left mainwheels were consistent with all four brakes functioning normally, and with differential braking to the left. There were heavy scrubbing marks from the two nosewheel tyres, and there was a distinct

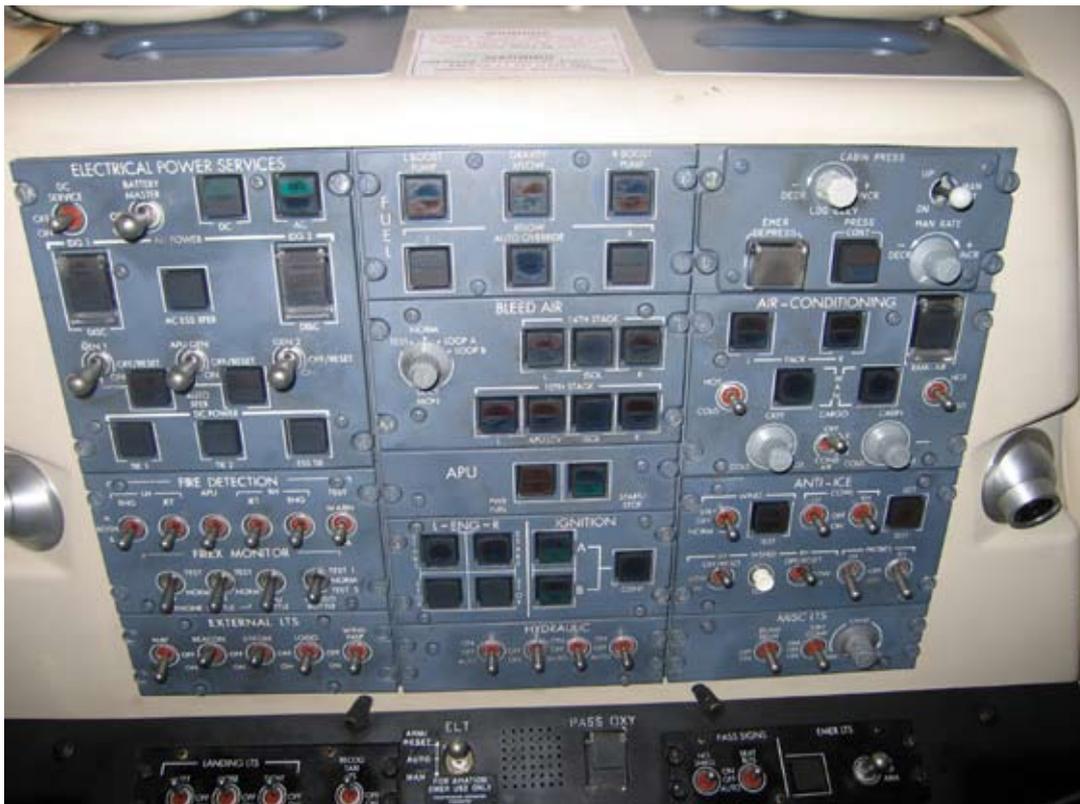
Figure 7
Overhead panel

There are selector switches for the hydraulic pumps on the overhead panel in the cockpit, as in Figure 7. The normal operating position for all four switches is down: Pump 1 AUTO, Pump 3A ON, Pump 3B AUTO, and Pump 2 AUTO.

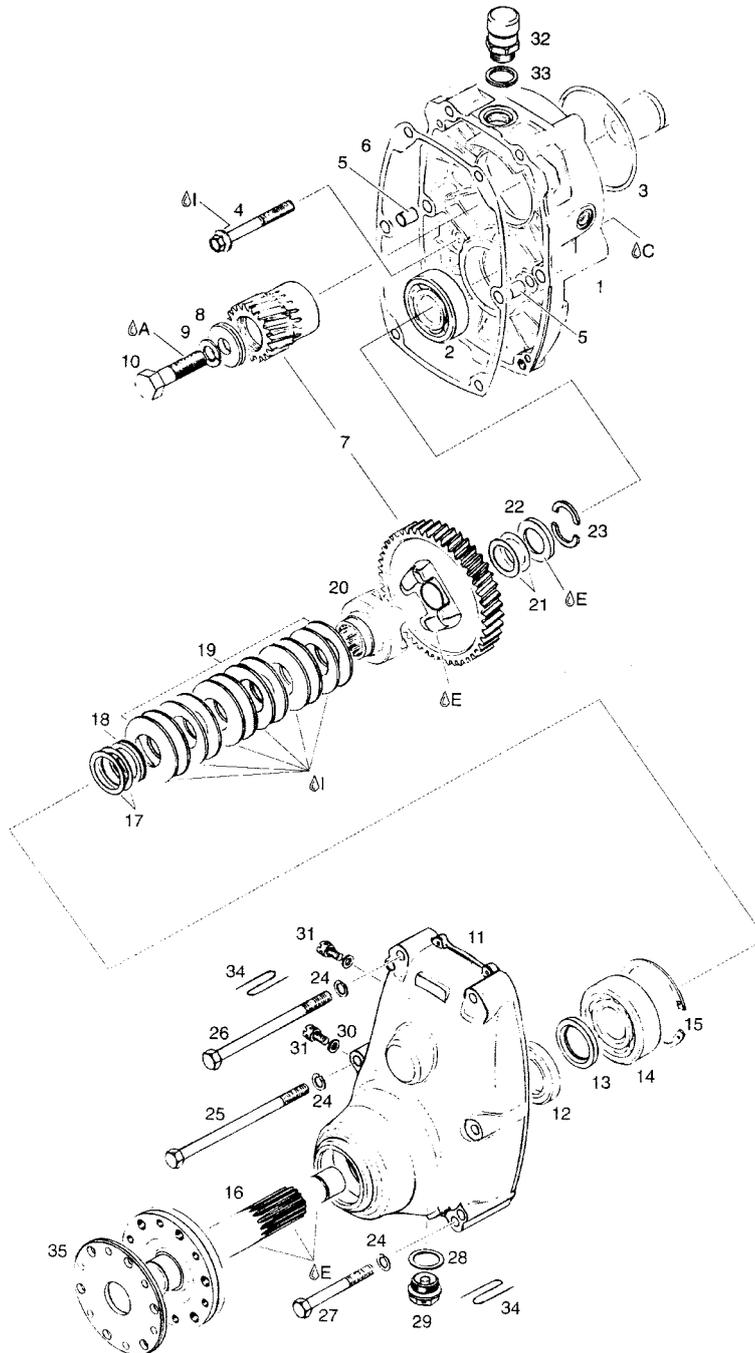
Figure 1

The Rotax 582 is a two-stroke engine and this unit was fitted with a reduction gearbox (see Figure 1). The propeller shaft, item 16 on Figure 1, rotates in two bearings

in the gearbox and is retained by two half-rings that sit in an annular groove in the shaft; these half-rings are housed inside an annular collar. The half-rings are known to wear and as a result require replacing during maintenance.

The engine had completed 600 hours and the gearbox had completed 27 hours since being overhauled. During the overhaul, which was undertaken by an engineer experienced with this type of engine, the half rings had been replaced.

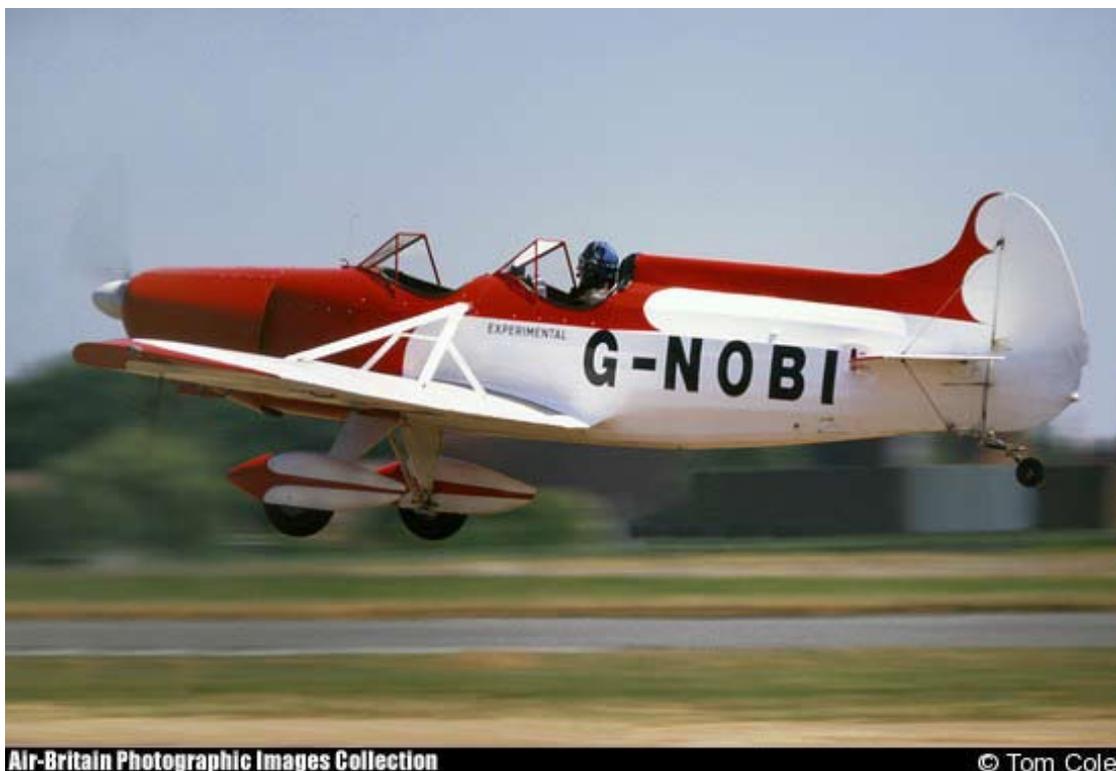
Figure 1

The Spezio DAL-1 is a single-engined, home-built aircraft and G-NOBI was fitted with a Continental C125-2 engine. It is a two-seat, low-wing monoplane with two cockpits arranged in tandem and with a tail-wheel landing gear, see Figure 1. As a result of the tandem cockpit layout it is sometime referred to as the 'Spezio Tuholer'. The aircraft has conventional primary flying controls but does not have flaps. Flight controls were fitted in both cockpits although the fuel management controls were only fitted to the rear cockpit.

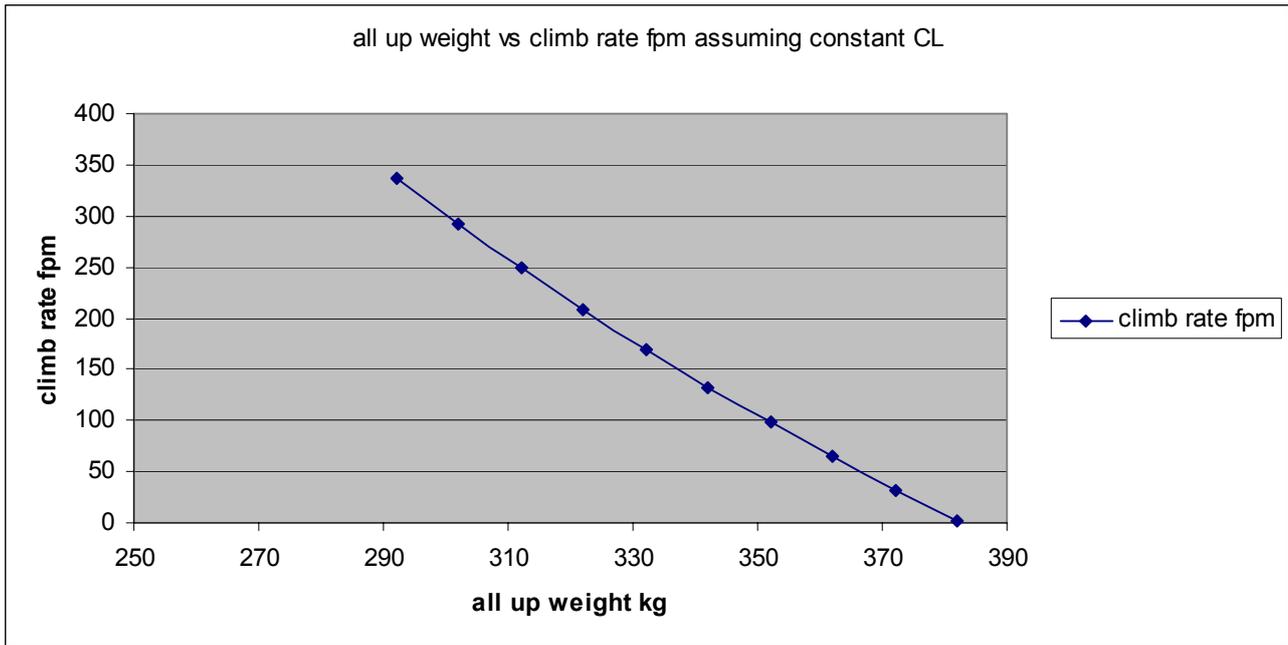
Figure 1

It can be seen that at a takeoff weight of 373 kg the aircraft designer estimated that the aircraft would have been able to achieve a rate of climb of less than 30 fpm, which is equivalent to a gradient, in still air, of approximately 1%.

The Fuji Robin EC-44-PM engine produced 50 bhp (brake horse power) when certified in the Dragon 200. The designer calculated that a rate of climb of 333 fpm at 292 kg equates to the engine producing only 39.5 bhp.
