CONTENTS

ACCIDENT

Aircraft Type and Registration:	Beech B200 Super King Air, G-BYCP	
No & Type of Engines:	2 Pratt & Whitney PT6A-42 turboprop engines	
Year of Manufacture:	1981	
Date & Time (UTC):	24 March 2007 at 1635 hrs	
Location:	Southend Airport, Essex	
Type of Flight:	Commercial Air Transport (Passenger)	
Persons on Board:	Crew - 2	Passengers - 5
Injuries:	Crew - None	Passengers - None
Nature of Damage:	Damage to nose fuselage, the nose landing gear and doors, and propeller tips	
Commander's Licence:	Commercial Pilot's Licence	
Commander's Age:	44 years	
Commander's Flying Experience:	3,800 hours (of which 2,200 hrs were on type) Last 90 days - 137 hours Last 28 days - 30 hours	
Information Source:	AAIB Field Investigation

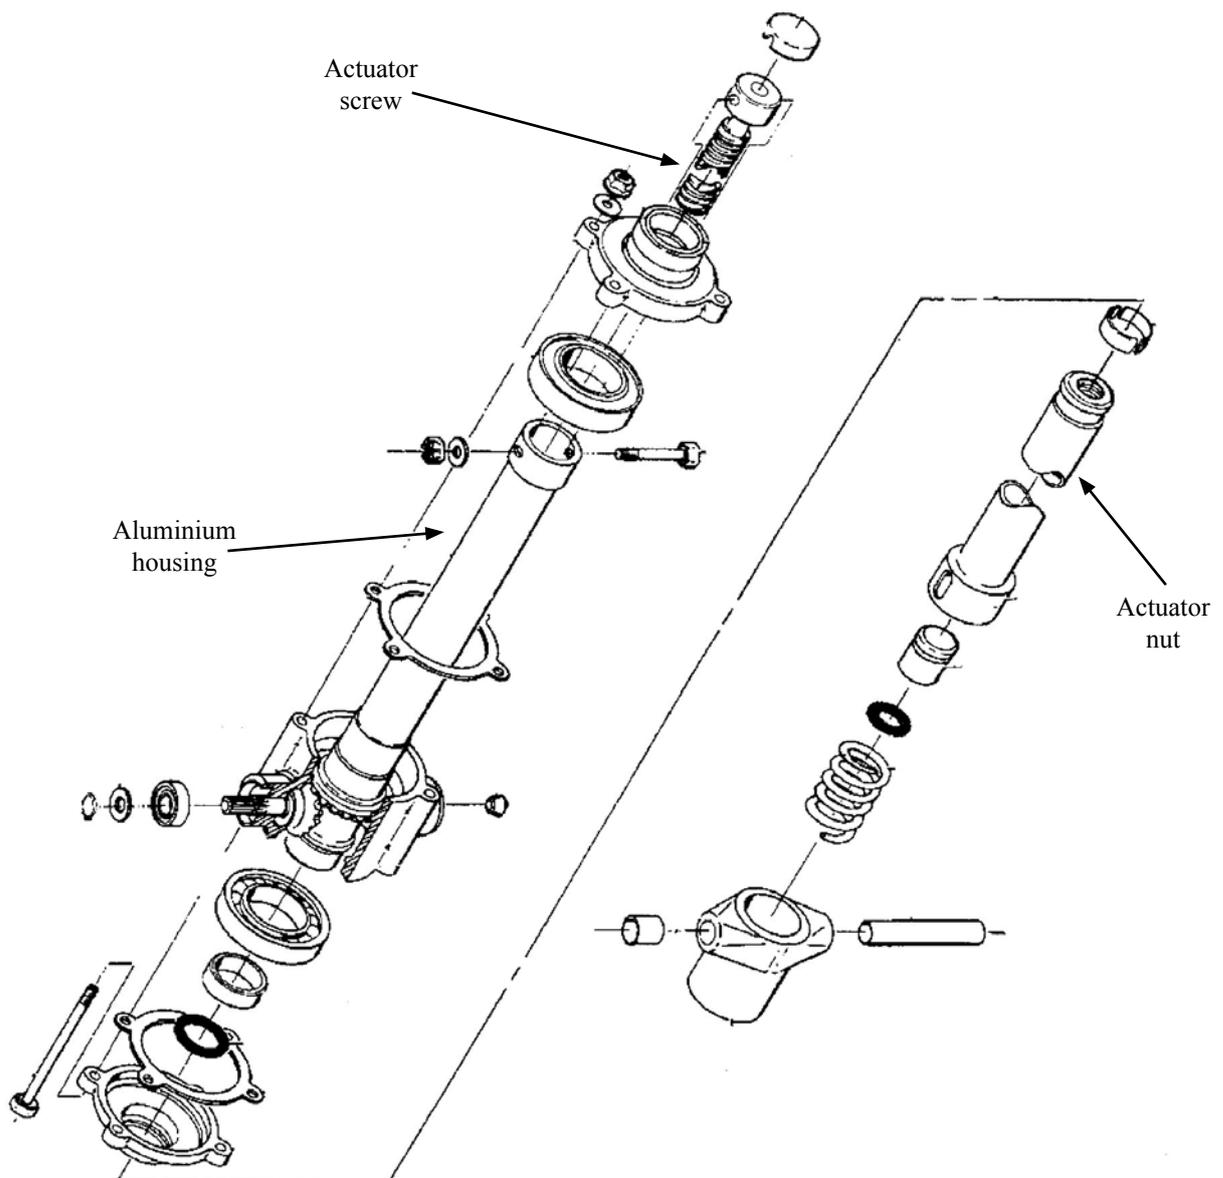
Figure 1

Nose Landing Gear Actuator Assembly

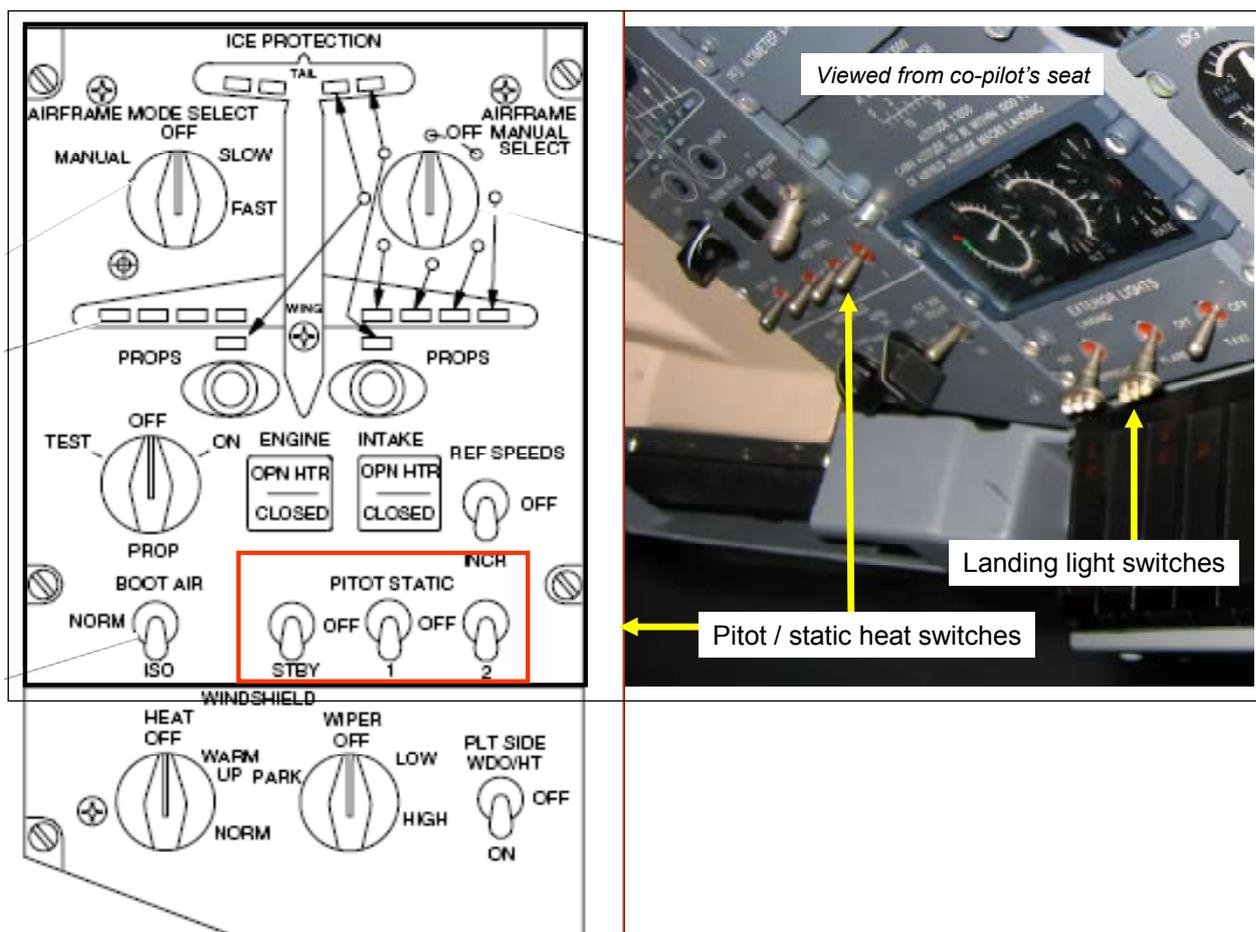
Figure 3

Pitot/Static probe heat switches – panel layout and cockpit view

The pitot heat switches were grouped together on the icing panel immediately above the commander's head. The switches were not large, and their throw was not great, such that it was difficult to be certain, when viewing the switches in isolation from either seat, whether they were all ON or all OFF. This was particularly true from the co-pilot's seat, looking up and across the panel (Figure 3), and even more so in low lighting conditions. However, this was only true when all the switches were in the same position: if one switch was in a different position from the other two, the fact was more obvious.

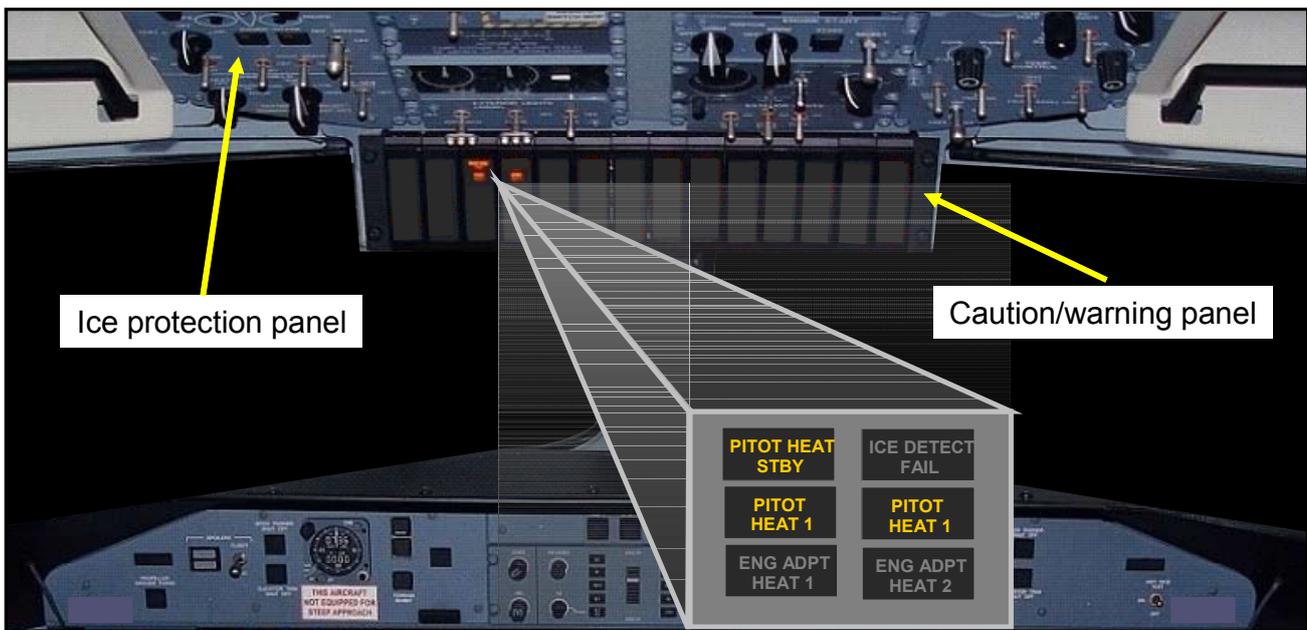
Figure 4

Each of the three pitot heat switches has an associated caution light on the CWP which illuminates if the systems fails or is switched off (Figure 4).

CWP arrangement and pitot/static caution lights

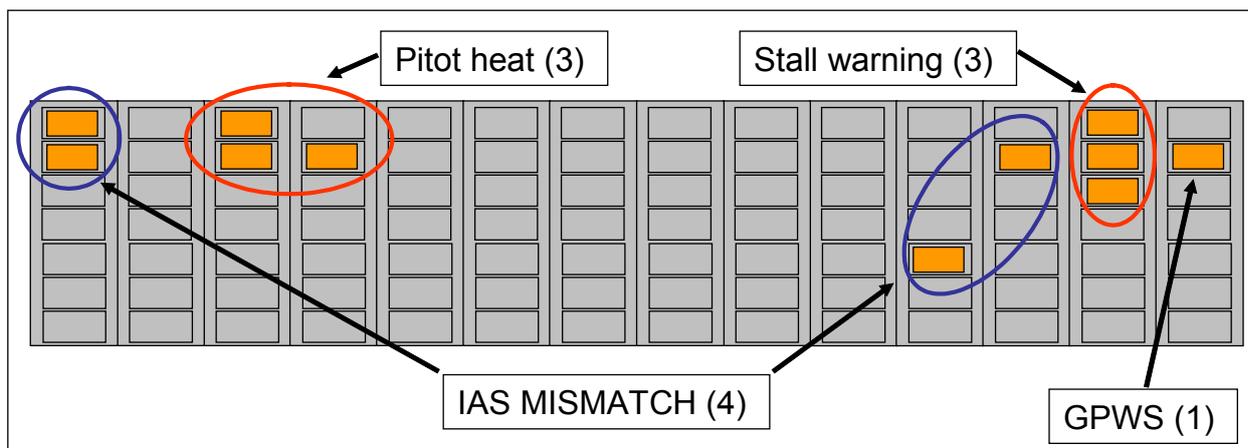
Figure 5

Distribution of CWP caution lights

of the stall protection modules or the AOA vanes. For other, non-critical failures, such as inputs from the ADCs, the SPS would not be prevented from generating a stall warning indication, so the CWP caution lights for such failures would be inhibited until 30 seconds after landing. The failure of both Mach number inputs to the SPS would generate all three cautions only after landing. The distribution of relevant CWP caution lights is shown at Figure 5.

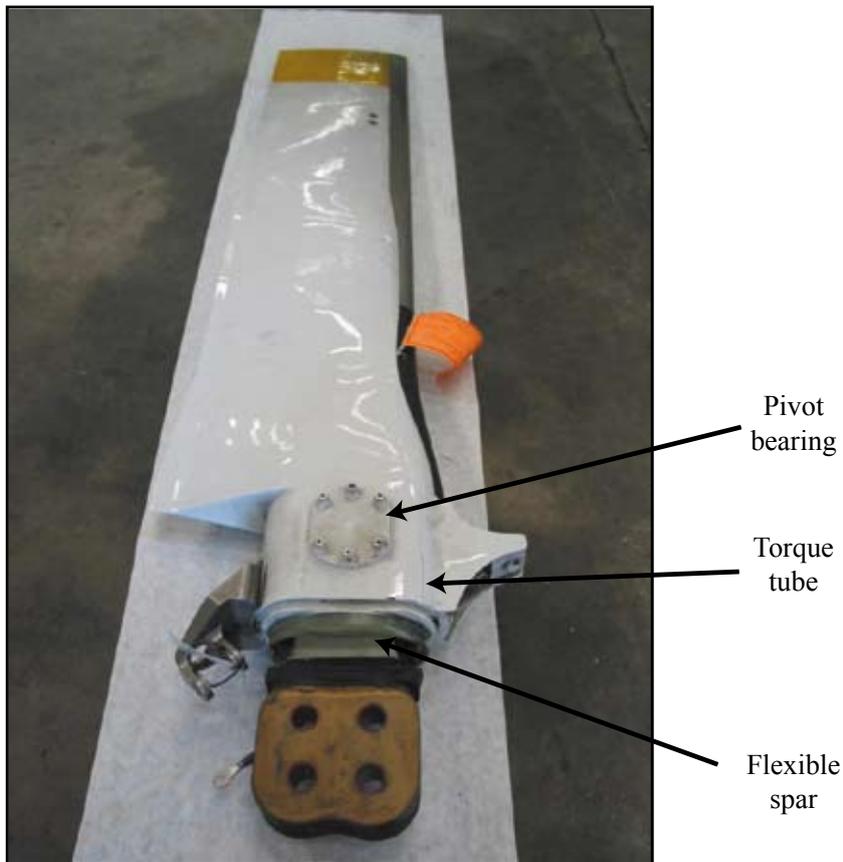
Figure 1
S-92 tail rotor blade

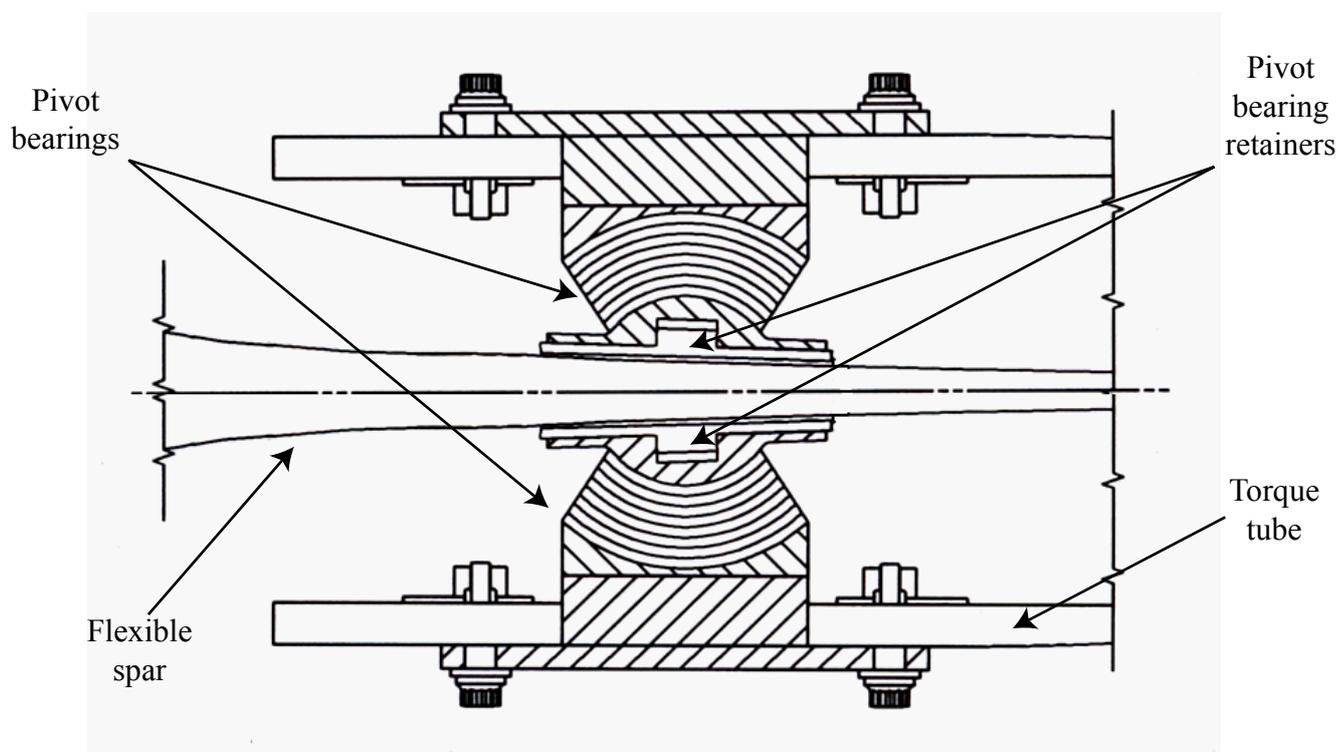
Figure 2

Two pivot bearings are located on either side of the flexible spar, towards the root of the blade (Figure 2). These are fixed to the torque tube and protrude into the hollow centre section of the blade. The bearings butt up against the flexible spar, which is clamped between them. The bearings are manufactured from an elastomeric material to allow some degree of movement between the flexible spar and the blade, in specific directions. One end of the bearing is bonded to a nut plate, which is attached to the torque tube with six fasteners. An end plate, comprising a metal disc with a central recess, is bonded to the other end of the bearing. This locates on to a retainer, comprising a metal disc with a central spigot, bonded to the surface of the flexible spar. The retainer further constrains the movement of the blade.

Longitudinal section through tail rotor pivot bearing

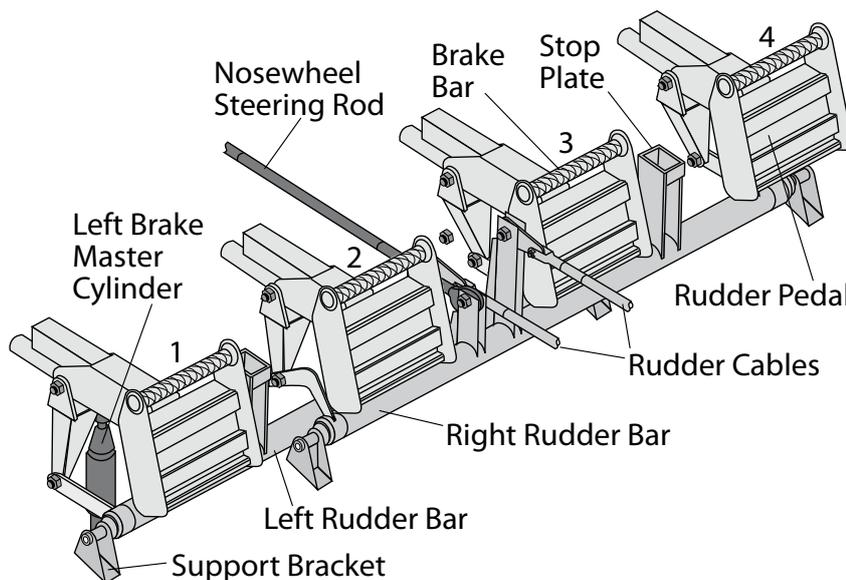
Figure 2

Primary flight controls are conventional, operated by dual cockpit controls. Rudder/brake pedal assemblies are numbered from 1 to 4 across the aircraft from left to right (Figure 2). The pedals are mounted on crank arms welded to two rotatable cross-shafts in the cockpit, known as rudder bars, with the left pedal of each pair (Nos 1 and 3) fixed to the left bar and the right pedals (Nos 2 and 4) fixed to the right bar. A crank arm on each bar is connected by a cable-fairlead system to operating levers attached to the rudder. The two bars are thus interconnected by the loop formed by the cables and the pivoting rudder. Two springs maintain the rudder bars centralised when the pedals are unloaded. An adjustable primary stop provided for each rudder bar limits the forward rotation of the bar (ie forward displacement of the respective pedals); these stops form the primary travel limiters for the system.

Rotation of the rudder bars also steers the nosewheel leg, via a control rod driven by a crank arm fixed to the right bar (Figure 2).

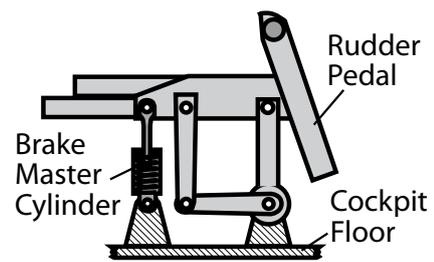
Figure 3

For each pedal, a pin-jointed parallelogram-type linkage pivoted to the respective rudder bar (Figure 3) maintains

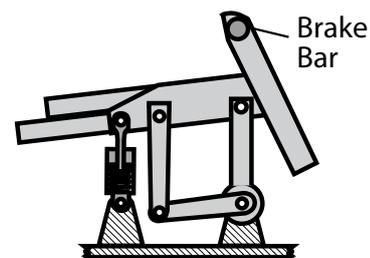
Figure 5

the vertical orientation of the pedal constant as it is displaced fore and aft to operate the rudder (Figure 4). The linkage allows each pair of pedals to be pivoted, by pushing a brake bar at the top of one of the pedals, to drive the master cylinder piston (Figure 5) and hence apply hydraulic pressure to the brake on the respective main wheel.
