CONTENTS

SPECIAL BULLETINS

COMMERCIAL AIR TRANSPORT

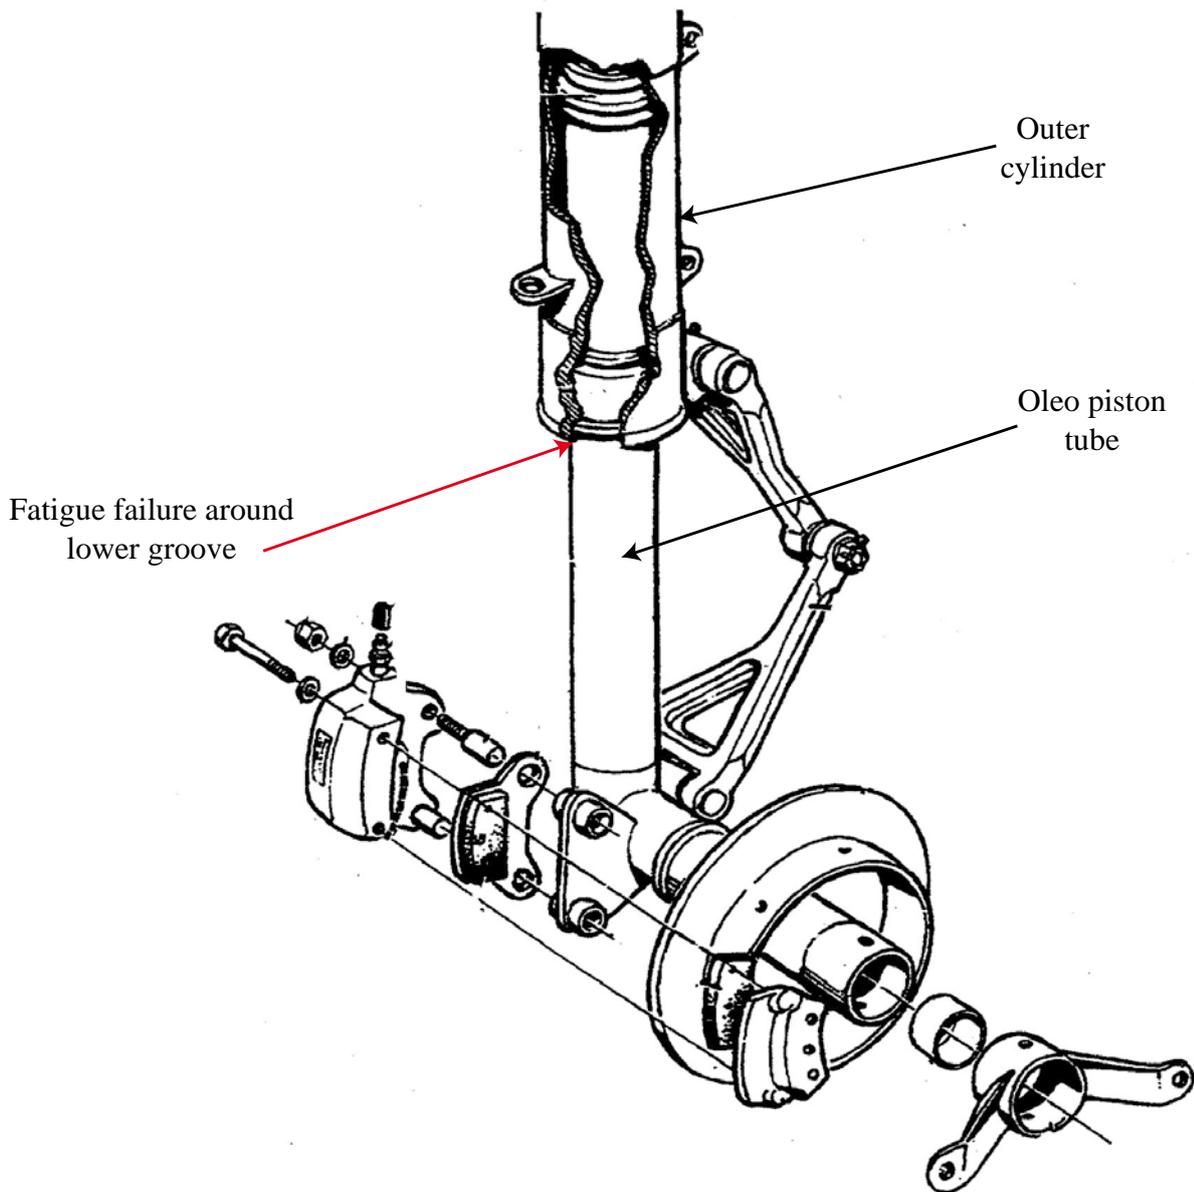
Figure 1

oleo piston tube, integral with the wheel axle, which operates within the outer cylinder to attenuate loads from the landing gear to the airframe on touchdown (Figure 1). The cylinder is connected to the axle via a torque linkage. The landing gear is maintained 'on condition' and there had been no history of loss in oleo pressure, or fluid leaks from the seals on the subject leg. It was not possible to establish the service history of the failed unit.

Diagram of the Robin HR200 Main Landing Gear unit

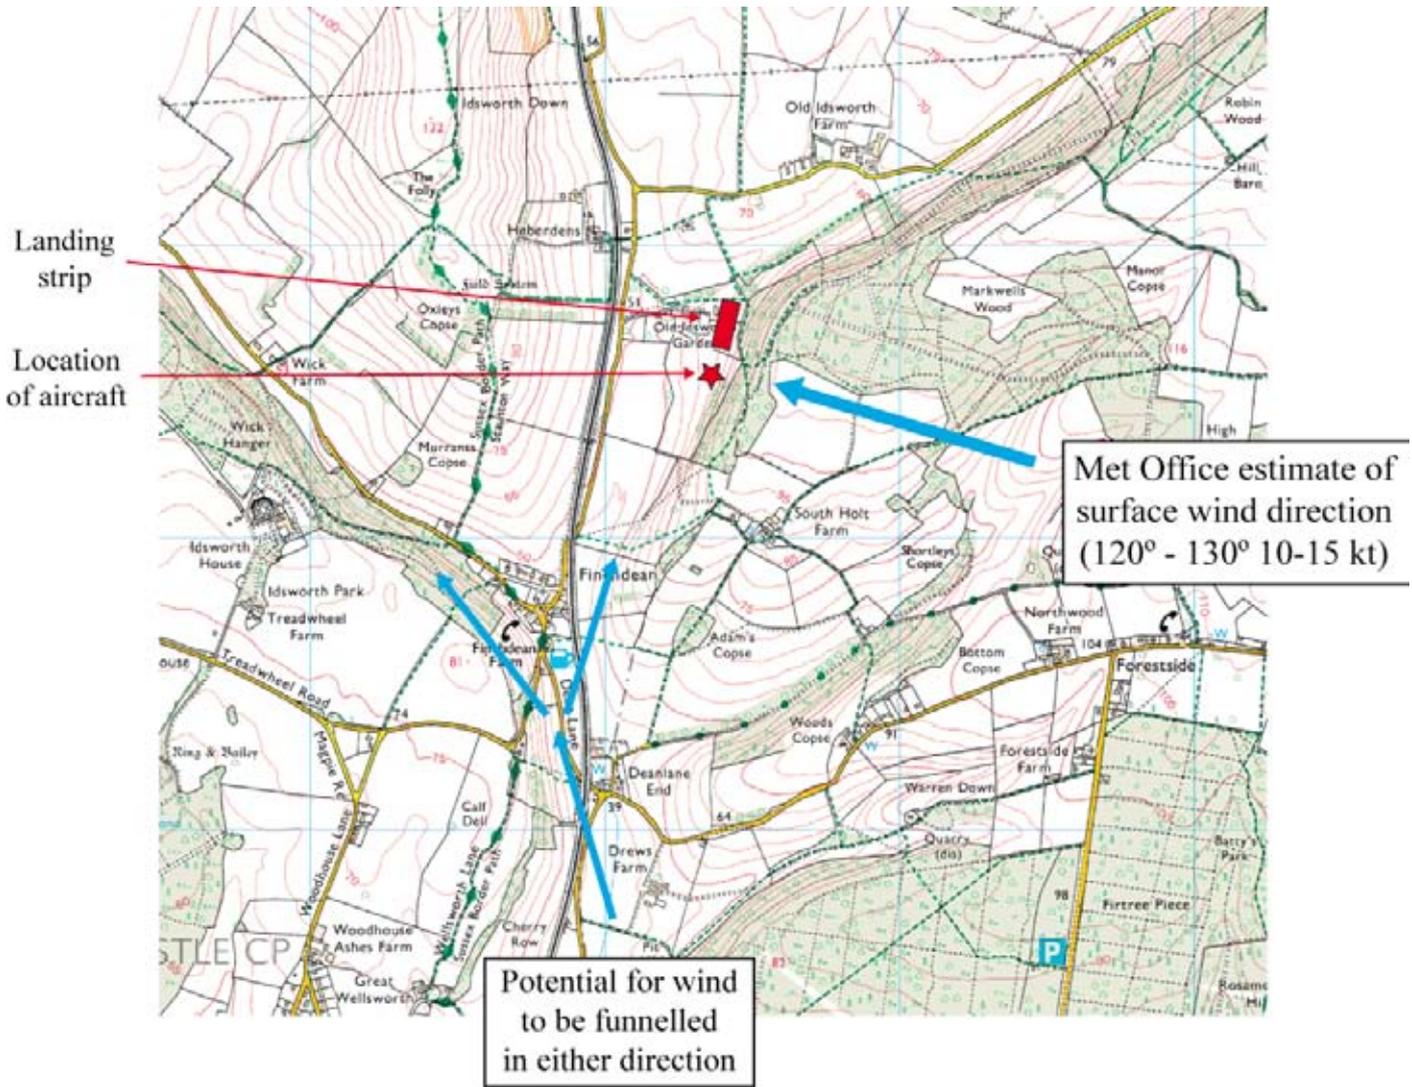
Figure 1

There are ridges to the east and west of the strip, which lies close to the foot of the western ridge (Figure 1). The wind direction at the time would have placed the strip downwind of the ridge and downdraughts and

The pilot attributed the accident to the downdraught created by the adjacent hills. This is a well known phenomenon and pilots are advised against flying at low level downwind of high ground, particularly in strong wind conditions, or in aircraft with low wing loadings that are susceptible to gusts.
