## CONTENTS

### COMMERCIAL AIR TRANSPORT

| Boeing 757-3CQ | G-JMAB | 12-Dec-07 | 1 |

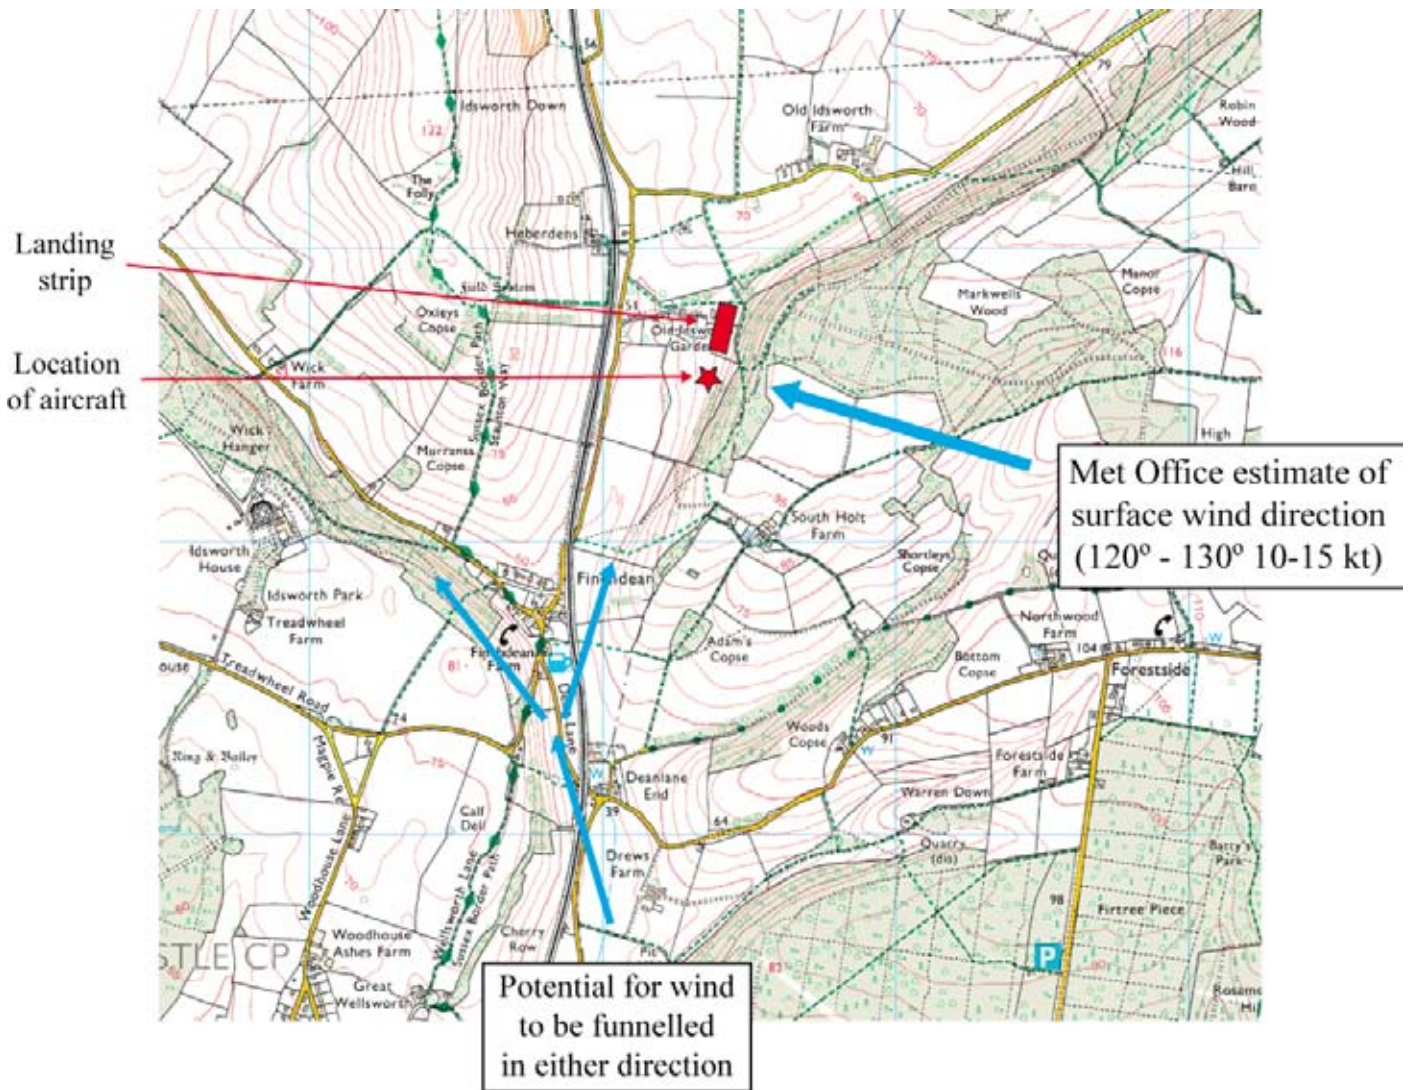
Figure 1

There are ridges to the east and west of the strip, which lies close to the foot of the western ridge (Figure 1). The wind direction at the time would have placed the strip downwind of the ridge and downdraughts and

The pilot attributed the accident to the downdraught created by the adjacent hills. This is a well known phenomenon and pilots are advised against flying at low level downwind of high ground, particularly in strong wind conditions, or in aircraft with low wing loadings that are susceptible to gusts.
