SPECIAL BULLETINS

Airbus A340-313	G-VAIR	27-Apr-08	1
-----------------	--------	-----------	---

(ALL TIMES IN THIS BULLETIN ARE UTC)

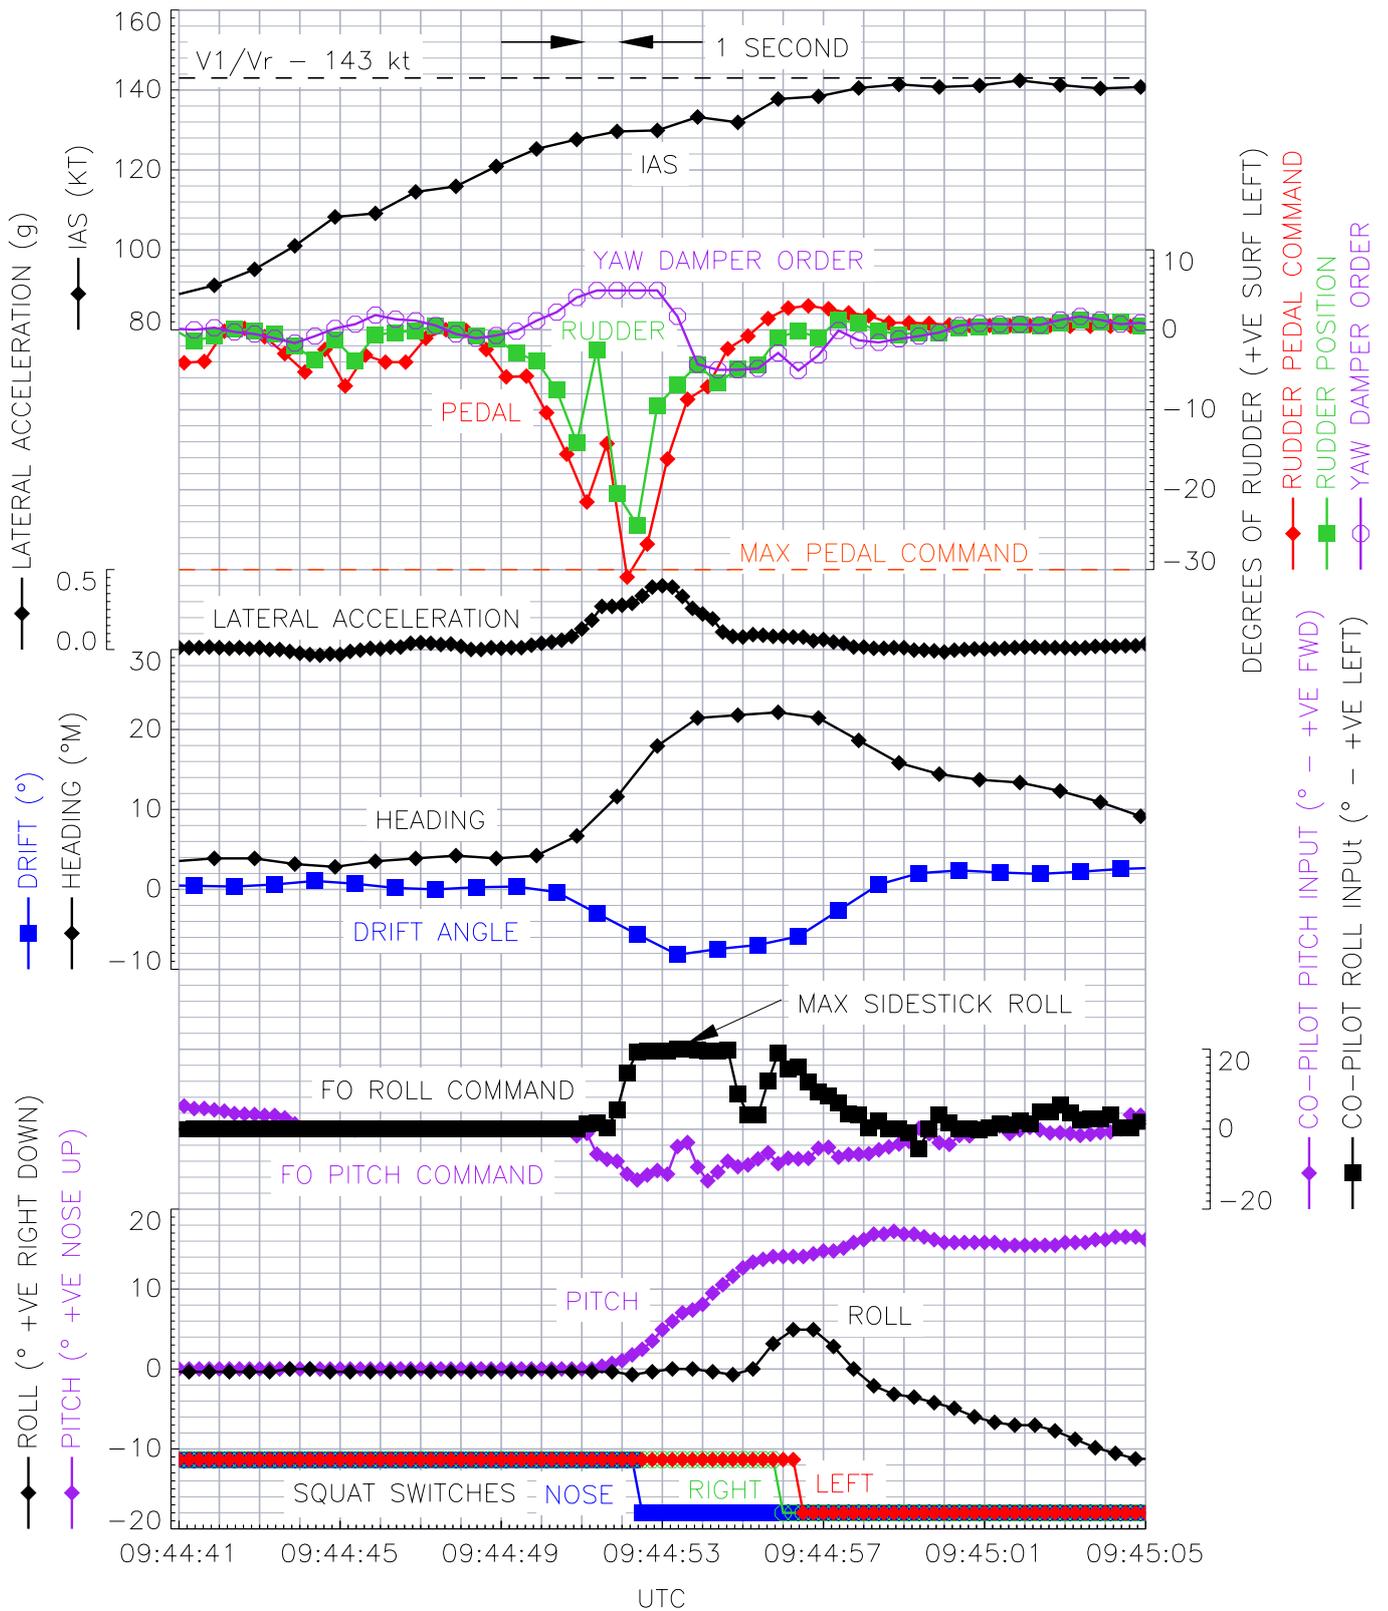
At 0944:13 hrs the thrust levers were advanced and the aircraft started to accelerate. With the exception of an initial left pedal/rudder input, the pedal/rudder inputs were minor and to the right; heading remained within 1.5° of runway heading (004°M). Figure 4 shows salient recorded parameters from the point when the aircraft accelerated through an indicated airspeed of about 90 kt.

FDR Parameters showing control inputs and aircraft motion.
(Incident to G-DBCI on 18 April 2007)

The pedal and rudder deflection reduced over the next 3.5 seconds and the heading stabilised at approximately 022°M. Drift angle peaked at 8° to the left of heading and started slowly reducing. During the rotation period, significant left roll was being commanded but this was opposed by the secondary roll effect of the yaw to the right and, with both main landing gear on the ground, main gear oleo compression. Hence no significant roll attitude was observed until the left roll command was brought to near neutral, resulting in a slight right

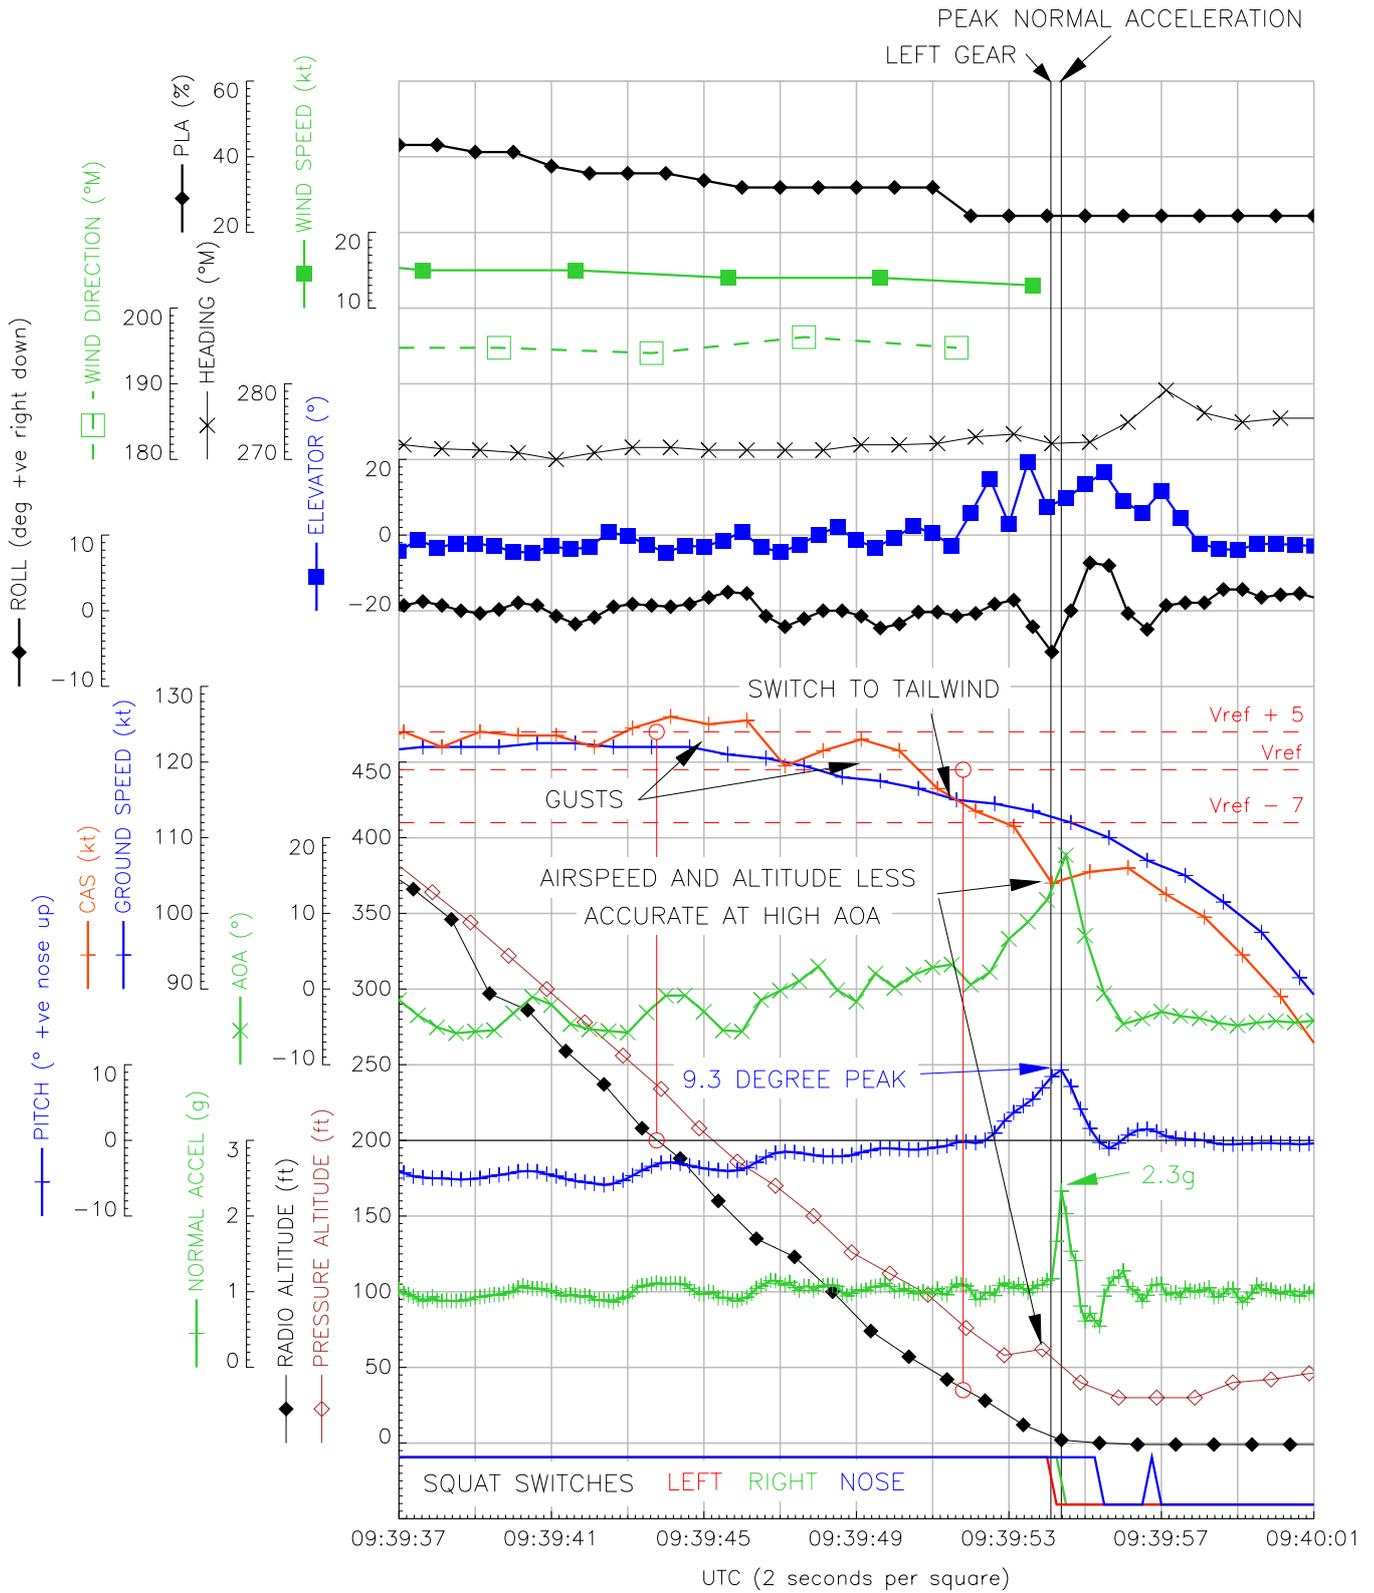
Figure 1
Salient FDR Parameter
(Accident to HB-IYU on 18 August 2007)

Figure 1 shows the salient parameters from the FDR, covering the approach from approximately 350 ft agl. This also shows the relevant target speeds for comparison.

Referring to the PAPIs, the crew observed that they were slightly high, which was then corrected. At the point the EGPWS issued a “MINIMUMS” automatic callout, the non-handling pilot issued a “+2” speed update, shortly followed by a “+1” call, just after the EGPWS “FIFTY” callout.

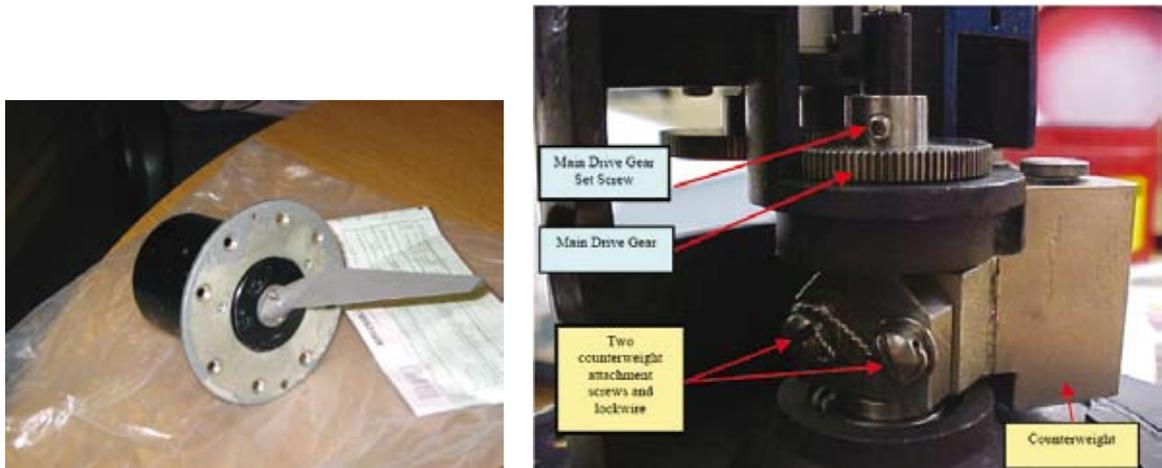
Schematic of AOA sensor

random readings of the resolver outputs with respect to vane displacement, which thus resulted in the right ADC receiving erroneous angle of attack data. An exploded view of an AOA sensor, together with photographs of an intact unit and the internal gear train, is shown at Figure 3.

The workshop report from 2005 contained no detail as to the nature of the repair; however, during the AAIB supervised examination, it was apparent, from its pristine condition, that the vane had been renewed. An internal examination revealed that a slight seepage had occurred from an oil-filled damper. When the unit was placed on test, with the resolver outputs being displayed on an oscilloscope and a digital voltmeter, a small calibration error was noted. The vane was rotated over its full range of movement and although the test initially appeared satisfactory, it was found that a slow rate of vane rotation revealed an 'open spot' for resolver No 2 at the approximate 29° position, possibly as a result of a contaminant particle in the brush-type resolver pick-off. In the opinion of the overhaul agent, this feature almost certainly accounted for the intermittent failure
