CONTENTS

SPECIAL BULLETINS

Summary of:	Aircraft Accident Report No: 2/2007	62
	Report on the serious incident to Boeing 777-236, G-YMME on departure from London Heathrow Airport on 10 June 2004

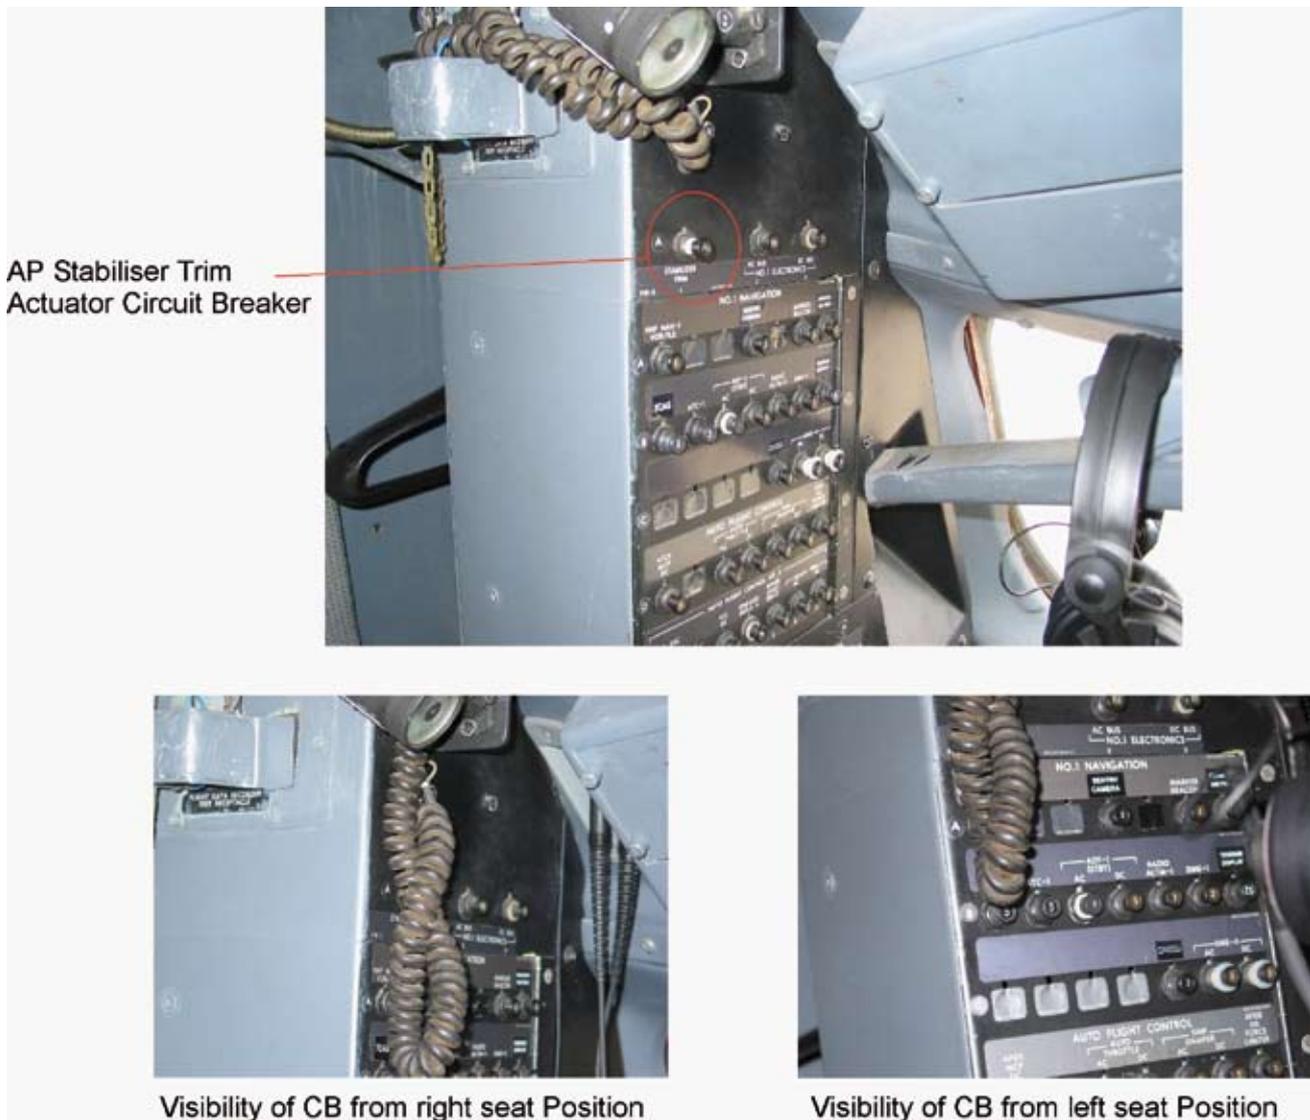
CB panel with its lead dropping down in a loop beside the panel. This coil of lead to the light is in such a position that it obscures the CB. Refer to Figure 3 below.
