CONTENTS

(ALL TIMES IN THIS BULLETIN ARE UTC)

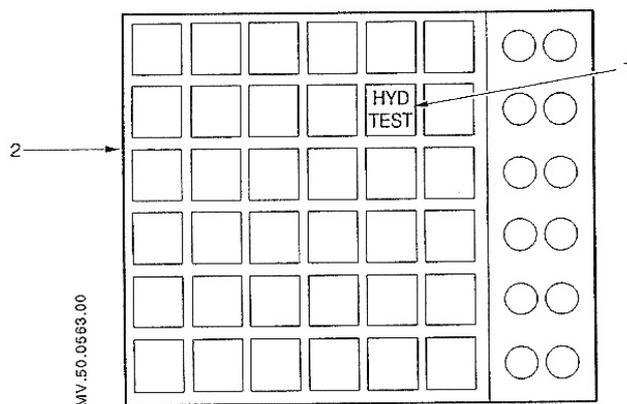
Figure 1

- Failure simulation (Figure 1)

In steady cruise flight, actuating the "HYD TEST" (1) pushbutton on the central console (2) produces the same effects as a real failure :

- . The hydraulic pump pressure is by-passed.
- . The main rotor accumulators give hydraulic assistance for a limited time.

The only difference from the real failure is that the tail rotor accumulator is discharged by this action and the pedal control loads are increased.

In stabilized cruise flight conditions, depress the "HYD TEST" (1) (Figure 1) pushbutton. The red HYDR light illuminates, the "gong" sounds immediately. Reduce collective pitch to adjust airspeed around 60 kt. Reset the "HYD TEST" (1) pushbutton (up position) to restore hydraulic pressure in tail rotor accumulator. Cut-off the hydraulic pressure switch (Figure 2) on the collective lever, the control loads are felt within 1 or 2 seconds. The "gong" sounds again. Apply the appropriate emergency procedure (red HYDR warning light) SECTION 3.3 page 2 of the present Flight Manual.
