## CONTENTS

**(ALL TIMES IN THIS BULLETIN ARE UTC)**

## ACCIDENT

<b>Aircraft Type and Registration:</b>	ATR 72-212A, D-ANFH	
<b>No &amp; Type of Engines:</b>	2 Pratt and Whitney PW127F turboprop engines	
<b>Year of Manufacture:</b>	2001	
<b>Date &amp; Time (UTC):</b>	17 September 2005 at 1202 hrs	
<b>Location:</b>	Guernsey Airport	
<b>Type of Flight:</b>	Public Transport (Passenger)	
<b>Persons on Board:</b>	Crew - 4	Passengers - 63
<b>Injuries:</b>	Crew - None	Passengers - None
<b>Nature of Damage:</b>	Damage to lower rear fuselage	
<b>Commander's Licence:</b>	Airline Transport Pilot's Licence	
<b>Commander's Age:</b>	54 years	
<b>Commander's Flying Experience:</b>	10,000 hours (of which 517 were on type) Last 90 days - 110 hours Last 28 days - 41 hours	
<b>Information Source:</b>	AAIB Field Investigation

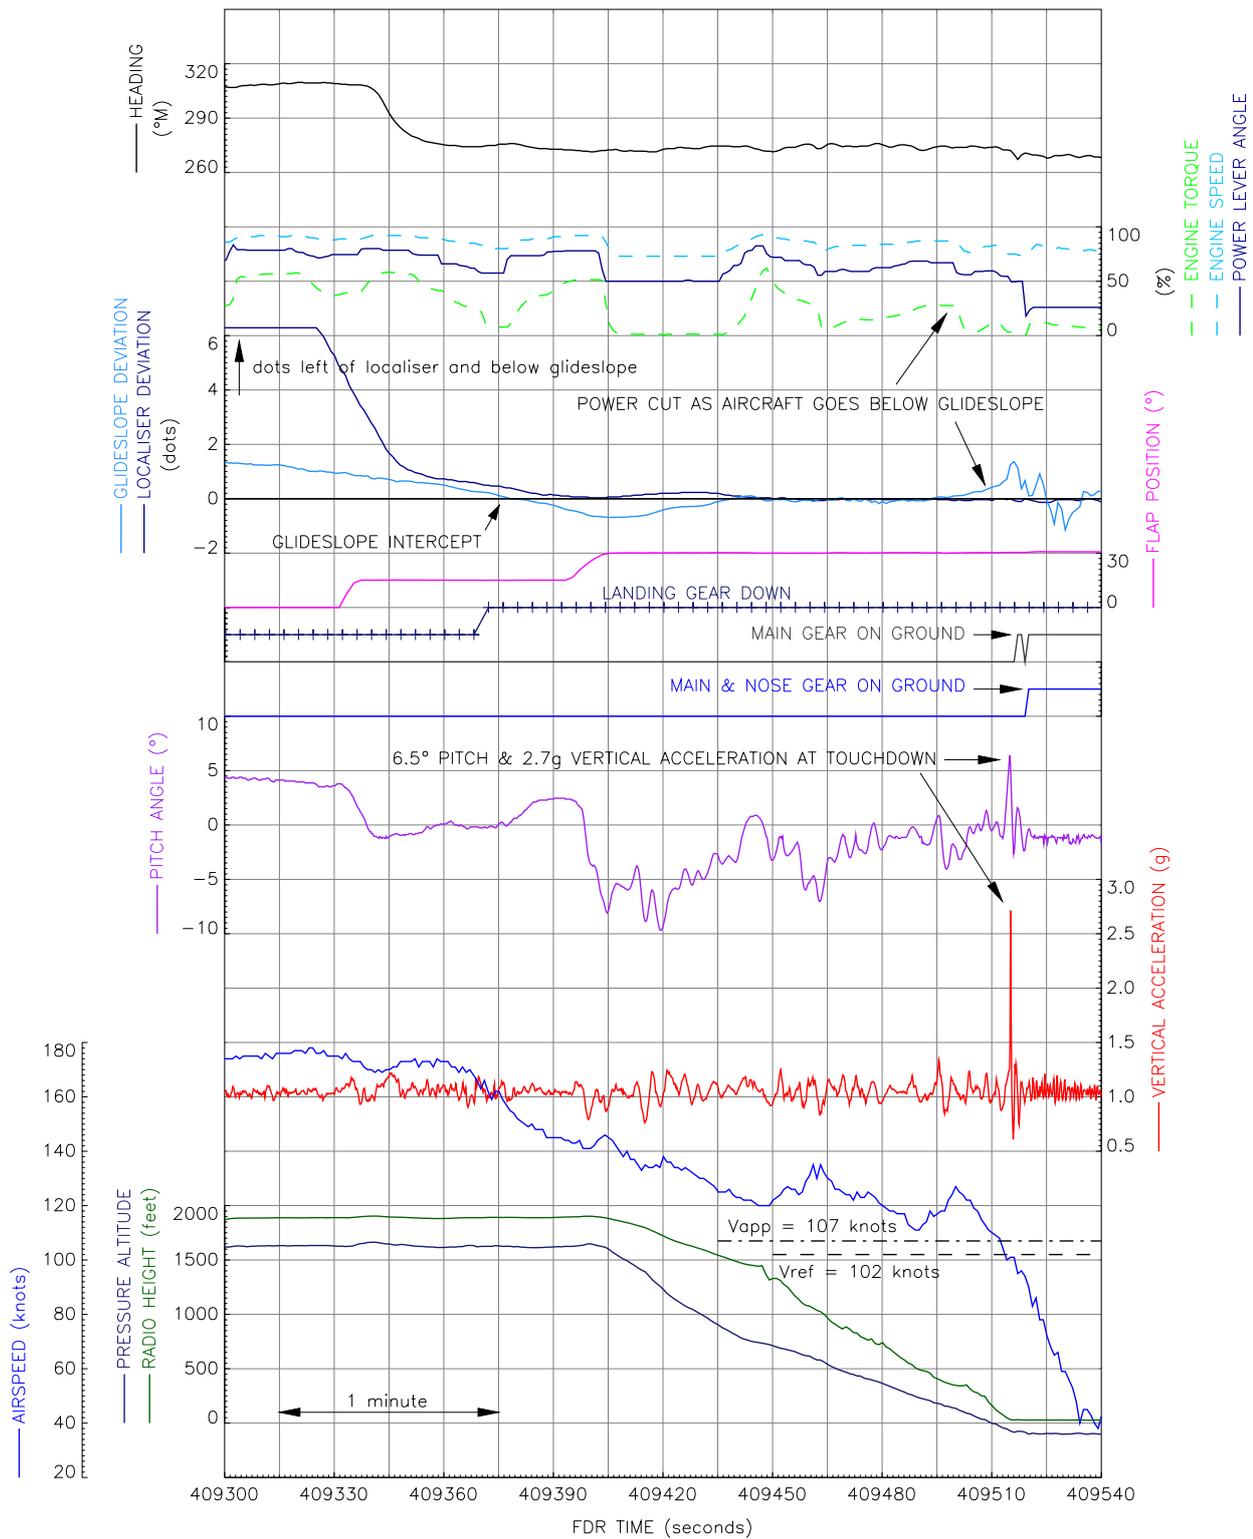
A time-history of the relevant parameters from the FDR during the approach and landing is shown at Figure 2. The data presented starts just over three and a half minutes before the touchdown with the aircraft in level flight at an altitude of approximately 1,800 ft, whilst flying at an airspeed of 175 kt and with the flaps and landing gear up. Some 30 seconds later, Flap 15 was selected and the aircraft turned to the left through 34°, to 275°M, on to an intercept with the Runway 27 localiser. Height and speed remained unchanged.

**Figure 2**  
 Salient FDR Parameters – Approach and Landing  
 (Accident to D-ANFH on 17 September 2005)

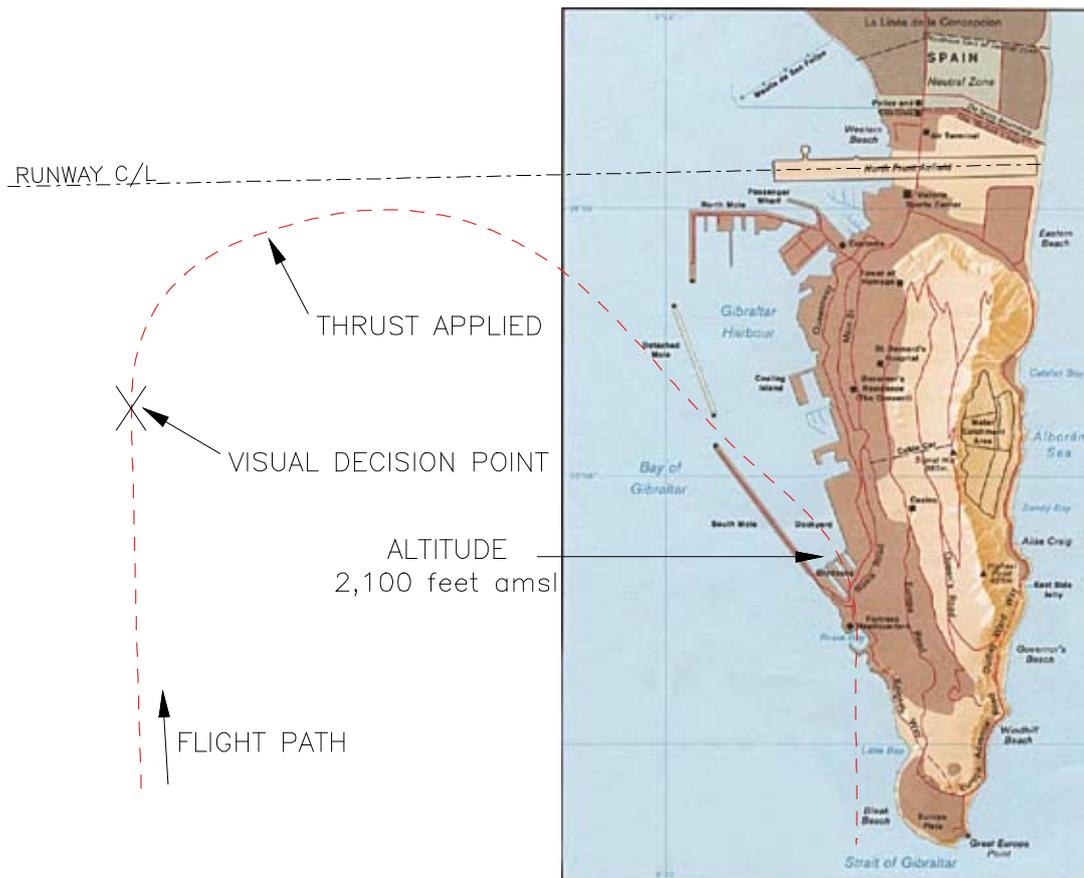
**Figure 1**

The flight path of the aircraft during the incident period was constructed from data recorded on the QAR. This flight path is presented in Figure 1. It commences as G-MONE tracked north on 001°M towards the VDP. At the VDP, the aircraft was at an altitude of approximately 1,000 ft, at a computed airspeed of 133 kt, and was descending at just under 900 ft/min. G-MONE then entered a descending turn to the right, achieving a maximum recorded bank angle of just over 26°.

Thirty seconds after the aircraft commenced the turn, the engine thrust increased for the 'Go-Around'. At this point G-MONE was descending through 650 ft at 134 kt, with a bank angle of 8° to the right and turning through a heading of 077°M. The aircraft descended a further 100 ft to 550 ft before it entered a climb. It then achieved a climb rate of about 3,000 ft/min whilst turning onto a heading of 140°M. It remained on this heading for 12 seconds before turning left onto a heading of 134°M for a further 12 seconds, followed by a turn to the right onto a heading of 180°M. As G-MONE turned onto the heading of 180°M, it was overland and climbing through 2,100 ft.

Reconstructed flight path of G-MONE

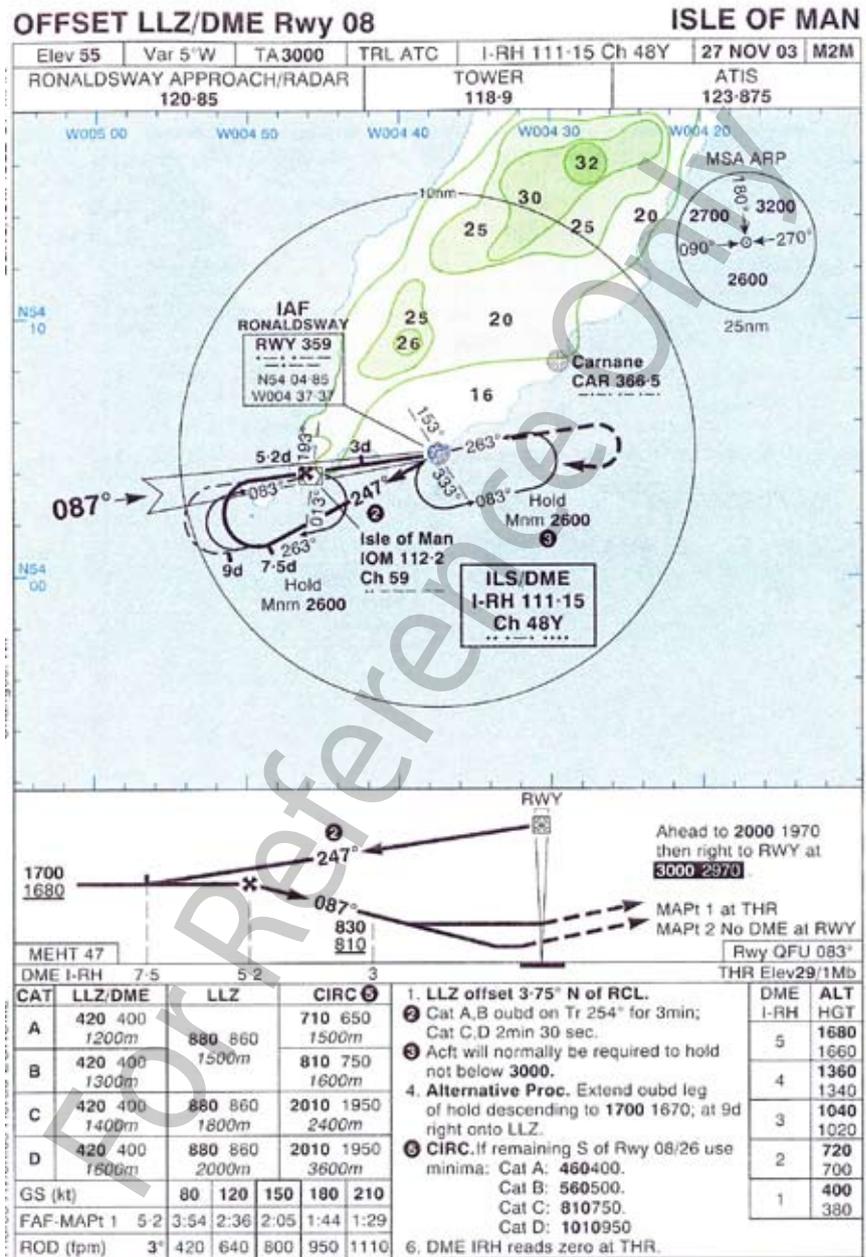
Figure 1

The aircraft took off from Manchester Airport at 0817 hrs with the commander acting as the handling pilot. During the cruise the commander briefed for a localiser/DME approach to Runway 08 at the Isle of Man, Figure 1. He recalled selecting the ILS frequency on his instruments for the approach whilst the first officer retained the Isle of Man (IOM) VOR. The crew were given radar vectors by ATC, to position the aircraft onto an intercept heading for the final approach and were cleared for the localiser/DME approach. The commander stated that, at about this time, and for reasons he cannot recall, either he or the first officer changed the ILS frequency previously selected on the commander's instruments to the IOM VOR frequency. The aircraft was fully configured for landing and the first officer reported to ATC that they were established on the localiser. The Approach controller then instructed the crew to transfer to the Tower frequency. The commander later stated that when he established the aircraft on the final approach track, by reference to the IOM VOR, he believed he was in fact establishing on the localiser. The IOM VOR antenna is positioned 5.2 nm to the west of the I-RH Localiser/DME antenna on the final approach track to the airfield, Figure 1<sup>1</sup>.

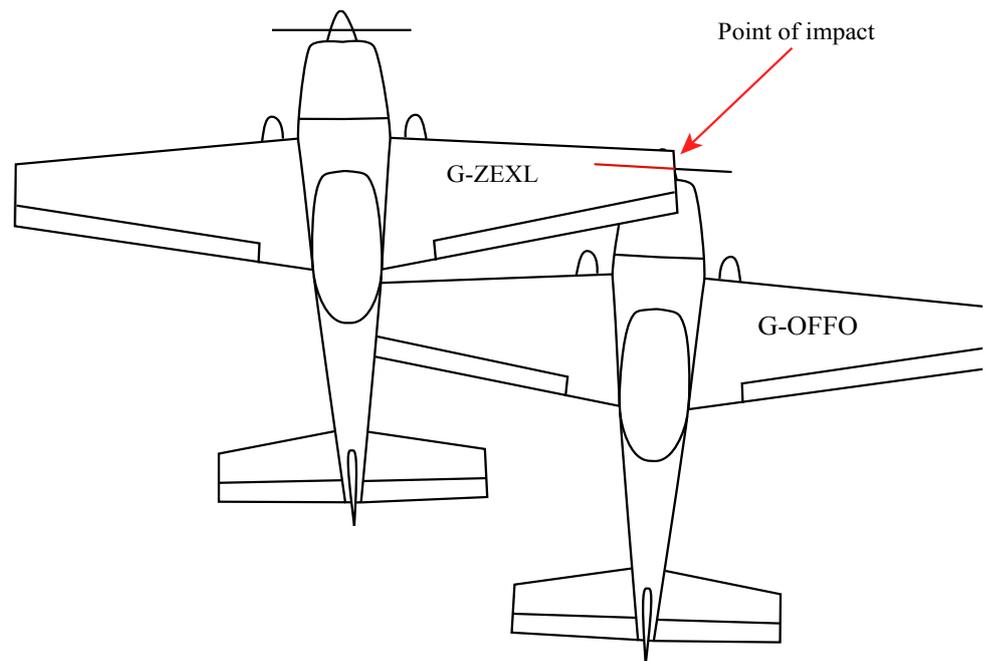
Figure 1

Both pilots agreed that the primary cause of the incident was a breakdown in communication. The pilot of 'XL' was not aware of the position of the other aircraft and thought that he was clear to turn to the right. This situation occurred because the pilot of 'FO' had not fully communicated his intention to take up the 'deep echelon right' position, merely that he would reposition

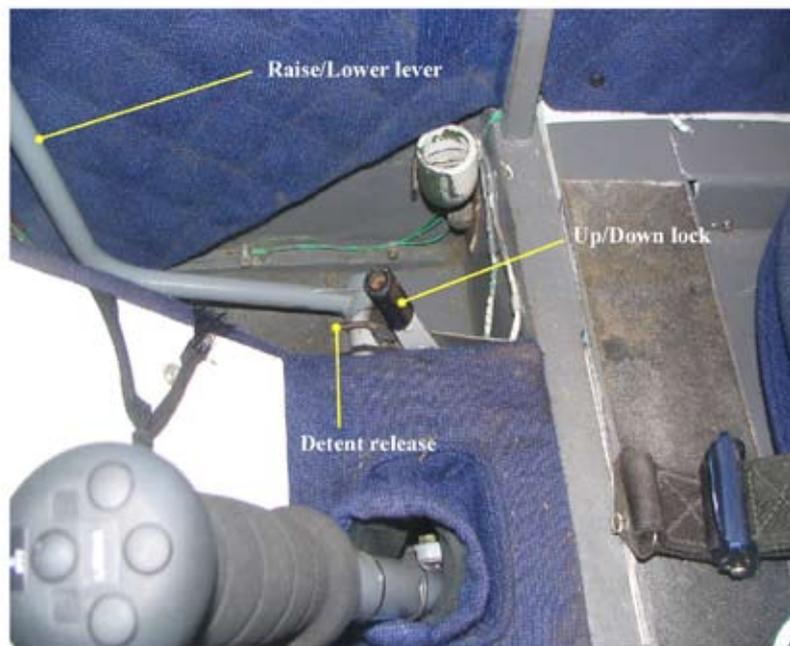
**Figure 1**

flown with the gear locked down and, when it came to extend it before landing, he simply operated the Raise/Lower lever to reverse its previous position, even though this retracted the gear. He pointed out that the positions were not labelled, but doubts whether this would have prevented the error.

Landing gear controls, G-AVKD
