(ALL TIMES IN THIS BULLETIN ARE UTC)

ACCIDENT

Aircraft Type and Registration:	Airbus A319-111, G-EZEU	
No & Type of Engines:	2 CFM CFM56-5B5/P turbofan engines	
Year of Manufacture:	2004	
Date & Time (UTC):	24 November 2005 at 0835 hrs	
Location:	Nottingham East Midlands Airport	
Type of Flight:	Public Transport (Passenger)	
Persons on Board:	Crew - 6	Passengers - 110
Injuries:	Crew - None	Passengers - None
Nature of Damage:	Damage to left wing tip and left wing tip of a neighbouring aircraft	
Commander's Licence:	Airline Transport Pilot's Licence	
Commander's Age:	45 years	
Commander's Flying Experience:	10,670 hours (of which 756 were on type) Last 90 days - 93 hours Last 28 days - 35 hours	
Information Source:	AAIB Field Investigation

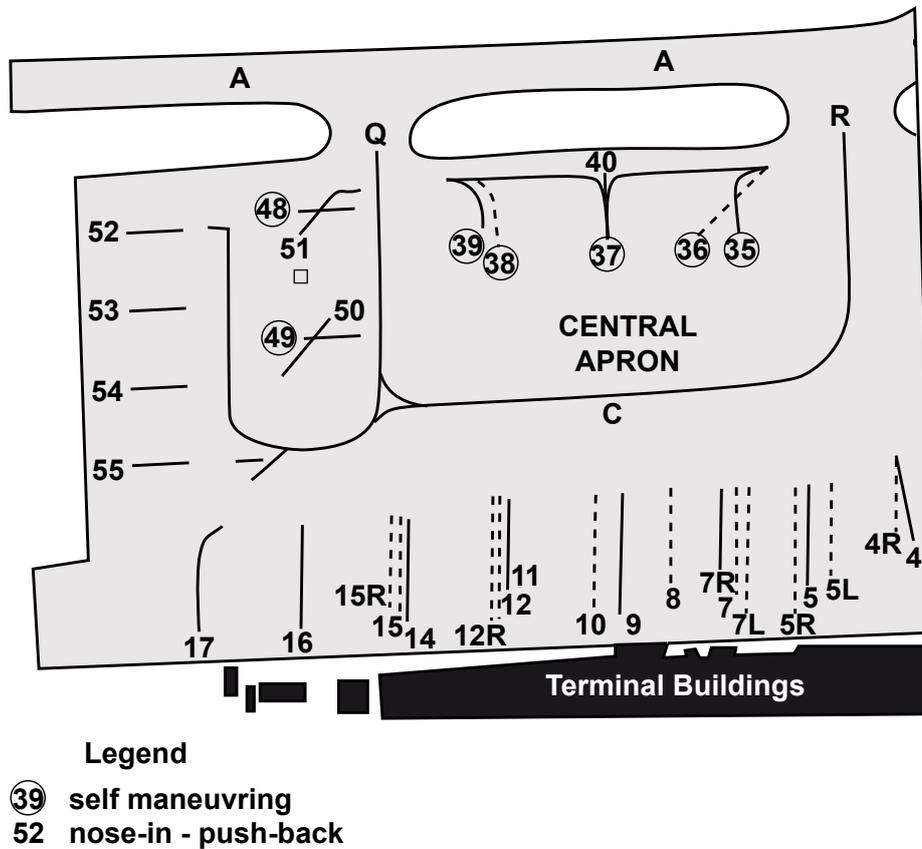
Figure 1

took up a position by the left wingtip of the A320 on Stand 51, in order to provide wing tip guidance. The co-pilot requested clearance to taxi and ATC cleared the aircraft to taxi to the holding point for Runway 27. The commander checked that the wingman was giving the ‘thumbs up’ signal and started to taxi the aircraft, with the intention of manoeuvring it onto Taxiway Q and then Taxiway A. The aircraft was taxied straight ahead for a few metres to gain some speed before the commander introduced a shallow turn to the right, aware that he needed to avoid the light pylon and left wingtip of the aircraft on Stand 51. He stated that he then saw the wingman making the ‘stop’ sign (crossed arms above his head) and applied the brakes. At the same moment he felt G-EZEU’s left wing tip strike the A320’s left wing tip.

Diagram of stands layout of the central apron at East Midlands Airport at the time of the wingtips collision

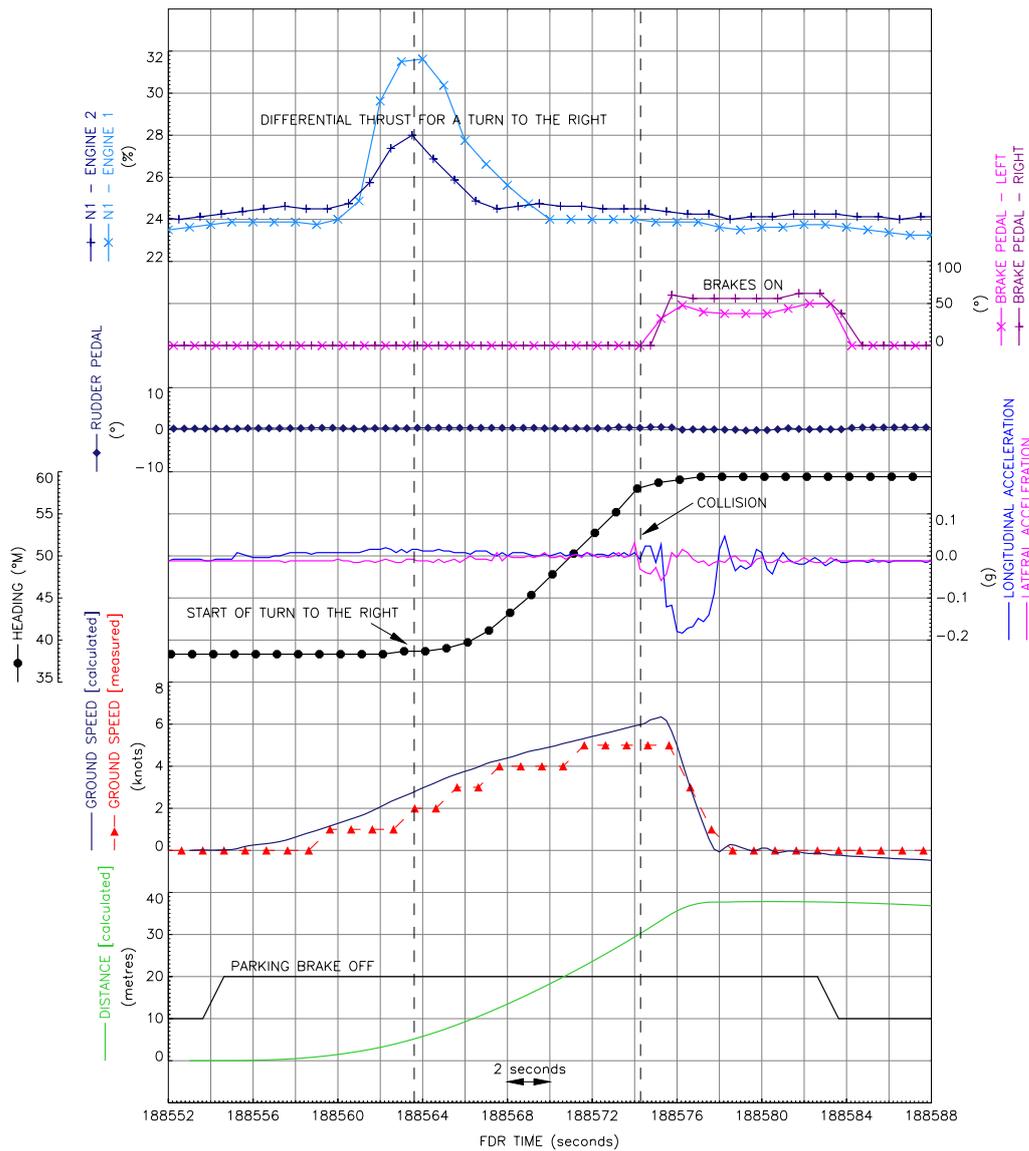
Figure 3
 Salient FDR Parameters
 (Accident to G-EZEU on 24 November 2005)

A time-history of the relevant parameters during the ground collision is shown at Figure 3. The data presented at Figure 3 starts one second before the parking brake is released and shows an initial recorded heading of just over 038°M and about 24% N_1 on both engines.

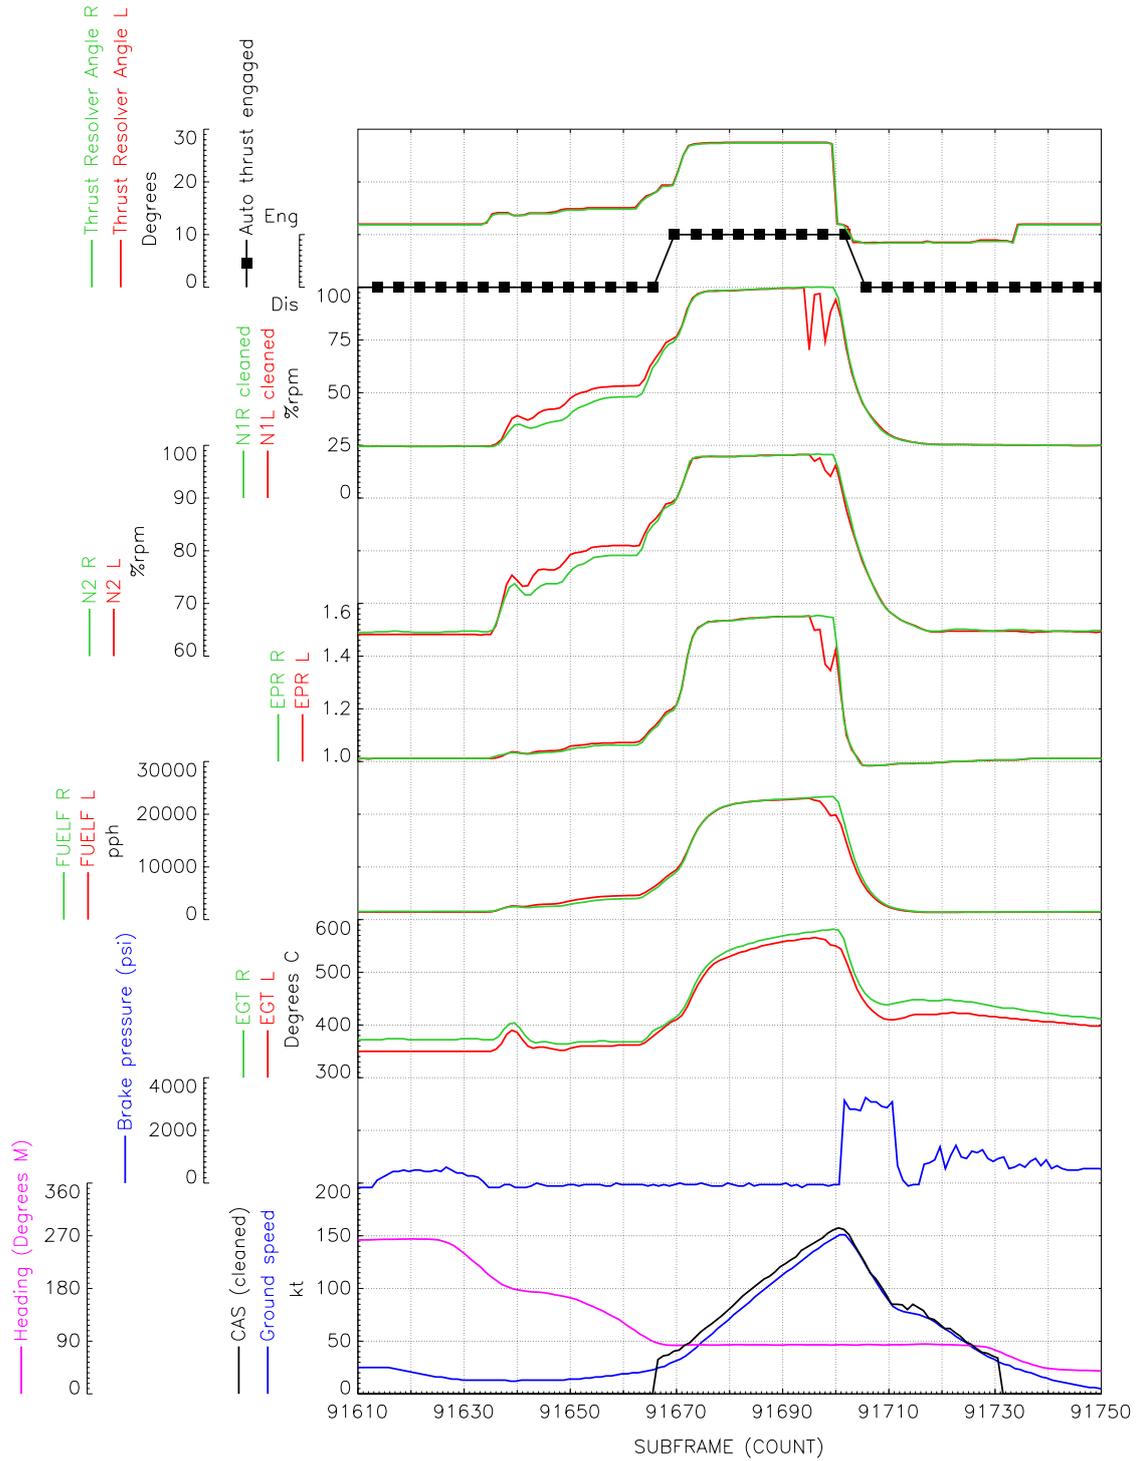
Figure 1
Recorded engine parameters during the rejected takeoff.

At 1942 hrs the brakes were released and the engine power was increased. The aircraft taxied with a ground speed of between 7 kt, in turns, and 25 kt, on straight sections of the taxiway. At 1950 hrs the aircraft was slowed to 12 kt and turned from the taxiway adjacent to the runway onto Runway 08R. The aircraft accelerated from half way through the turn, reaching 30 kt by the time the heading stabilised on the runway heading of 83°M. At this point the auto thrust was engaged, in takeoff mode, and the aircraft continued to accelerate, with the engine parameters matched throughout the acceleration period. The N_2 values reached a maximum of just under 98%, five seconds after turning on to the runway. The rise in N_1 and EPR started to stabilise shortly afterwards, although both continued to climb slightly throughout the takeoff run, and the EGTs continued to climb as the aircraft speed increased smoothly. Approximately 27 seconds after turning on to the runway, the N_1 of the left engine recorded a sharp drop from the previous 100% reading to a value of just over 70%. In the next second this recovered to 97% but the N_2 , EPR and fuel flow values showed a drop. Over the next four seconds the N_1 remained erratic and

the N_2 , EPR and fuel flow values decreased, at which point the thrust levers were retarded and the brakes were applied.

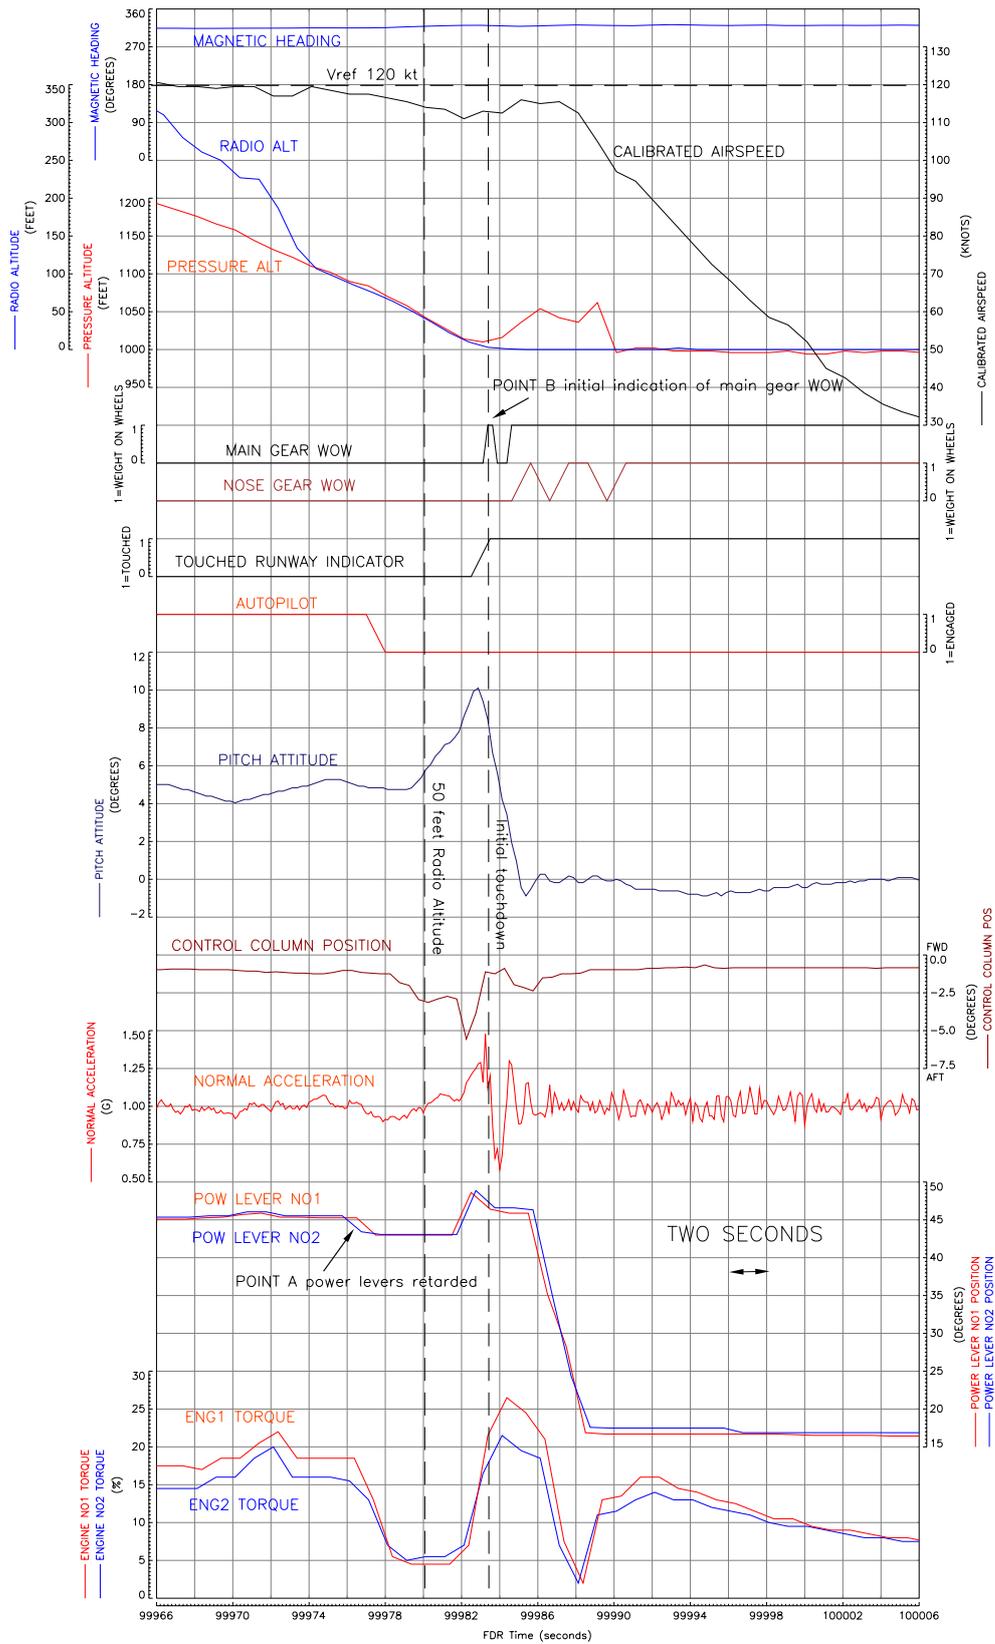
Figure 1
Salient FDR Parameters
Incident to G-JEDW on 20 October 2005

Recorded parameters indicated that the aircraft continued to descend as it tracked both the ILS glideslope and localiser signals. At about 130 feet agl, the airspeed was approximately 120 kt and the left and right engine torques were approximately 16 % and 18 % respectively. At 75 ft agl, the autopilot disconnected. Almost coincident with this, both power levers were retarded slightly (Figure 1 Point A) and both the engine torques and airspeed started to reduce. Shortly afterwards the commander said "DON'T PULL THE POWER BACK... YOU PULLED ALL THE POWER BACK..."

Two seconds later, at 50 ft agl and 115 kt airspeed, the aircraft started to flare. By this time both engines had stabilised at about 5% torque. Two seconds later, at 25 ft agl, with the pitch attitude approximately 7.5° nose

up and the airspeed at 113 kt, both power levers were advanced and the engine torque started to increase. The pitch attitude continued to increase to approximately 10° before reducing slightly to 9.4°, at which time a normal acceleration value of about 1.47g was recorded. This was coincident with the main gear weight on wheels parameter indicating that the aircraft had touched down (Figure 1 Point B). Almost simultaneously, the master and 'touched runway' warnings were recorded.

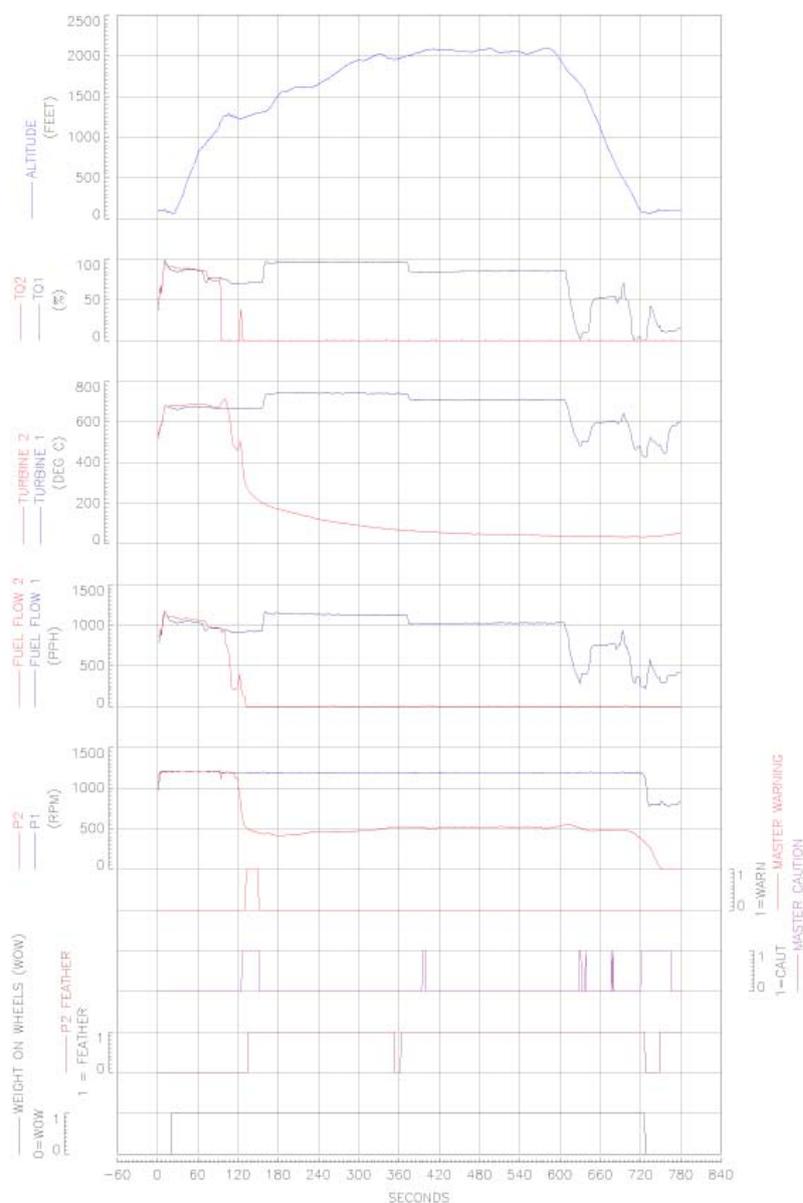
Figure 3
Salient FDR Parameters
(Incident to G-NVSB on 9 August 2005)

Data from the aircraft's flight data recorder covering the incident flight is presented in Figures 3 and 4.

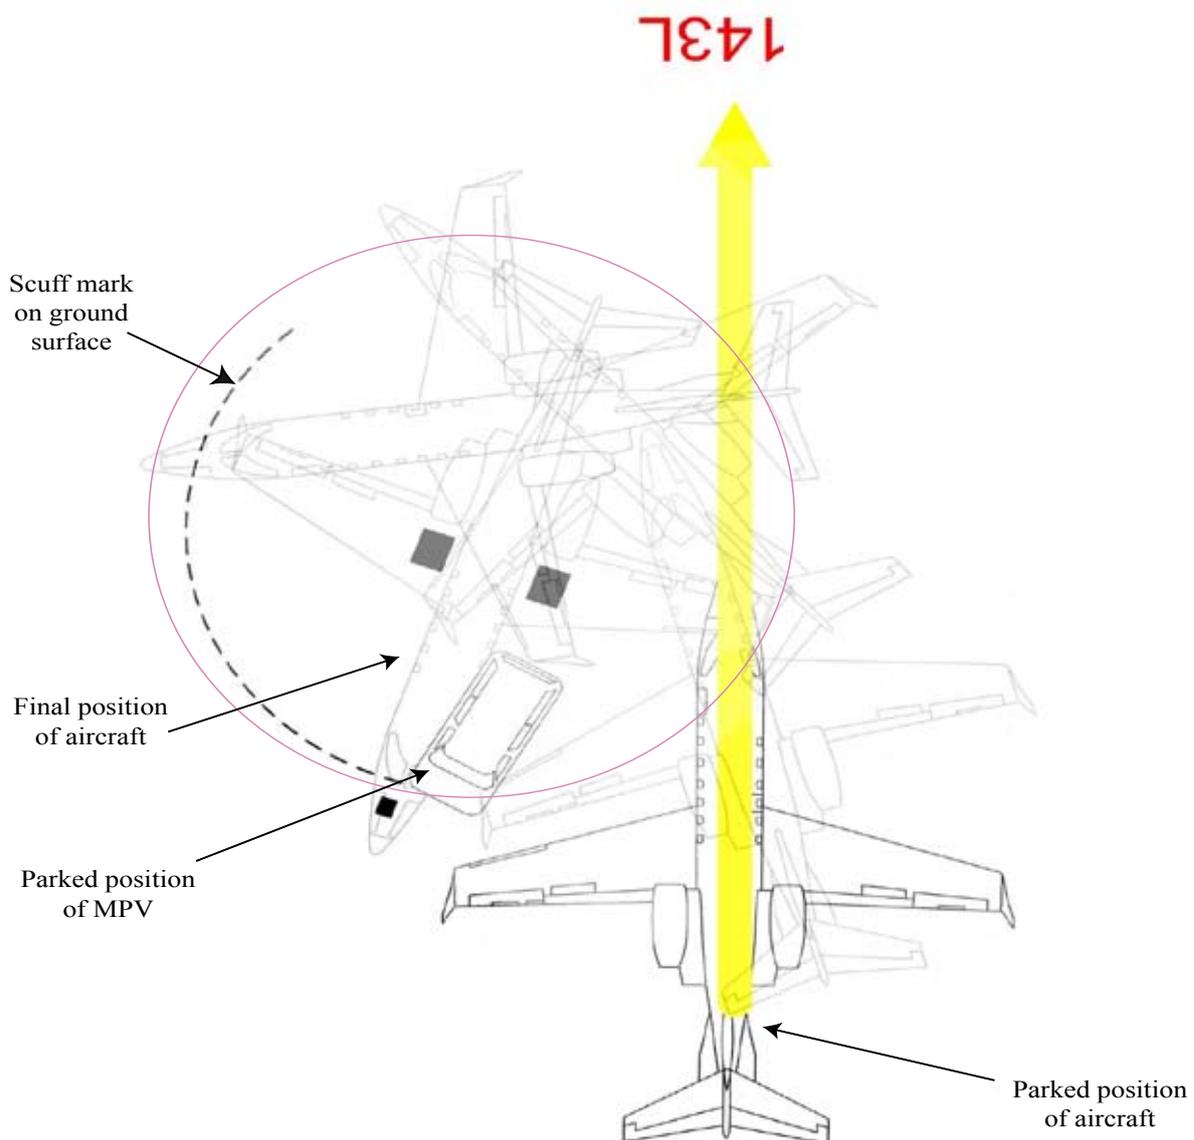
Figure 1

Location of aircraft and ground support vehicle

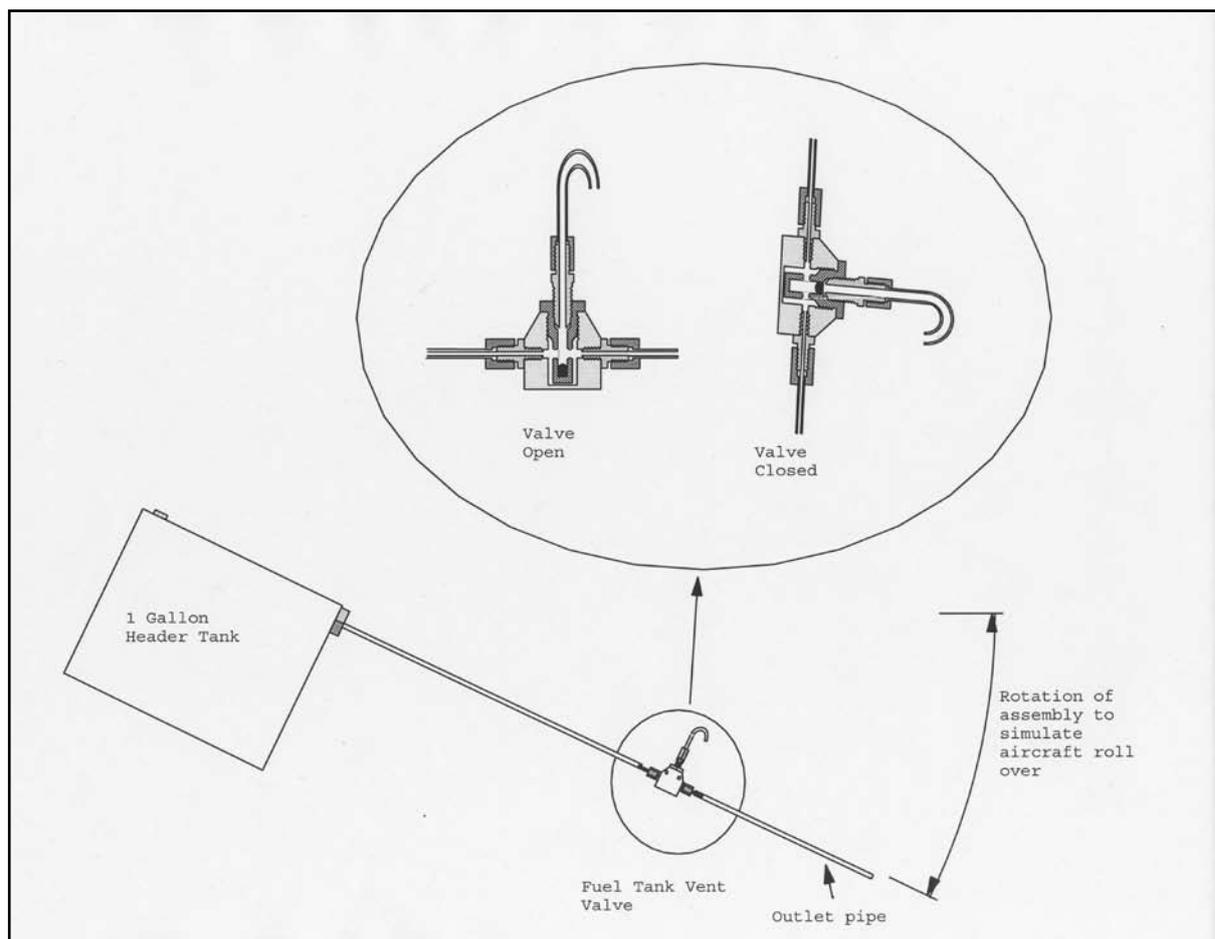
Figure 2

The first series of tests allowed free fluid flow from a one gallon unsealed header tank through the vent system, whilst rotating the system to simulate the roll over, see Figure 2. This resulted in a few drops of fluid being released from the vent tube before the vent valve closed at approximately a 91° roll angle.

A second series of tests were conducted by closing the outlet pipe before the system was rolled to simulate the 'overfilling' of the lower fuel tank. In this condition, at roll angles greater than 45°, fluid flowed from the vent tube at a rate of 0.5 litres per minute until the system was rotated to 95°, when the flow ceased by the action of the valve closing. This series of tests was repeated after sealing the header tank, to simulate an airtight system. The maximum flow rate from the vent tube was reduced to 0.3 litres per minute, with the valve closing at 91° on the majority of occasions. During three of these tests, the valve failed to close completely, and could be clearly heard 'shuttling' in the valve body, with pressure pulses felt within the system. In this condition, a very rapid dripping flow of five drips per second was released from

the vent tube for approximately 45 seconds, or until the roll angle had been increased to 99°.
