## CONTENTS

### SPECIAL BULLETINS

### COMMERCIAL AIR TRANSPORT

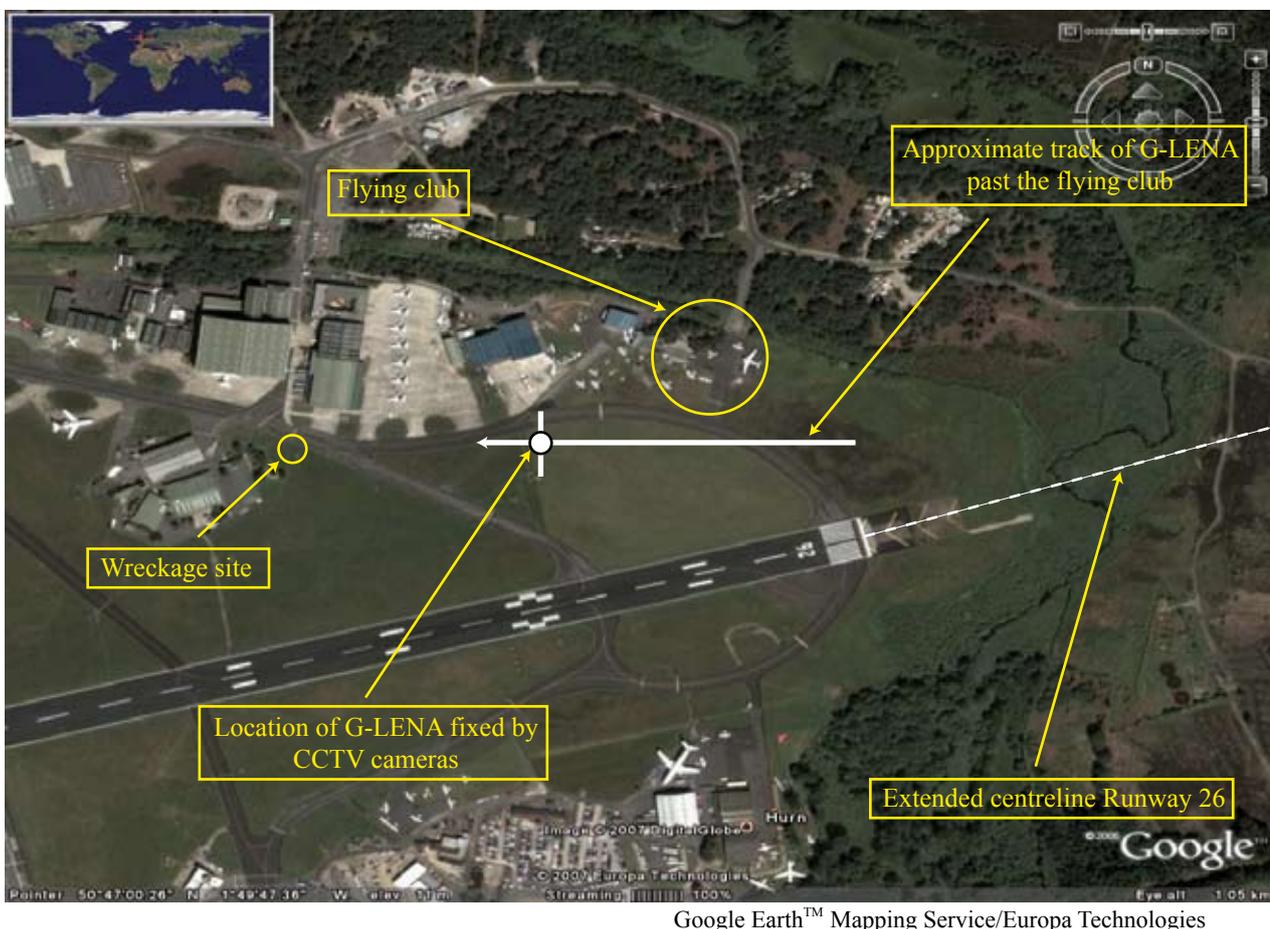
**Figure 1**

Diagram illustrating accident site location, Runway 26 threshold area, estimated track of G-LENA and location of the flying club in relation to the accident site

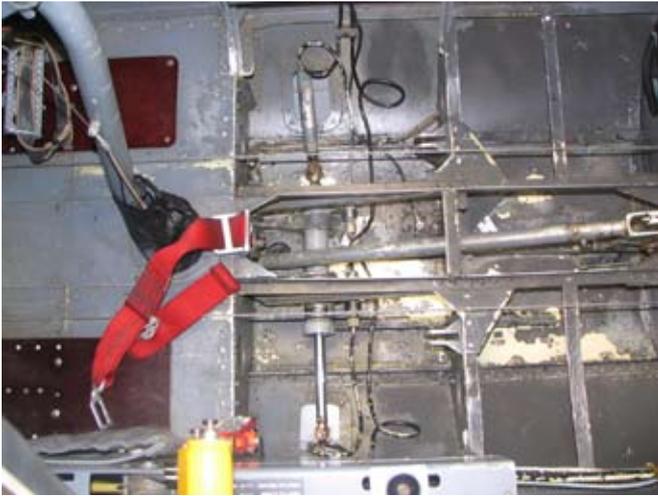
**Figure 9**

However, further testing demonstrated that it was possible for the buckle on an unsecured crotch strap to interfere with the roll control mechanism beneath the rear seat, as a significant gap exists between the aft end of the rear cockpit floor and the seat. Here, it is possible and relatively easy for the strap buckle to become trapped between the pitch control rod<sup>5</sup> and fixed structure, and jam the control when either a right or left roll signal is applied, Figures 9 and 10. This jam has the potential to maintain a right or left roll input to the ailerons and prevent the input being cancelled or reversed. A gap also exists in the front cockpit, but tests showed that it would be significantly more difficult for the crotch strap to migrate to the flight control linkage area below the front seat. However, there was a potential for the strap to interfere with the controls in this area.

View of structure beneath rear seat position of a similar aircraft to G-LENA showing controls with right roll applied
