CONTENTS

(ALL TIMES IN THIS BULLETIN ARE UTC)

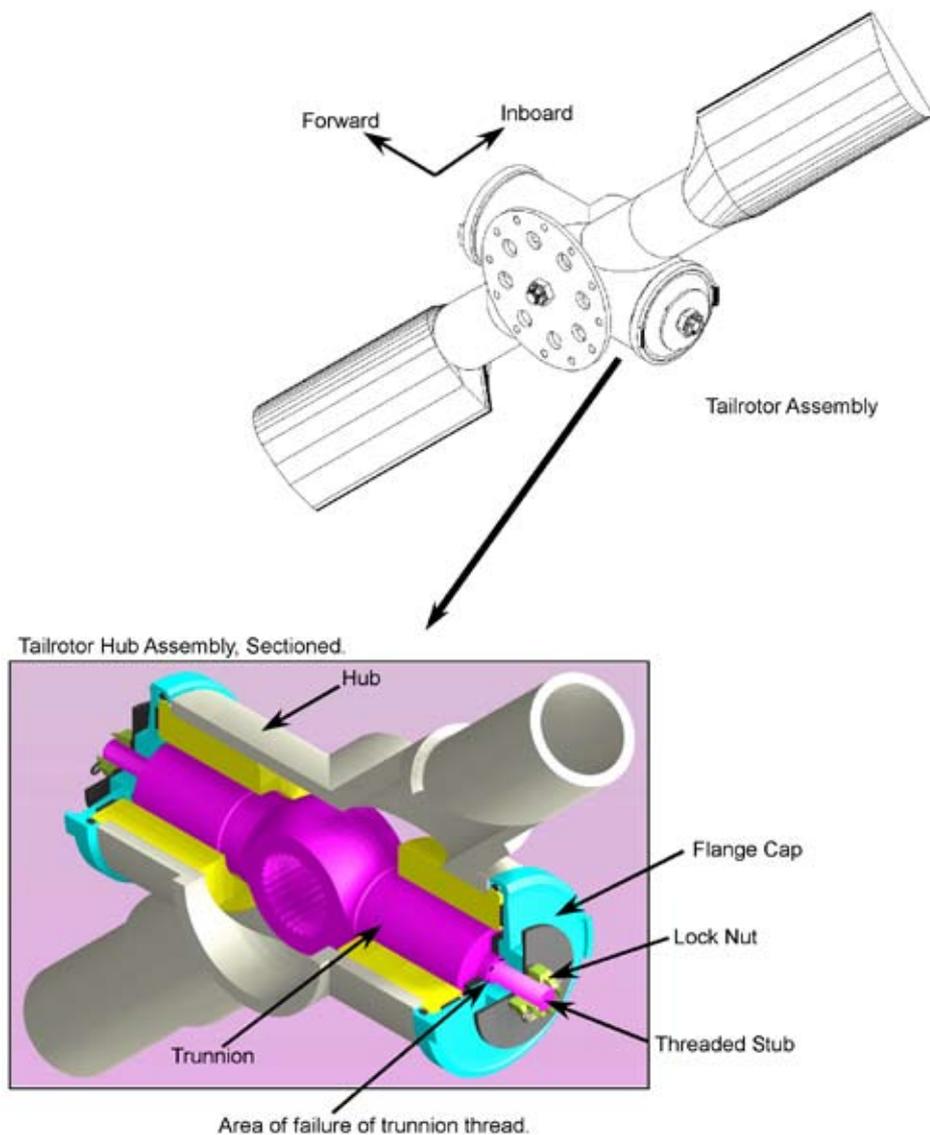
Figure 1

The drive shaft runs from the gearbox, located within the tail boom, and connects onto splines within the tail-rotor trunnion. The trunnion then transfers drive, through the surrounding hub, to the rotor blades.

The A109S 'Grand' (Figure 1) has flange caps, with an internal thread, which locate onto the stubs at each end of the trunnion. Lock nuts then secure the assembly in place within the hub.

Trunnion assembly and drive

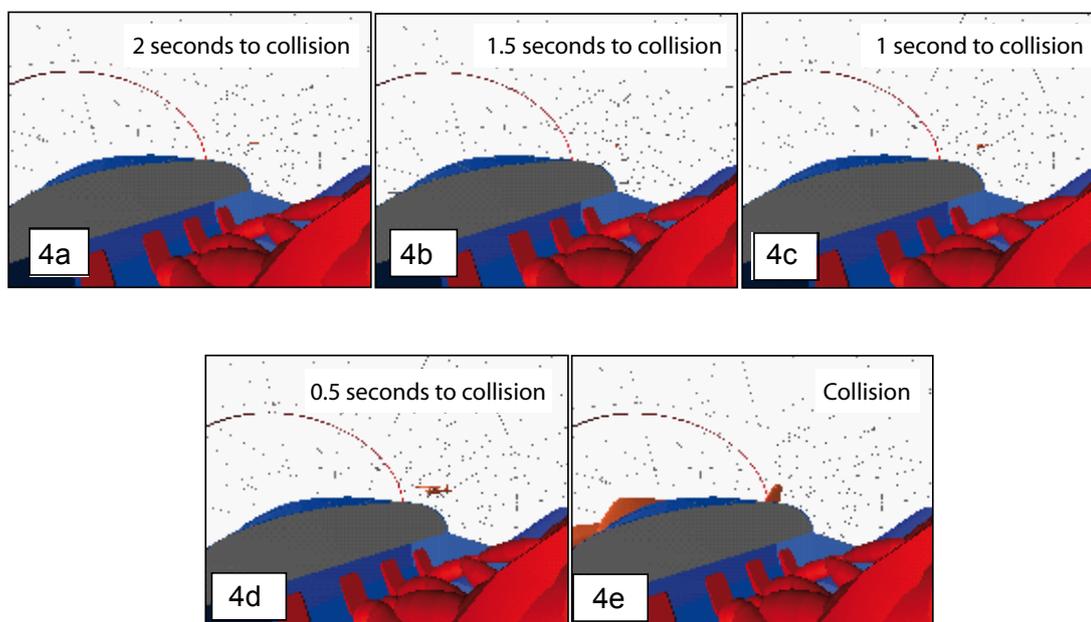
Figures 4a to 4e

This analysis suggested that, unless the Eurostar had been banked to the left, its pilot would have had a direct line of sight to the Cessna and that it would not have been obstructed by the instrument panel, cockpit surround or any other part of the aircraft. However, the angle subtended at his eye by the Cessna (ie the size of image formed on his retina), would have been very small and would have changed very little until the final second or so before the collision. If the Cessna had been in the Eurostar pilot's peripheral field of view, where visual acuity is poor and *rate of change* (movement across, or growth of image size on, the retina) is the primary factor in triggering a response, it is unlikely that he would have registered its presence in time to take effective avoiding action. Figures 4a through 4e mimic the images that would have been produced if a camera with a standard lens was positioned at the Eurostar pilot's eye position, pointed towards the Cessna, and the shutter triggered at half-second intervals during the final 2 seconds prior to the collision. The small size of the Cessna in relation to

Simulated view from the Eurostar, G-GHEE

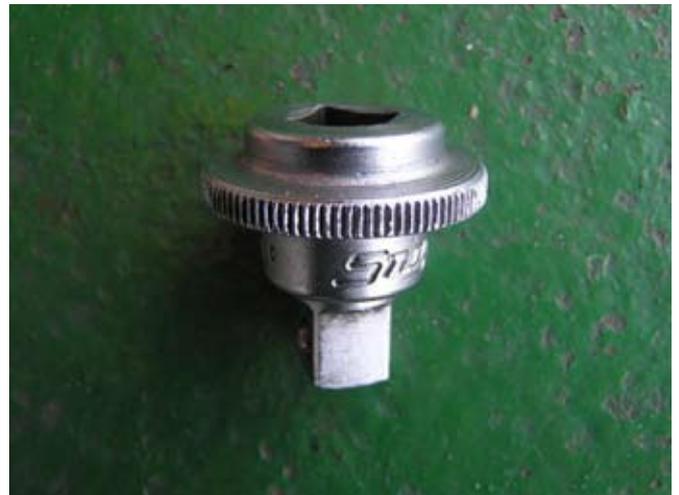
As a suggestion of the type of article that could have been responsible for the damage, Figure 5 shows a photograph of a ratchet adaptor, the serrated edge of which appears to be similar to that seen on the propeller blade shown in Figure 1.

Type of article that may have caused the damage to the aircraft

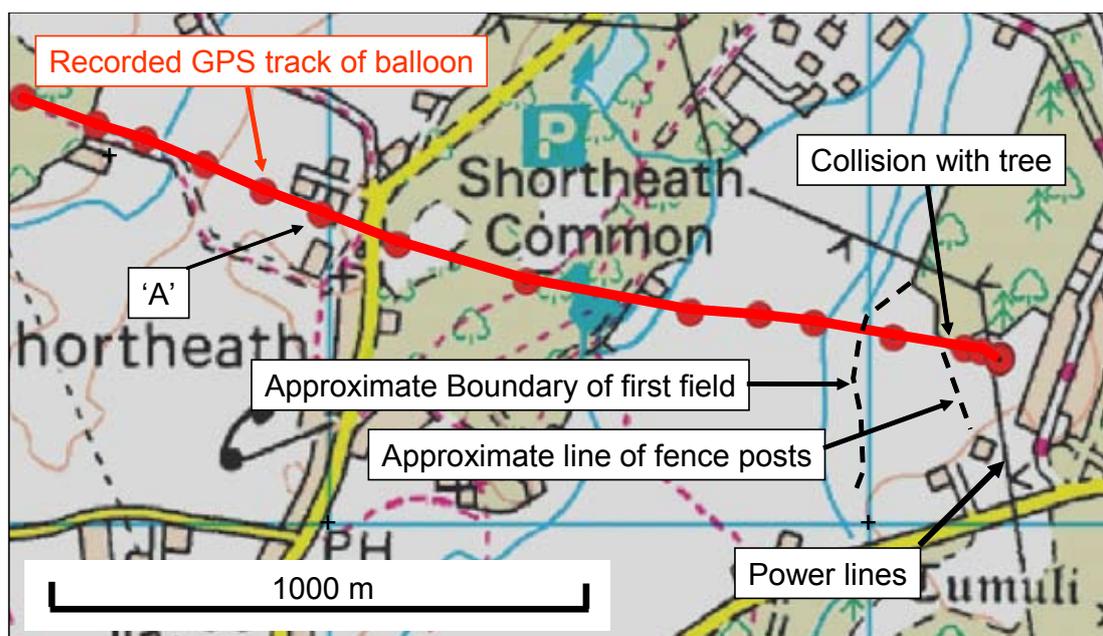
Figure 1

The accident events centred on two adjoining fields on the western outskirts of the town of Bordon (Figure 1). Originally a single field, it was divided into two by fence posts. Although this gave the appearance that the fields were physically separate, there were in fact no wires between the posts. The westerly field was the larger of the two, bounded at its western edge by a hedgerow which contained a number of moderately sized trees. A wooded area protruded into the two fields from the north, forming a 'V' shape, at the point of which was the large tree which the balloon basket struck shortly before contacting the power lines. The distance from the tree to the centreline of the power lines, in the direction of flight of the balloon, was 89 m. The protruding wooded area formed a 'neck' across the fields divided by the fence posts.

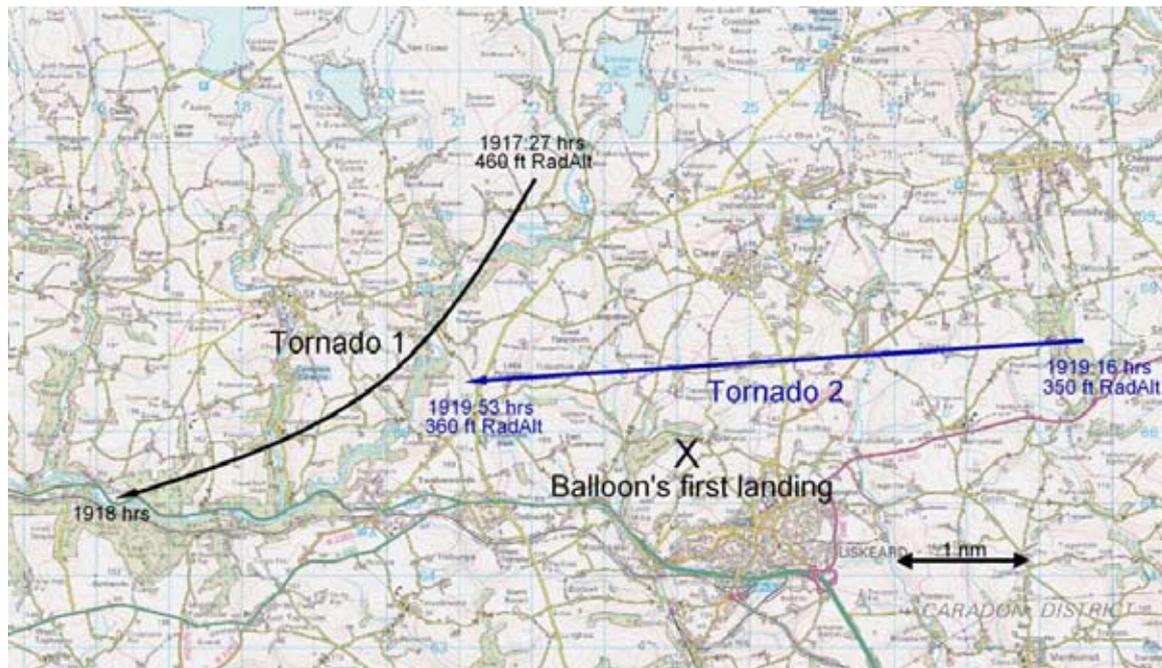
Figure 2

The radar and on-board recordings were compared. They agreed with each other and also confirmed the routings which had been planned before the three Tornados took off. The radar recordings are shown on Figure 1. The first and second Tornado aircraft tracks near to the balloon's landing site, which were reconstructed from the on board equipment recordings, are shown at Figure 2. The more westerly and lead aircraft passed 1.9 nm to the north-west of the balloon's landing site, south bound, at approximately 450 ft agl, at 1917:35 hrs, before turning away to the west. The second aircraft passed 0.6 nm to the north of the balloon landing site, west bound, at 1919:39 hrs, at about 350 ft agl and approximately 420 kt. The third aircraft was reported as being 2 nm astern of the second aircraft and slightly to the north of its track. On that basis, this third aircraft would have passed about 0.6 nm to the north of the landing site, at a similar height and speed to the second aircraft, at approximately 1919:56 hrs.
