## CONTENTS

### COMMERCIAL AIR TRANSPORT

**INCIDENT**

<b>Aircraft Type and Registration:</b>	Airbus A320-200, I-BIKE
<b>No &amp; Type of Engines:</b>	2 CFM-56 turbofan engines
<b>Year of Manufacture:</b>	1999
<b>Date &amp; Time (UTC):</b>	25 June 2005 at 0740 hrs
<b>Location:</b>	On approach to Runway 09L at London Heathrow Airport
<b>Type of Flight:</b>	Public Transport (Passenger)
<b>Persons on Board:</b>	Crew - 6                      Passengers - 98
<b>Injuries:</b>	Crew - None                      Passengers - None
<b>Nature of Damage:</b>	Failure of No 1 and 3 ADIRUs
<b>Commander's Licence:</b>	Airline Transport Pilot's Licence
<b>Commander's Age:</b>	41 years
<b>Commander's Flying Experience:</b>	8,300 hours (of which 1,300 were on type) Last 90 days - 130 hours Last 28 days - 50 hours
<b>Information Source:</b>	AAIB Field Investigation

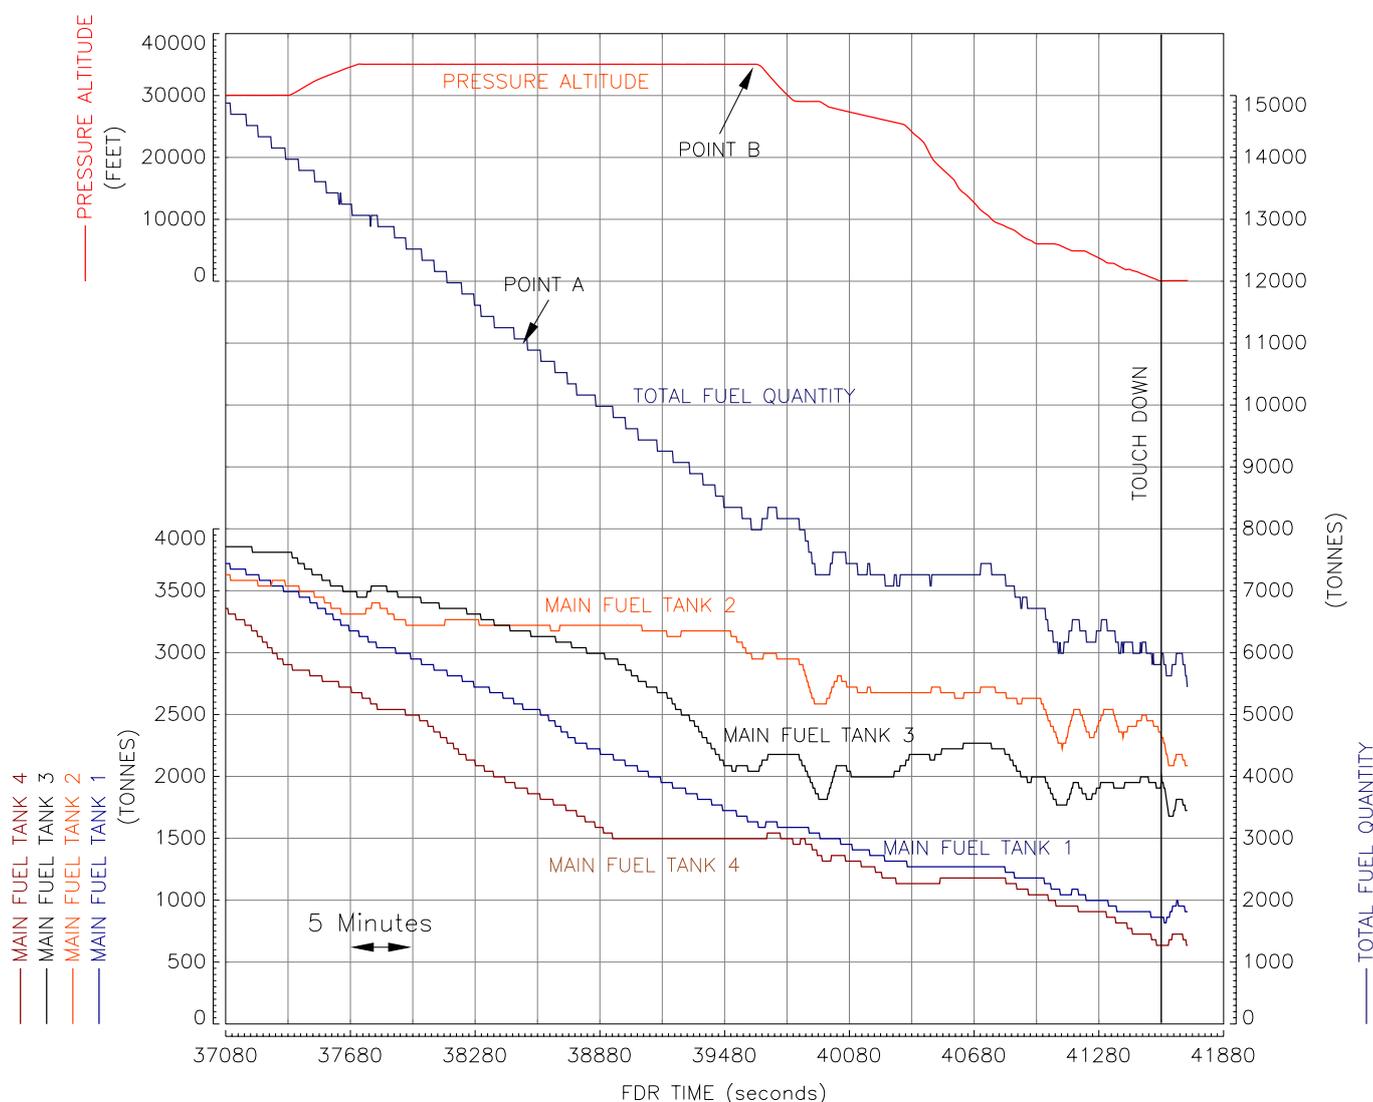
**Figure 4**  
 Salient FDR Parameters  
 (Incident to G-BLNG on 20 February 2005)

The main tank fuel quantities prior to the top of descent until the landing are depicted in Figure 4. At 1513 hrs (Figure 4, point A) whilst at FL350, the total fuel quantity was 11 tonnes. The stabiliser, and both reserve fuel tank quantities were at zero with the centre tank at 0.2 tonnes and the main fuel tank quantities for No 1 to No 4 tanks were: 2.6 tonnes, 3.2 tonnes, 3.1 tonnes and 1.9 tonnes respectively. At 1532 hrs (Figure 4, point B), with a total fuel quantity of 8.1 tonnes, a descent to FL290 was initiated; this altitude was maintained until 1537 hrs when the final descent was commenced.

Touchdown occurred at 1604 hrs when the total fuel quantity was 5.8 tonnes. The fuel distribution across the No 1 to No 4 main fuel tanks was: 0.9 tonnes, 2.4 tonnes, 1.9 tonnes and 0.6 tonnes respectively. The FDR stopped recording at 1617 hrs when the aircraft was shutdown.

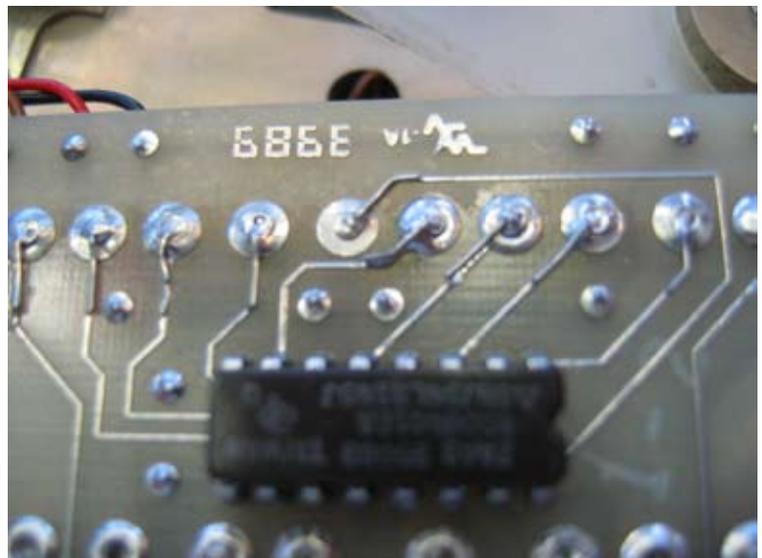
**Figure 6 (right)**  
Correctly configured distribution board

The fault was traced to the distribution board. The distribution board forms part of the crash protected tape transport assembly. Part of its function is to provide an interconnecting point between the four heads and the FDR's circuitry that was external to the crash protected assembly. A short circuit, between terminals E48 and E49, was found on the underside of the distribution board (see Figure 5). The short circuit was made by a terminal attachment wire, from terminal number E48, becoming

detached from its correct position and becoming soldered to the adjacent terminal, E49. It was also noted that other attachment wires were in close proximity to adjacent circuitry. Figure 6 shows the attachment wires in the correct positions.

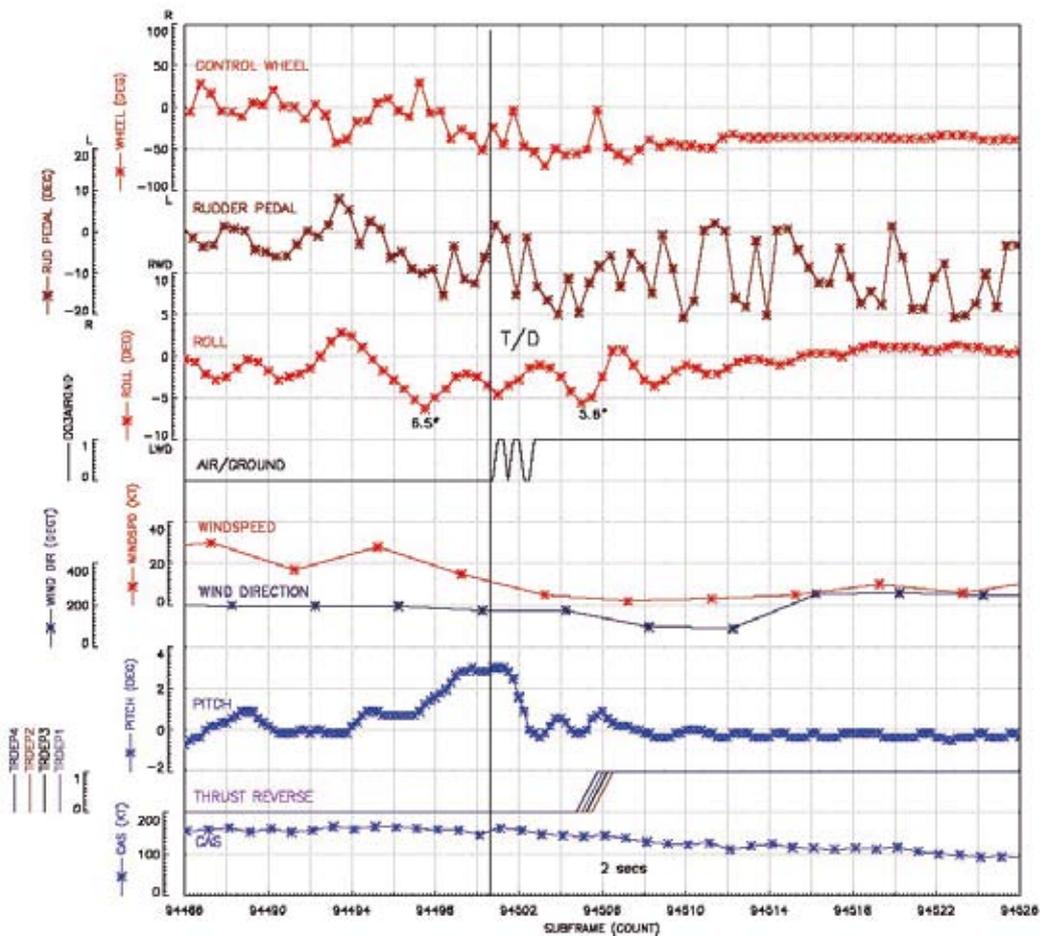
**Figure 2**  
Relevant Flight Data Parameters

Data from the Flight Data Recorder (FDR) and Quick Access Recorder (QAR) were successfully recovered. A time history of relevant FDR parameters for the final approach and landing roll is shown in Figure 2. It can be seen that, up to about 6 seconds before touchdown, the recorded wind direction was generally from the south (actual direction about 200°), with a windspeed that varied from about 15 to 30 kt. Right rudder pedal was applied about 6 seconds before touchdown. The recorded QAR windspeed reduced to about 8 kt just before touchdown. These wind parameters were derived from inertial navigation system data. The aircraft appears

to have touched down with a small amount of left bank (about 2°) at about 147 kt. After touchdown, there was a rocking motion in roll with a period of about 4 seconds. The bank angle was generally about 2° to the left with an amplitude of about ±2°. After touchdown, left (into wind) control wheel was applied. About 5 seconds after touchdown, the bank angle reached a value of about 5.6° to the left. This coincided with the selection of the thrust reversers. It can also be seen that the control wheel was reduced to the neutral position when this bank angle was achieved, and that the bank angle returned to about zero. Thereafter, into wind (left) control wheel was applied for the remainder of the landing roll.

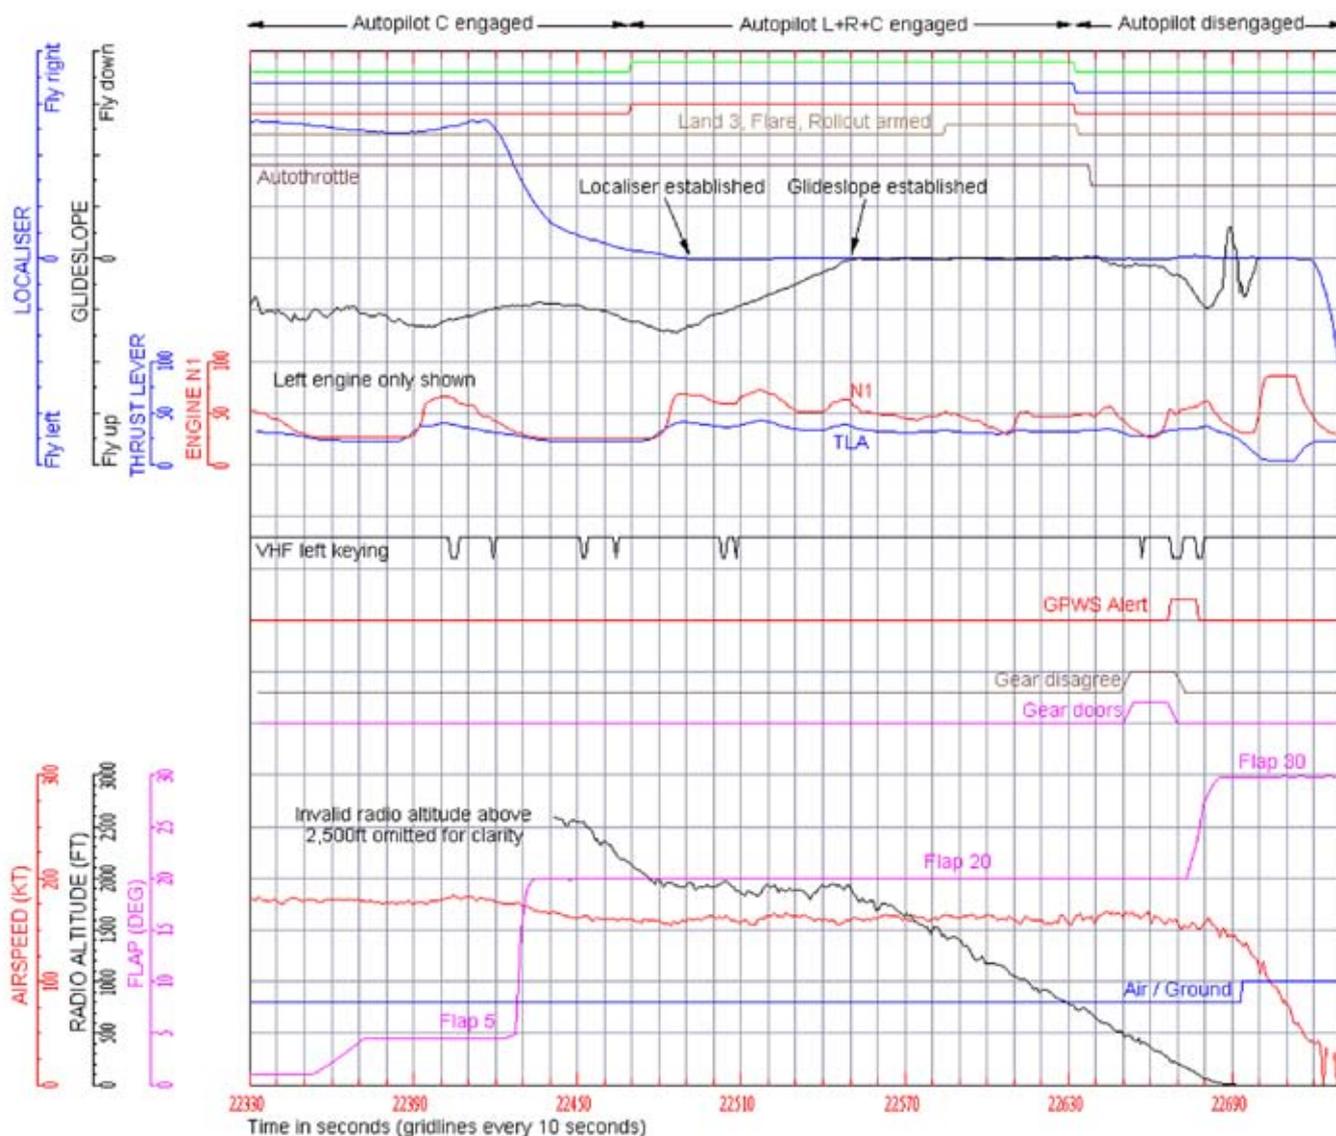
**Figure 1**  
Selected parameters

The commander recollected having briefed the crew for a visual approach to Runway 26. He recalled that he had disconnected the autopilot and flown manually from around 10,000 ft. He remembered that at some stage ATC had asked for speed control on approach. Then, descending through 1,000 ft with the flap set at 20° he had called “GEAR DOWN AND LANDING CHECKLIST”, but the FO had apparently missed the call. He then called for flap 30° but the FO pointed out to him that the gear was not down. The commander

asked again for the gear down and landing checklist. He remembered that ATC had contacted the aircraft during the approach and advised that there was no landing gear. He did not recollect hearing any warnings from the GPWS.

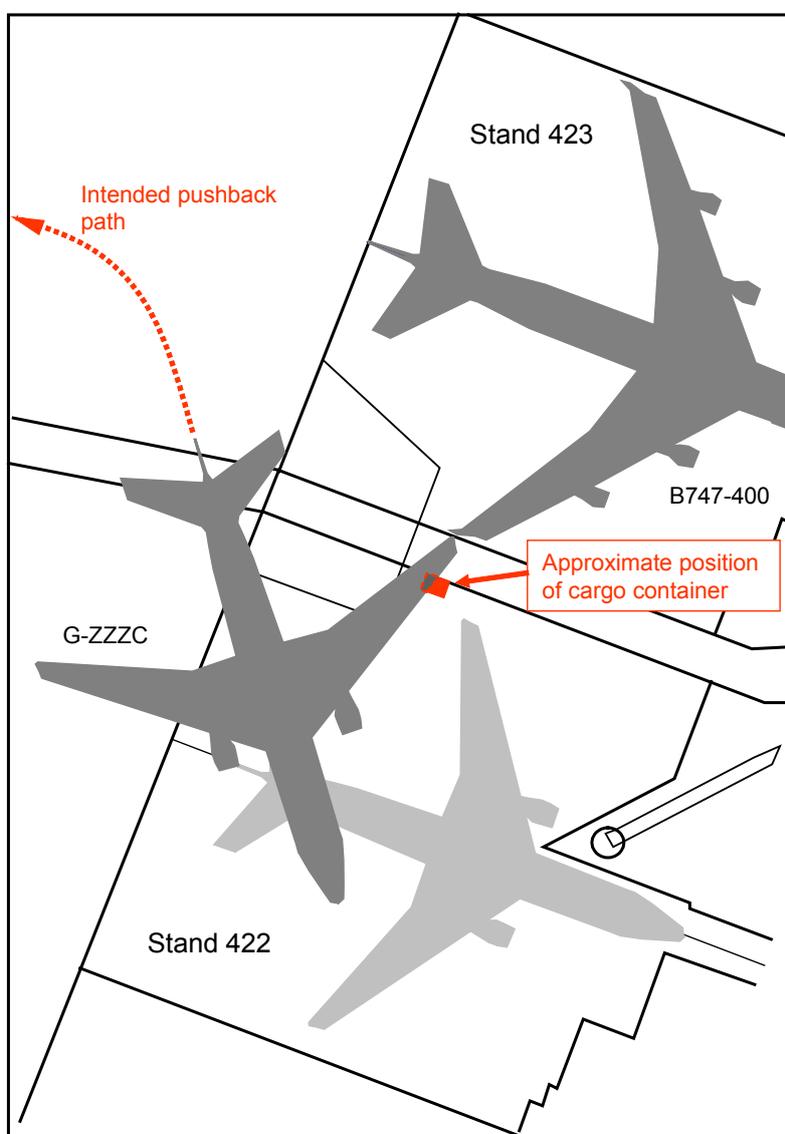
**Figure 1**

pushed back onto the taxiway centreline in readiness for taxiing out of the 'cul-de-sac' (Figure 1). The specific duties of the observers were to ensure safe clearance of the left wing tip during the initial pushback, and then to ensure clearance of the tail from the blast screen at the 'cul-de-sac' head during the latter stages of the manoeuvre. Any hazard was required to be communicated directly to the TBL driver by the use of approved hand signals, and this requirement meant that the observers were to remain in direct sight of the driver at all times during the pushback.

Aircraft positions at point of collision

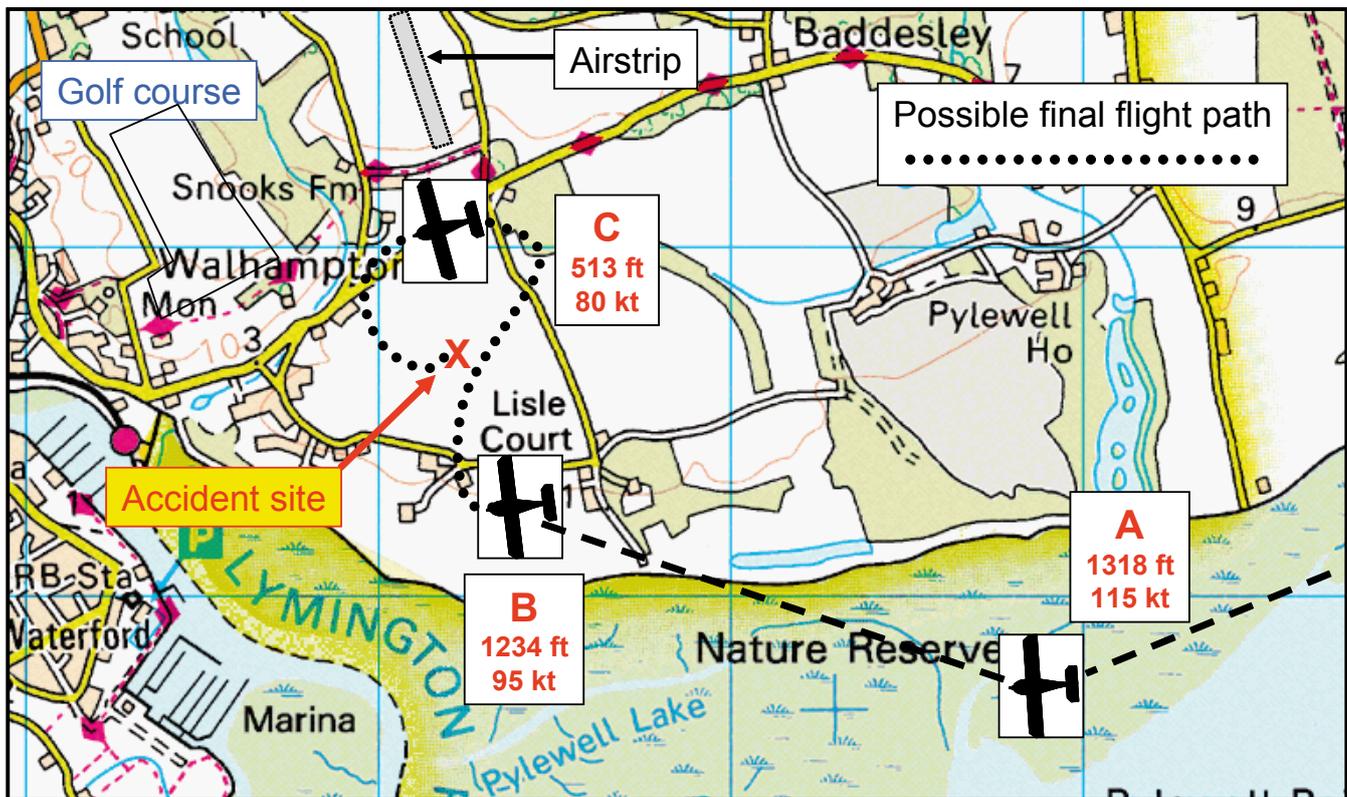
**Figure 1**  
Accident area and GPS derived data

was recorded as being 1,318 ft (Position A, Figure 1). Both of these values were outside the narrow height band within which the aircraft had been flying during the few minutes since the aircraft had completed the descent requested by ATC.

Point A was the last recorded point on the aircraft's original track. The next and penultimate point (B) showed a GPS altitude of 1,234 ft and a reduced groundspeed of 95 kt. The average rate of descent from A to B was less than 200 ft per minute (ft/min), though this increased to about 1,400 ft/min between B and C. The next and final recorded point was 800 m from the previous, and almost due north of it, though the aircraft's track at this stage was just south of west, similar to that of the previous position. Groundspeed at C was 80 kt and the recorded GPS altitude was 513 ft. Based on the position

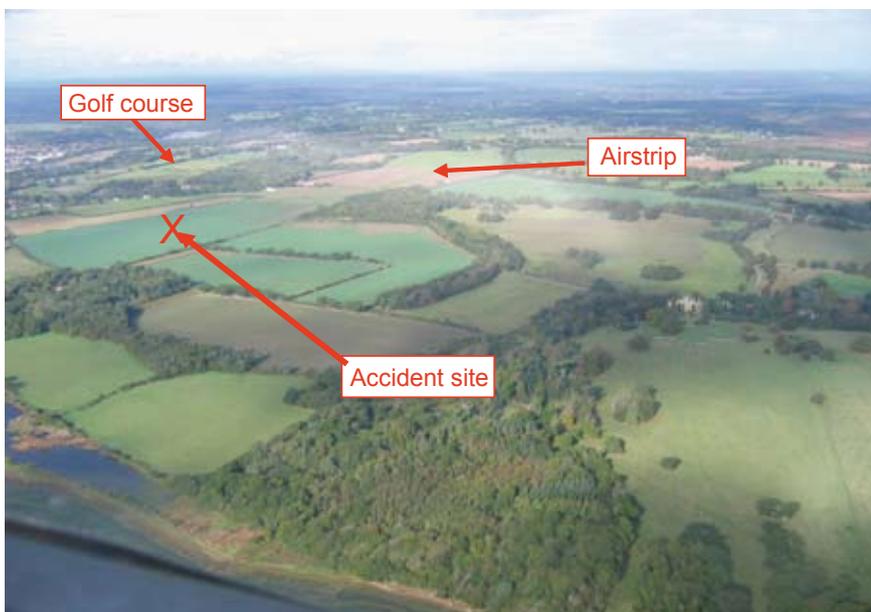
**Figure 2 (left)**

A general view of the accident area from about point A is at Figure 2. The accident site can be seen to be in the largest field in the area and would have been an obvious choice for a landing, even before the aircraft reached point A. With the northerly wind, the pilot would have been well positioned to land in the field without extended manoeuvring. At this point, it is doubtful whether the airstrip to the north would have been obvious and, in any case, it would not necessarily have presented a better option than the large field.

Accident area as seen from point 'A' of Figure 1 (page 96)

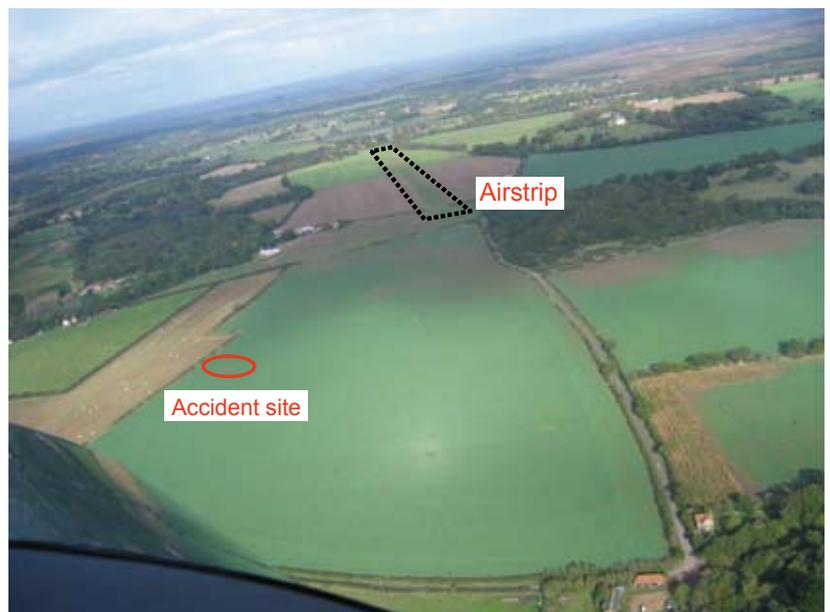
As the field in which the aircraft crashed appears to be the largest and most suitable in the area, it may be expected that, if an immediate landing was desired, then by point B the aircraft would be lower and manoeuvring for a landing in a northerly direction, which does not appear to be the case. A view of the accident area from about 1,200 ft at point B is at Figure 3, which shows that, as well as the field itself, the airstrip and field to the north would have been available.

**Figure 3**  
Accident area as seen from point 'B' of Figure 1 (page 96)

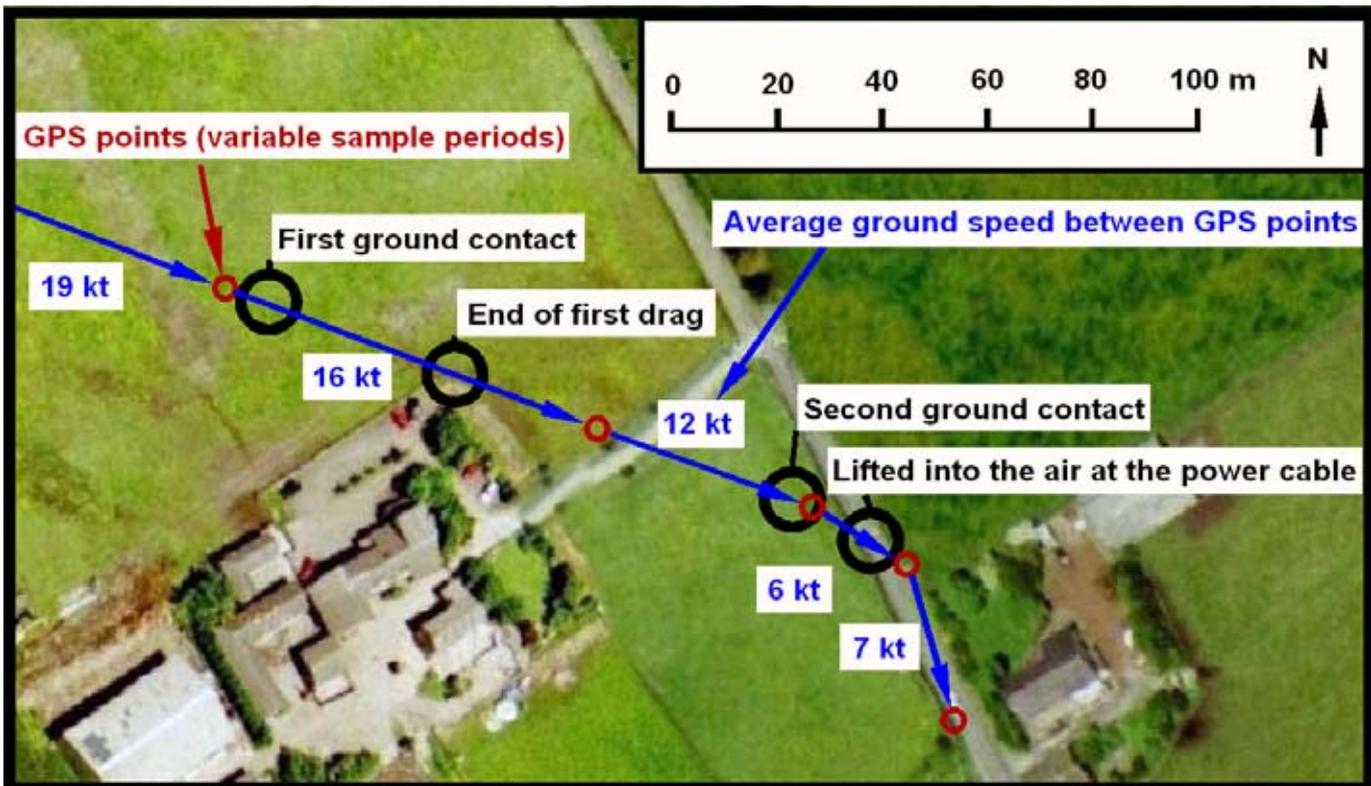
**Figure 4**

The flight recorded on the day of the accident started at 1402 hrs UTC, lasted 52 mins and covered 12 nm. The flight path of the accident flight is shown in Figure 2. Figure 3 shows a plot of the average ground speed of the GPS unit between the recorded track points. Figure 4 shows the end of the flight overlaid on an aerial photograph, aligned by reference to photographs of the landing points provided.

Final flight path
