Aircraft Type and Registration:	Avro 146-RJ100, G-CFAD	
No & Type of Engines:	4 Lycoming LF507-1F turbofans	
Year of Manufacture:	2000	
Date & Time (UTC):	26 August 2003 at 0656 hrs	
Location:	London City Airport, London	
Type of Flight:	Public Transport (Passenger)	
Persons on Board:	Crew - 6	Passengers - 110
Injuries:	Crew - None	Passengers - None
Nature of Damage:	Lower rear fuselage scraped, tail bumper strip removed, skin, stringer and frame damage	
Commander's Licence:	Airline Transport Pilot's Licence	
Commander's Age:	35 years	
Commander's Flying Experience:	3,283 hours (of which 110 were on type) Last 90 days - 96 hours Last 28 days - 38 hours	
Information Source:	AAIB Field Investigation

Synopsis

After an uneventful flight the aircraft was positioned onto the ILS approach to Runway 10 which has a 5.5° glidepath. During the manually flown final stages of the approach the aircraft descended slightly below the glidepath. In regaining the glidepath insufficient power was used to correct for the resultant decay in airspeed and the thrust levers were closed early during the landing flare. These factors led to the aircraft being 8 kt below the correct speed at touchdown. In an

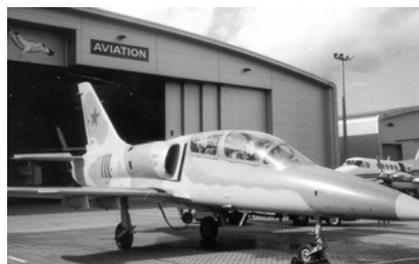
The Aero Vodochody L-39ZO Albatros aircraft is a two-seat tandem military jet trainer manufactured in the former Czechoslovakia. The aircraft has a maximum take-off weight of 5,600 kg and a maximum operating speed of Mach 0.80/490 KIAS. It is equipped with two ejection seats and is powered by an Ivchenko AI-25TL twin shaft bypass turbofan engine.

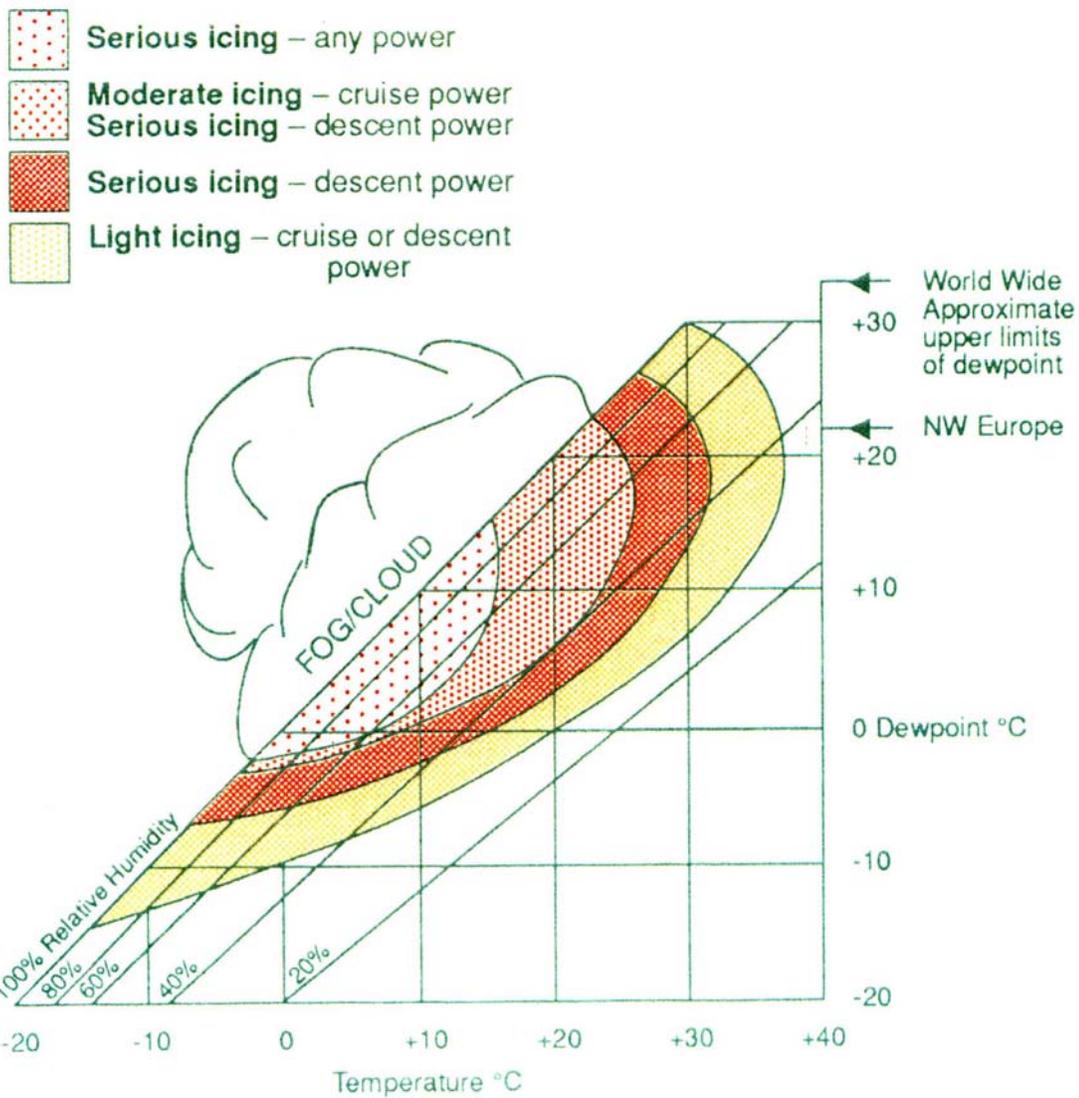
CARB ICING

More information on Robinson R22 carburettor icing is available for downloading from the website: www.morningtonsanfordaviation.co.uk under the heading 'No Ice, Thank You!'
