Aircraft Type and Registration:	Boeing 737-59D, G-BVKC	
No & Type of Engines:	2 CFM56-3C1 turbofan engines	
Year of Manufacture:	1990	
Date & Time (UTC):	21 February 2004 at 2300 hrs	
Location:	Cardiff Airport, Wales	
Type of Flight:	Public Transport (Passenger)	
Persons on Board:	Crew - 6	Passengers - 114
Injuries:	Crew - None	Passengers - N/A
Nature of Damage:	Damage to left main landing gear	
Commander's Licence:	Airline Transport Pilot's Licence	
Commander's Age:	49 years	
Commander's Flying Experience:	8,160 hours (of which 3,800 were on type) Last 90 days - 203 hours Last 28 days - 71 hours	
Information Source:	AAIB Field Investigation

Synopsis

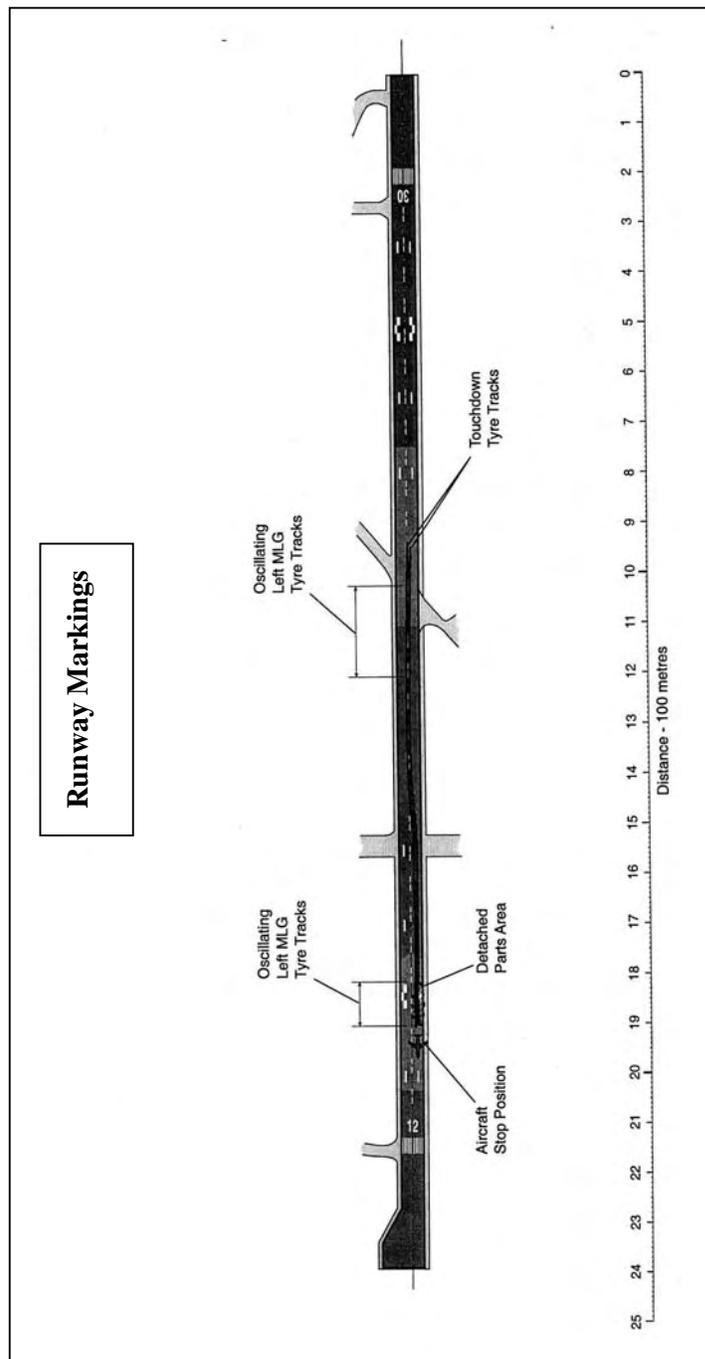
Figure 2

Runway 30 is 2,392 metres long and 46 metres wide, with a Landing Distance Available of 2,201 metres. The surface is generally concrete but tarmac in places. The aircraft had been removed by the time of AAIB arrival but runway tyre track markings, clearly associated with G-BVKC's landing roll, were apparent on the runway. These were continuous from touchdown to the point at which the AFS reported that G-BVKC had come to rest, Figure 2. Runway access was limited by heavy traffic and the measured distances were approximate.

Runway Markings

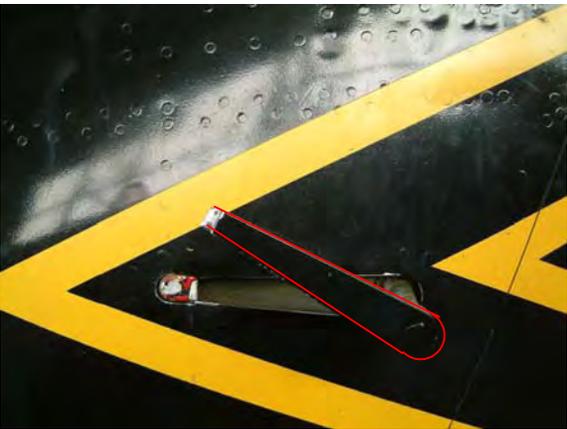
Figure 3

When the canopy is unlocked, the external handle will appear as shown in Figure 2. In order to lock the canopy from outside, the handle must be rotated anti-clockwise, beyond the stowed position. When released it should appear as shown in Figure 3. However, the handle can be stowed, as shown in Figure 4, regardless of whether or not the canopy has been locked. Consequently, visual confirmation that the handle is stowed does not guarantee that the canopy is locked.

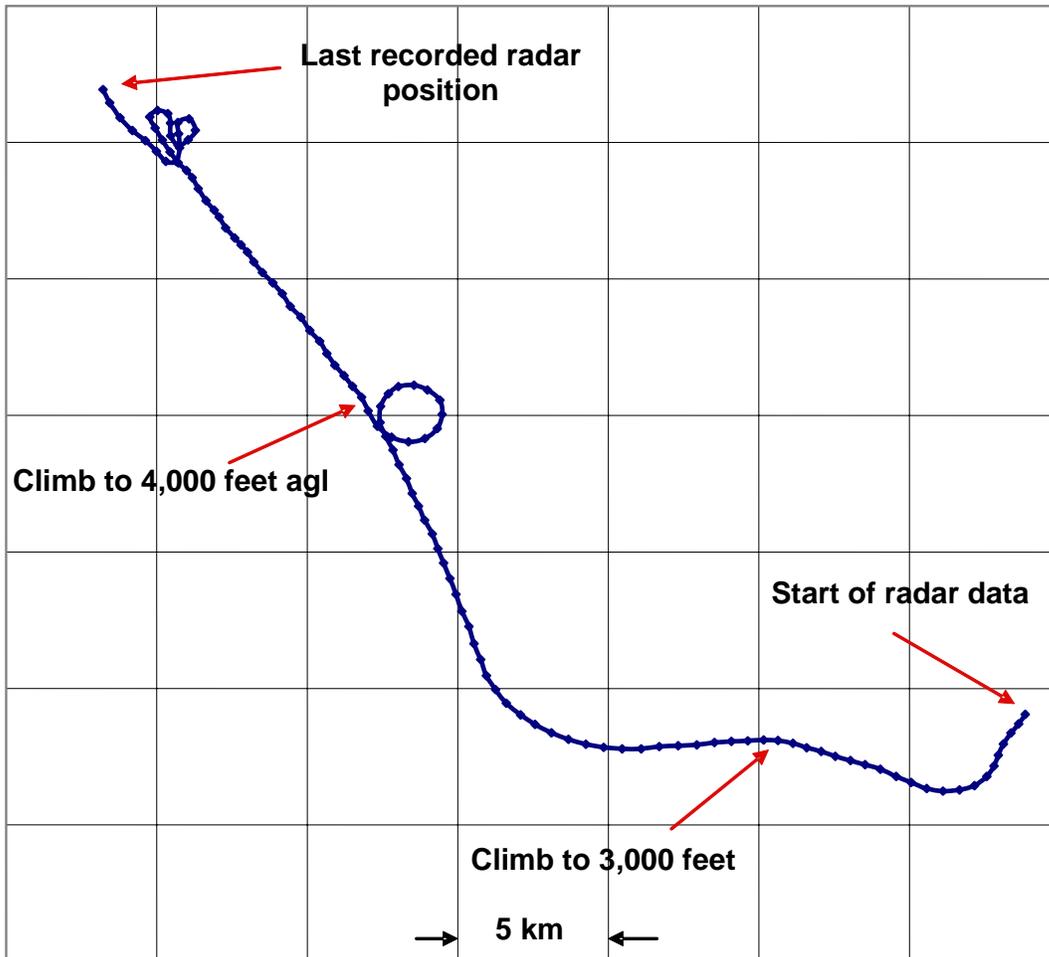
Figure 1 - Still Air Plot of Complete Flight

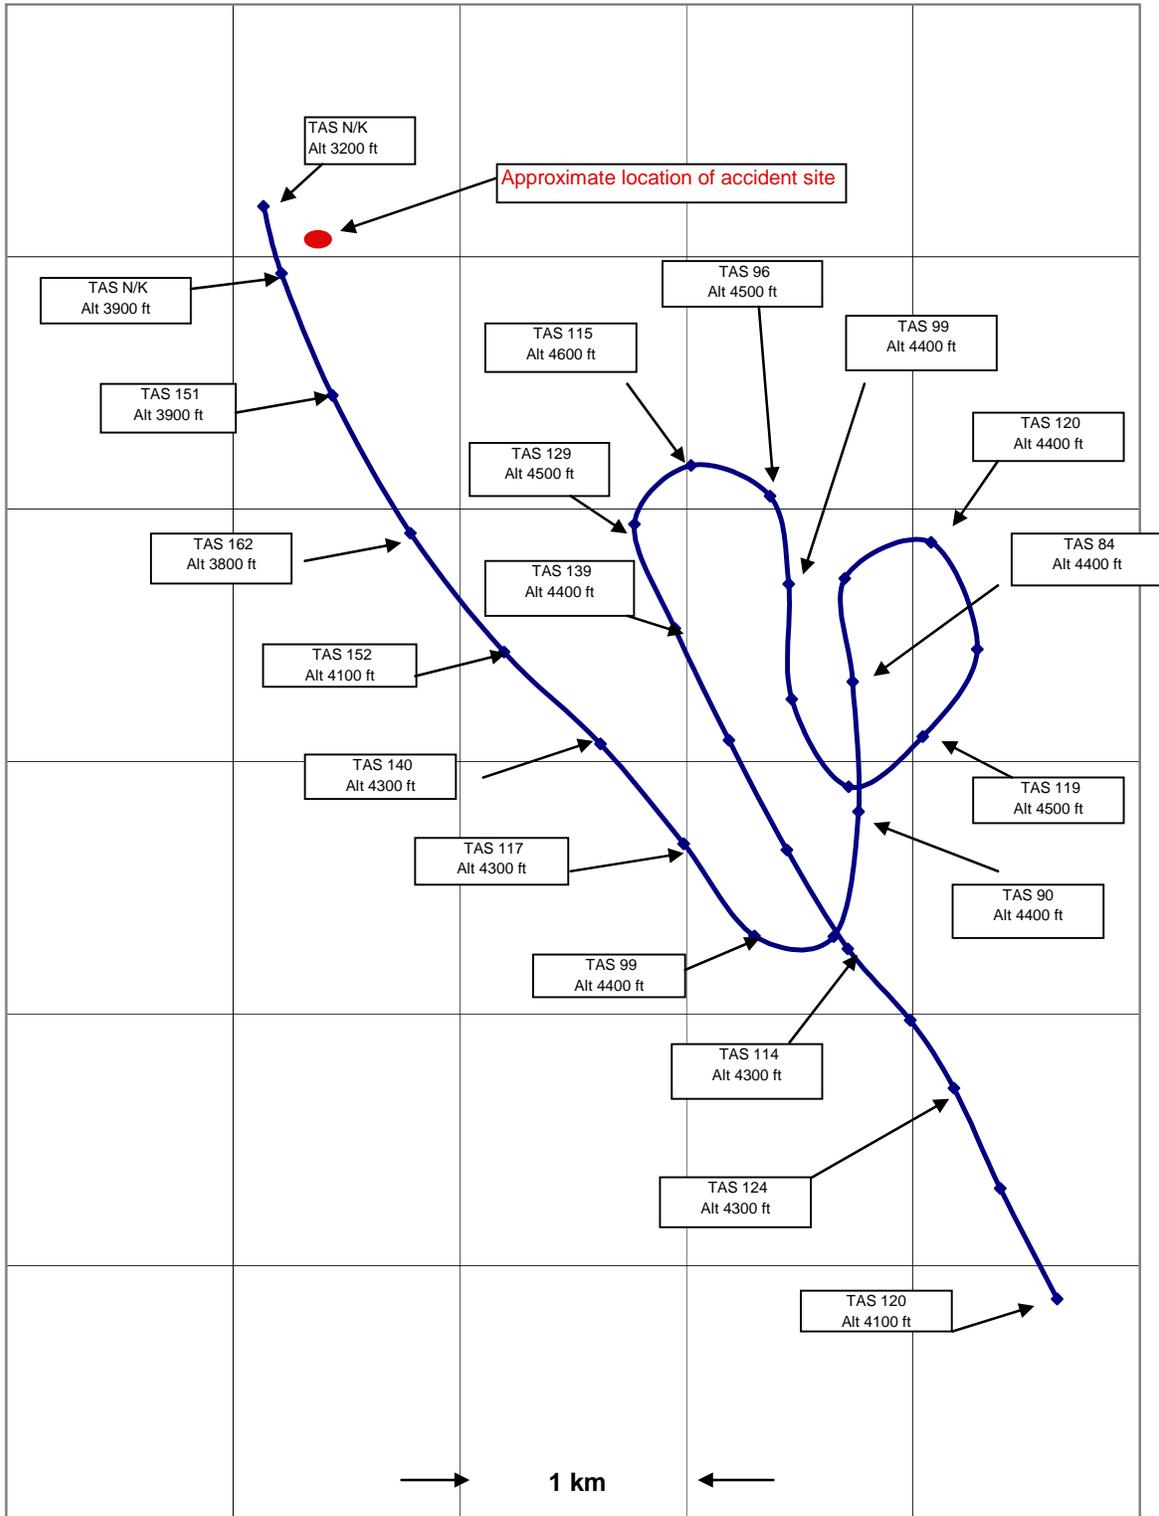
Radar heads situated at Claxby and Great Dun Fell recorded much of the aircraft's flightpath. The recorded radar returns show the aircraft flying west from Humberside Airport for 7 nm before turning northwards to the Humber estuary. An orbit was carried out at approximately 3,000 feet altitude before the northerly track was resumed and the aircraft climbed to approximately 4,000 feet. The wind at altitude was westerly at 25 kt. Allowance for the wind was applied to the radar data to derive the equivalent 'still air' flight path, thus removing wind effect from the manoeuvres depicted by the radar plot. The entire 'still air' flight path is depicted at Figure 1 and the final three minutes of the flightpath is shown, together with associated altitudes and approximate airspeeds, at Figure 2.

Figure 2 - Final Still Air Manoeuvring

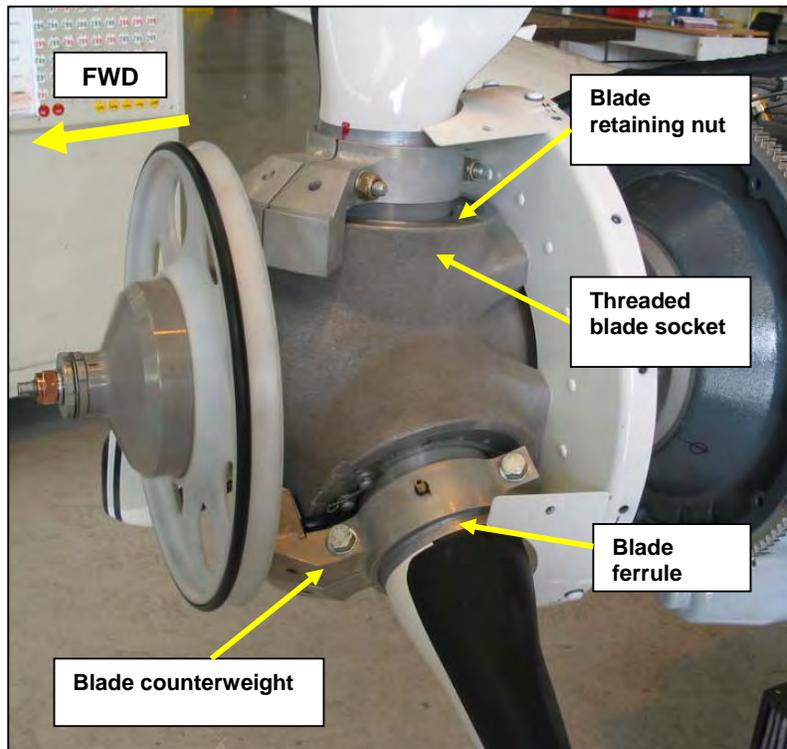
Figure 3

The Grob G115E is fitted with a Hoffmann HO-V343K-V/183GY three-bladed constant-speed propeller (Figures 3 & 4). The hub is manufactured from forged aluminium alloy and the Type 183GY propeller blades are manufactured from compressed hardwood and spruce, with an outer sheath of carbon fibre. Each blade is mounted in a duralumin carrier, or ferrule. The blade is attached to the ferrule by large screws, that screw into the compressed hardwood blade root. The ferrule locates into a socket in the propeller hub. Needle roller bearings transmit blade centrifugal loads to the hub and allow the blade to rotate in pitch. The propeller blade is secured in the hub by a blade retaining nut, which screws into the threaded blade socket and is torque-tightened to between 30 and 40 Newton-Metres (Nm). A 'T-shaped' locking plate prevents the nut from rotating.

Grob G115E propeller assembly

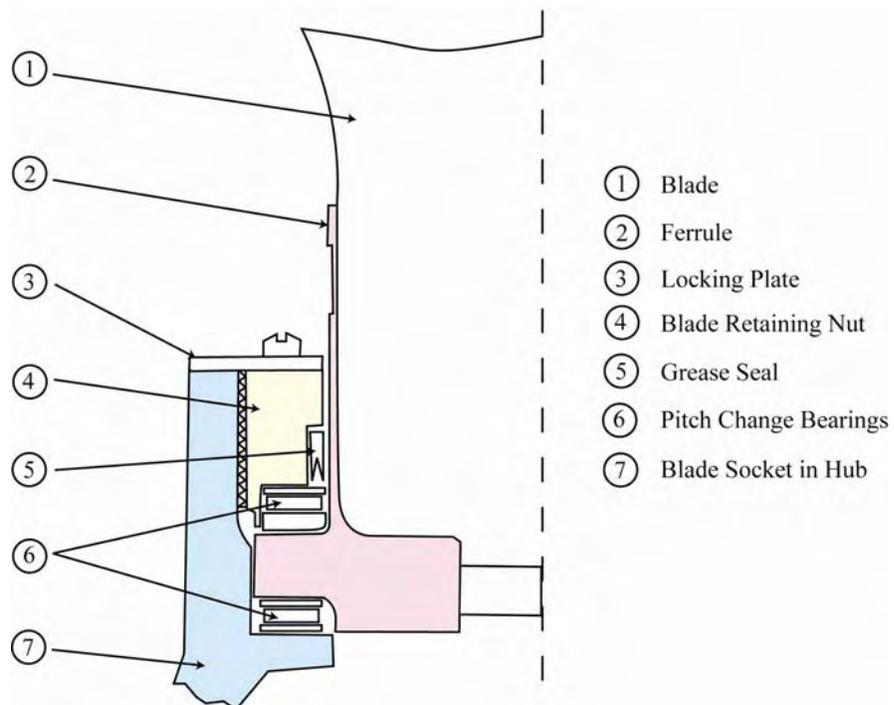
Figure 4

Part section through blade socket components

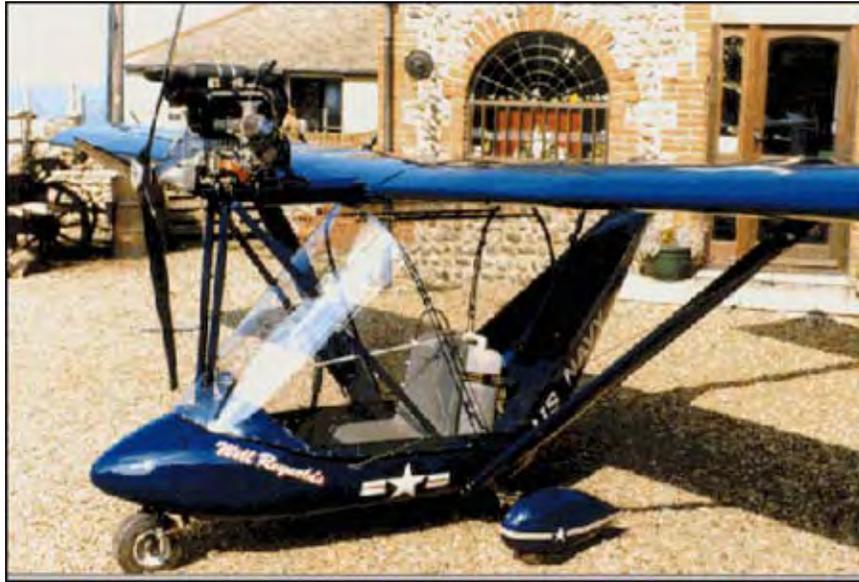
A photograph of G-MZEI shown above. The main structural member of this type of aircraft is a longitudinal alloy boom running from the tail, through the wing centre section and then beyond the leading edge. The fuselage is located below the wing such that the boom runs along the cockpit roof. The engine is mounted on the front of the boom and so is positioned above and forward of the pilot. This arrangement had served to protect the pilot to an extent, as the main force of the impact had been borne by the engine and mounting structure. However, additional bracing was provided in the form of struts located between the engine mount and the cockpit sides, and the compressive failure of one of these during the impact had resulted in a broken end penetrating the pilot's right thigh, causing a serious injury.

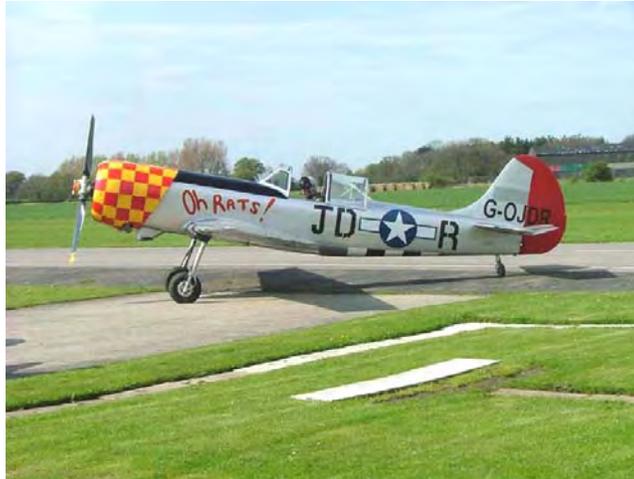
Figure 1 Accident aircraft

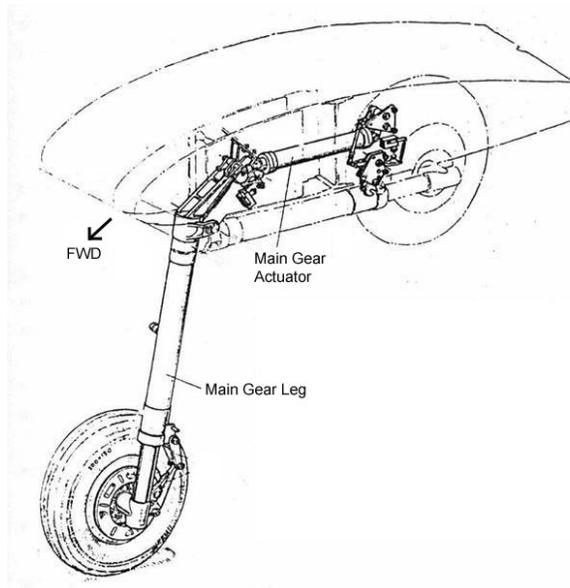
The aircraft has retractable main landing gear and a non-retractable tailwheel. The main landing gear legs are unconventional in that they retract aft into the wing rather than sideways. Half of each wheel retracts into the wing leaving the other half and the landing gear leg exposed to the airstream (see Figure 2). The design makes wheels-up landings (on hard surface runways) practicable while minimising damage to the aircraft's underside. The left and right main gear actuators are pneumatically powered. When the gear is selected DOWN pneumatic pressure causes each actuator arm to pull on the top of the respective main gear leg, rotating the leg forwards into the air stream. The leg needs to rotate approximately 10 degrees forward of the vertical before it will lock down. Two spring loaded hooks on the main gear leg engage a fixed stop within the wing as the leg is forced forwards against it until the hooks lock the gear in place. The hooks also press against a microswitch which triggers the 'green' down and locked light in the cockpit. If not properly rigged it is possible for the 'green' down and locked light to illuminate before the gear has fully locked into position.

Figure 2 Yak-50 main landing gear

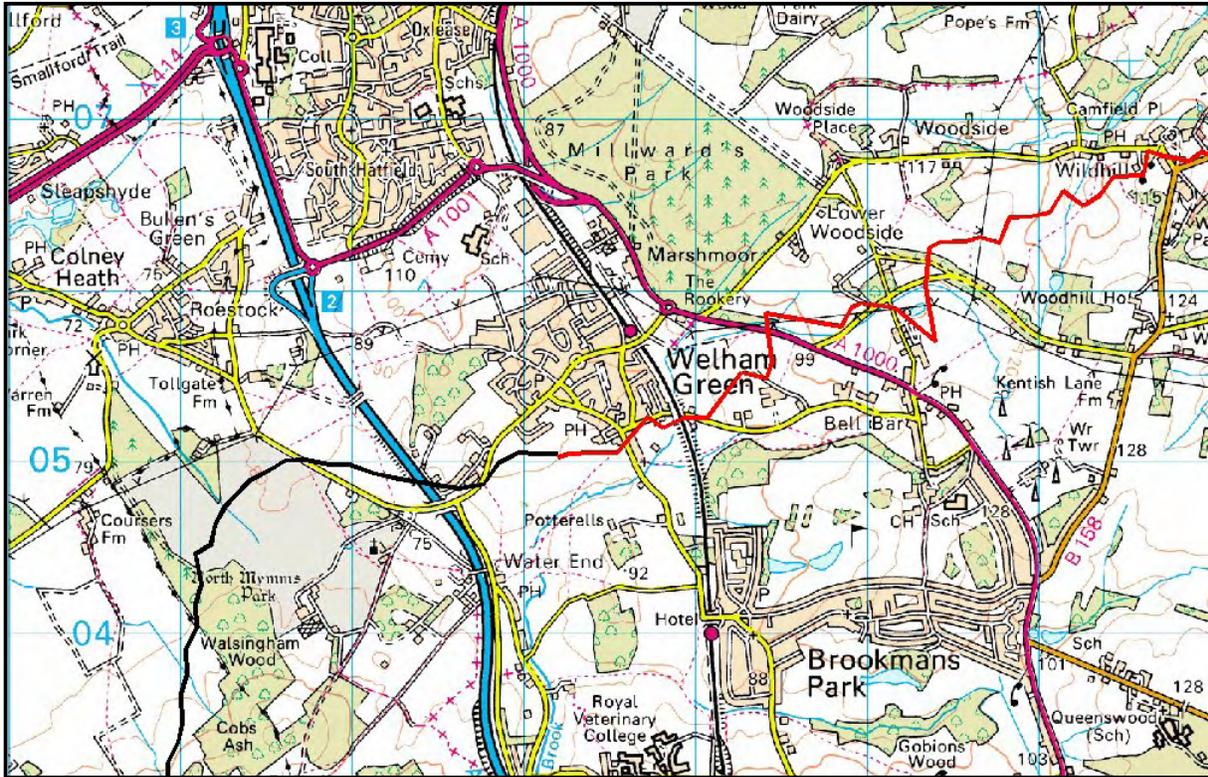
Figure 1 - Radar tracks of microlight G-MTJP (in red) and helicopter G-LIDS (in black)

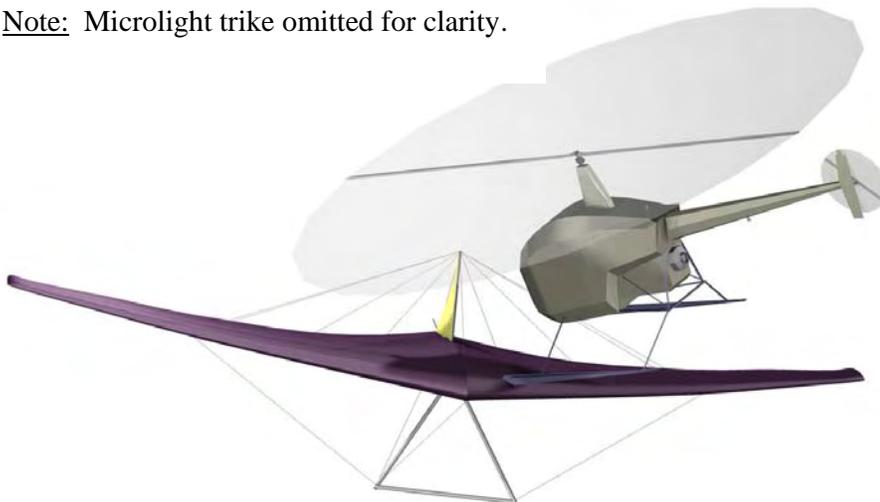
The sum total of the evidence led to a 'best fit' of the parts of each aircraft that came into contact in the air, which in turn suggested that the R22 was banked approximately 30° to the left, relative to the microlight, on a relative heading of around 135°. This is represented graphically in Figure 2 where it can be seen that the helicopter's left skid would contact the left inboard leading edge of the microlight wing, with the right skid remaining clear of the left wing rigging wires. From this position, the helicopter's nose would go on to brush the wing upper surface, with the main rotor cutting into the right tip. It was not clear how all but one of the upper surface wing wires escaped being damaged, although the effect of the impact on the leading edge may have resulted in an instantaneous loss of tension, causing them to droop out of the way.

Figure 2 - Representation of the two aircraft immediately prior to impact
