Aircraft Type and Registration:	Boeing 777-236B, G-VIIA	
No & Type of Engines:	2 GE90-85B turbofan engines	
Year of Manufacture:	1997	
Date & Time (UTC):	26 June 2003 at 1000 hrs	
Location:	Near Reigate, Surrey	
Type of Flight:	Public Transport (Passenger)	
Persons on Board:	Crew - 14	Passengers - 272
Injuries:	Crew - None	Passengers - None
Nature of Damage:	Access door detached, cabin windows damaged, minor damage to fuselage and fin	
Commander's Licence:	Airline Transport Pilot's Licence	
Commander's Age:	49 years	
Commander's Flying Experience:	14,750 hours (of which 2,350 were on type) Last 90 days - 190 hours Last 28 days - 36 hours	
Information Source:	AAIB Field Investigation

Synopsis

Aircraft Type and Registration:	McDonnell Douglas DC-8-63F, 9G-MKO
No & Type of Engines:	4 Pratt & Whitney JT3D-7 turbofan engines
Year of Manufacture:	1971
Date & Time (UTC):	29 April 2003 at 1500 hrs
Location:	RAF Lyneham, Wiltshire
Type of Flight:	Public Transport (Cargo)
Persons on Board:	Crew - 4 Passengers - None
Injuries:	Crew - None Passengers - N/A
Nature of Damage:	Right main landing gear fractured
Commander's Licence:	Airline Transport Pilot's Licence
Commander's Age:	43 years
Comm

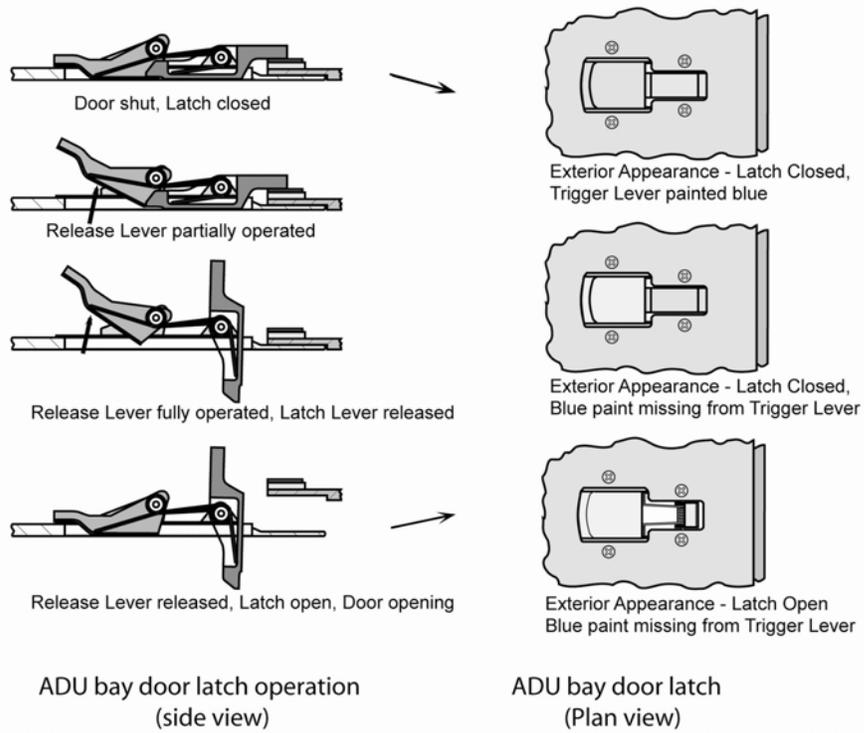
Figure 4

The catch is released by manually pushing the trigger lever inwards until it disengages from the latch lever, allowing the latch lever to rotate under spring loading and disengage from the pad (Figure 5). The latch lever rotates 90°, its inner end passing through the door cut-out and protruding 0.85 inch beyond the outer surface of the door. The protruding portion has a generally rectangular cross section of approximately 0.7 x 0.4 inch; on G-VIAA the exterior face (when closed) was painted the same dark blue as the door and the side and inner faces were generally unpainted silver-coloured aluminium. It was noted that the side faces of the latch levers on the replacement door were painted orange. The trigger lever returns to its flush position when released. The outer face of the trigger lever was generally painted dark blue; in G-VIIA's case this paint had disappeared from some of the catches, leaving the silver-coloured metal surface of the trigger levers visible (Figure 6).

ADU bay door latch

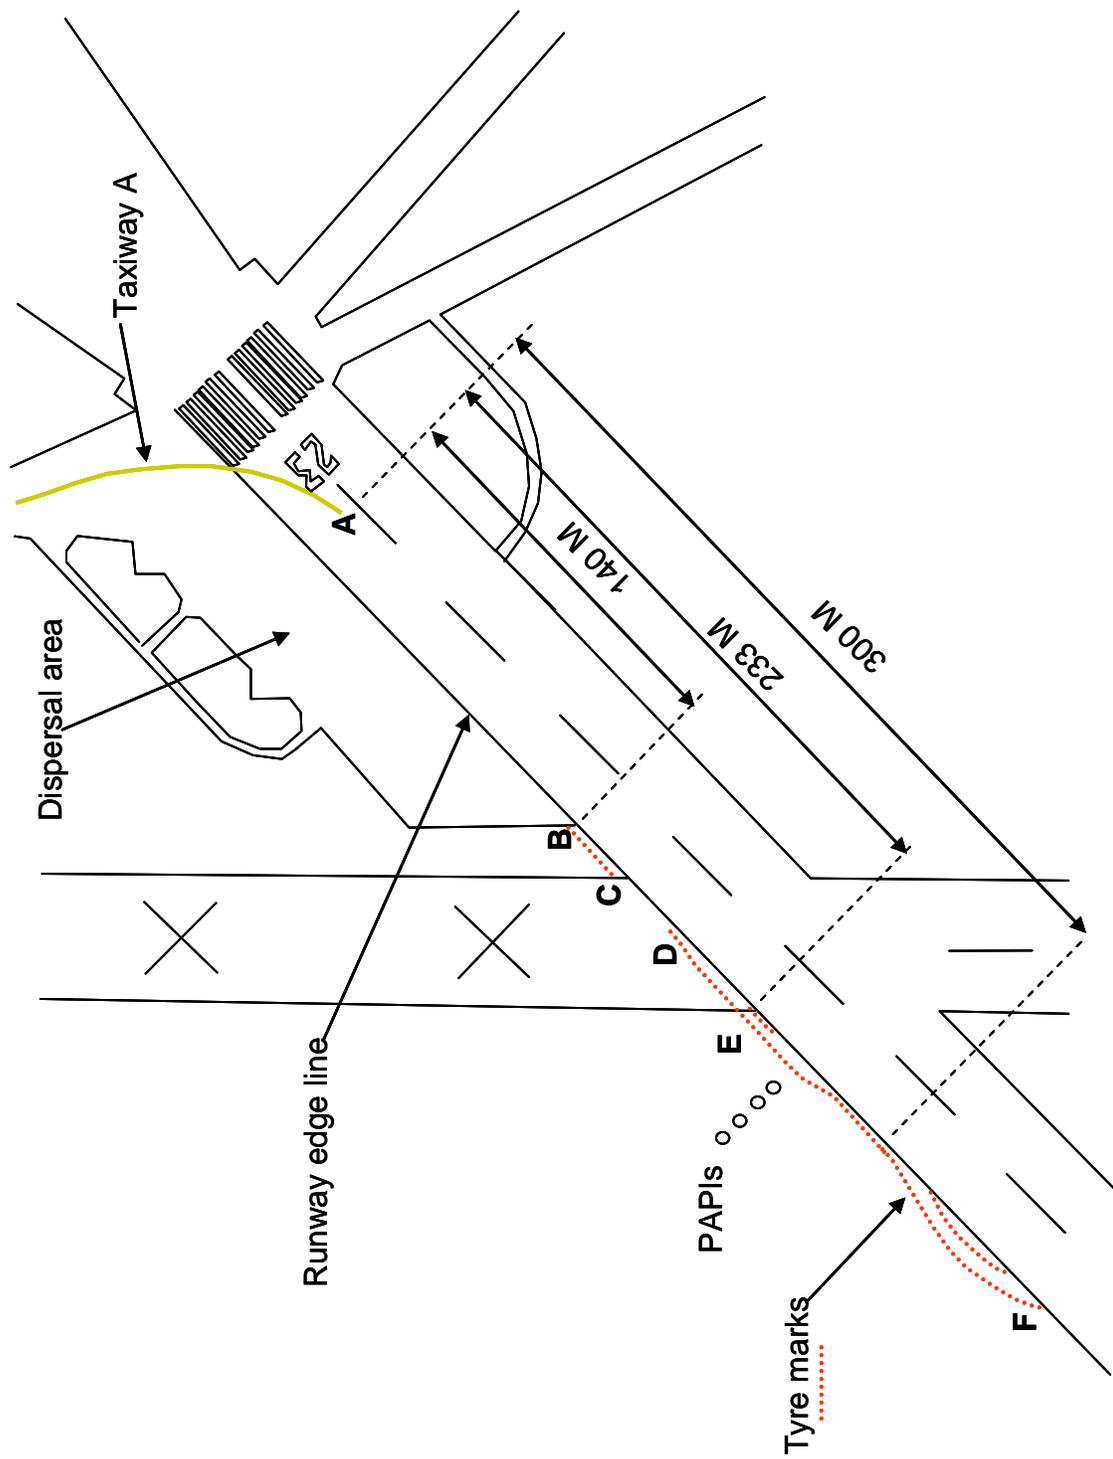
Figure 1

An examination of the site was conducted by the airport operator. The results of the examination are shown diagrammatically at Figure 1. The diagram also shows the centreline of Taxiway Alpha entering the runway, and a notional point A indicating the start of take-off roll for an aircraft following this yellow line.

The ground markings at Teesside Airport are the subject of a current refurbishment programme. In the light of this incident and as part of that process, the airport operator has scheduled a review of the ground markings for Runway 23 which will take place early in 2005. Additionally, an upgrade to the airfield ground lighting system is scheduled for mid-2005.

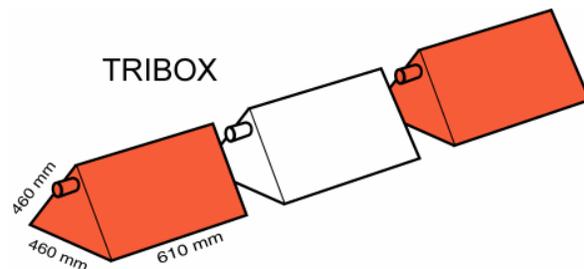
Each triangular 'Tribox', constructed of strong medium-density polythene, is 610 mm long, with sides measuring 460 mm in length and standing 398 mm high. Individual boxes may be locked together by means of spigots that locate into holes in an adjoining box.

The 'Tribox' itself is relatively light-weight. By calculation however, a Tribox containing water to half its height would weigh some 40 kg more than its empty weight.
