## CONTENTS

## SPECIAL BULLETINS

## COMMERCIAL AIR TRANSPORT

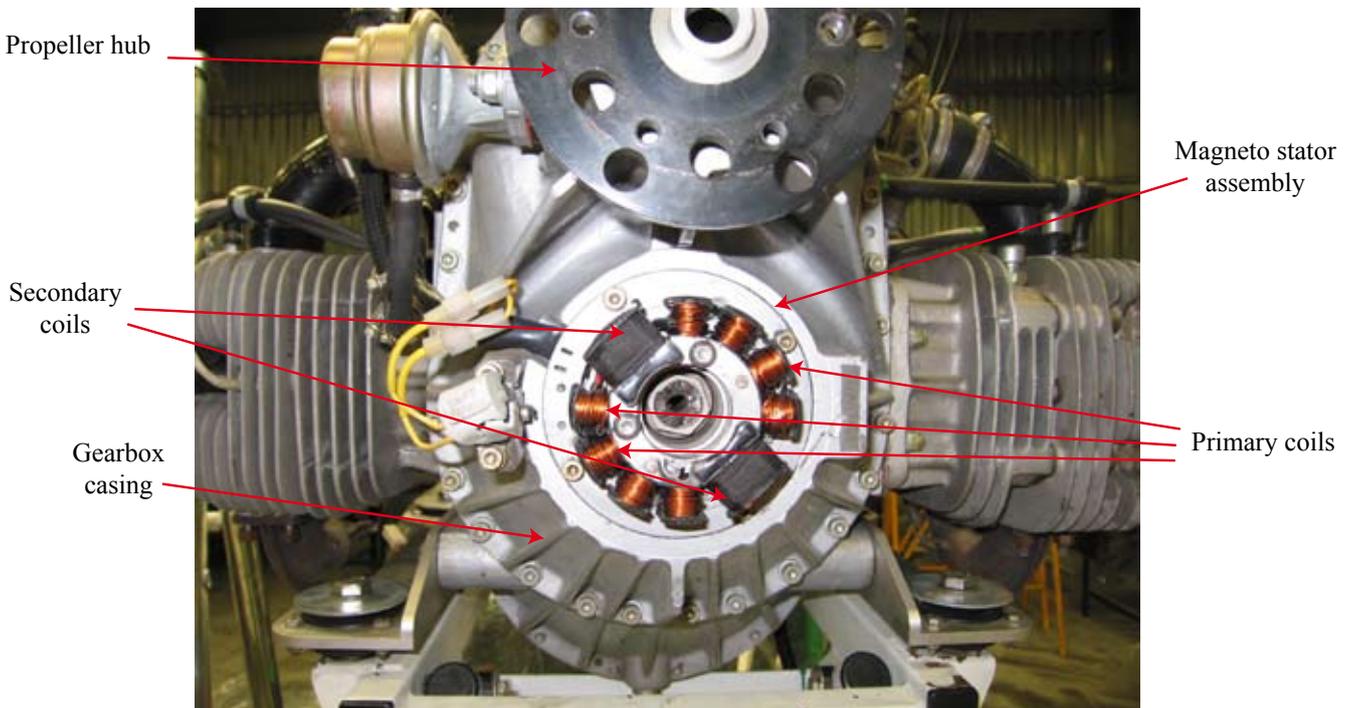
**Figure 1**

The magneto on the Verner 133M engine is located on the front of the engine, immediately below the propeller shaft. It consists of eight primary and two secondary coils secured to the front of the gearbox casing (Figure 1). Magnets are secured to the inside of a rotating casing which covers the entire assembly. The casing is bolted to a steel stub shaft, pressed into the forward end of the crankshaft, which passes through the centre of the coils, (Figure 2).
