INCIDENT

Aircraft Type and Registration:	Boeing 747-2D7B, N523MC	
No & Type of Engines:	4 General Electric CF6-50 turbofan engines	
Year of Manufacture:	1979	
Date & Time (UTC):	12 December 2004 at 1611 hrs	
Location:	On approach to Runway 05 at London Stansted Airport, Essex	
Type of Flight:	Public Transport (Cargo)	
Persons on Board:	Crew - 3	Passengers - None
Injuries:	Crew - None	Passengers - N/A
Nature of Damage:	None	
Commander's Licence:	FAA Airline Transport Pilot Certificate	
Commander's Age:	56 years	
Commander's Flying Experience:	Approximately 14,000 hours (of which 6,000 were on type) Last 90 days - 196 hours Last 28 days - 66 hours	
Information Source:	AAIB Field Investigation and operating company report

Synopsis

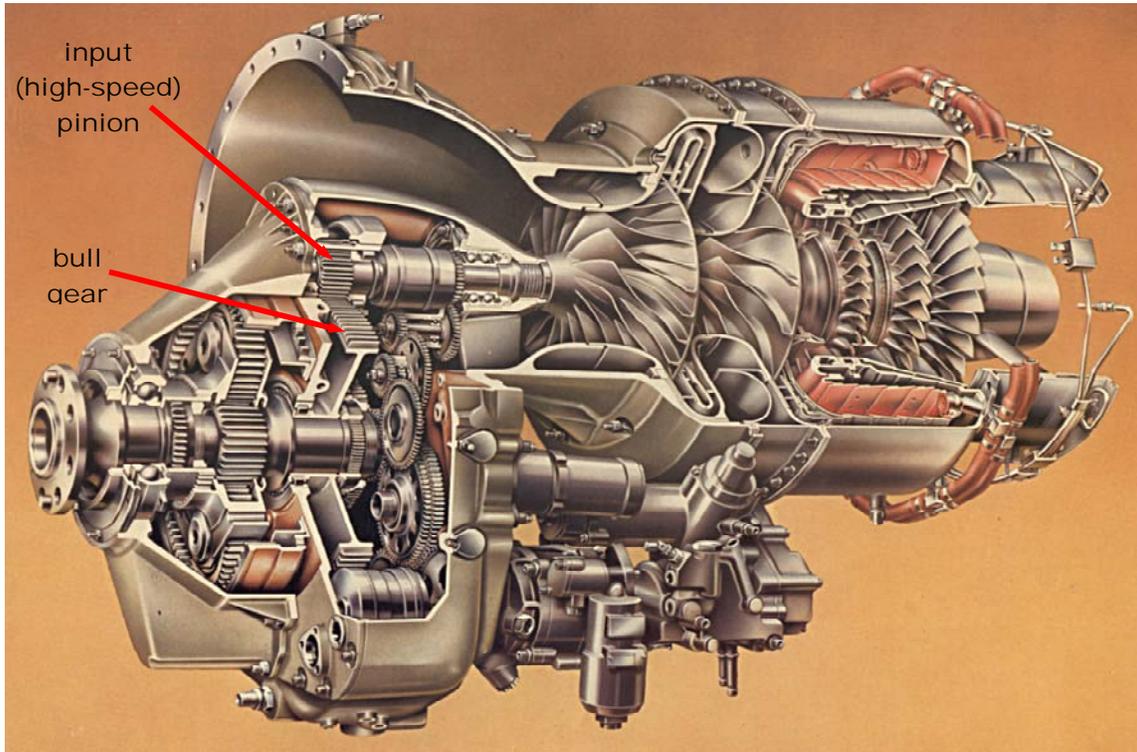
Figure 1:
Configuration of TPE 331 engine as installed on the Jetstream

Figure 1 is a cut-away view of the TPE 331 series engine and gearbox of the type installed in G-BYRA. The 41,750 RPM rotational speed of the gas generator is reduced to 1,591 RPM at the propeller in two stages. The first stage reduction is achieved via a simple pair of straight-cut gears, comprising a high-speed (input) pinion mounted on the engine shaft driving a large bull gear. The second (epicyclic) stage reduction comprises a sun gear, formed integrally with the forward face of the bull gear, driving a set of planet gears which in turn drive the propeller shaft directly via a splined coupling to the planet gear carrier.

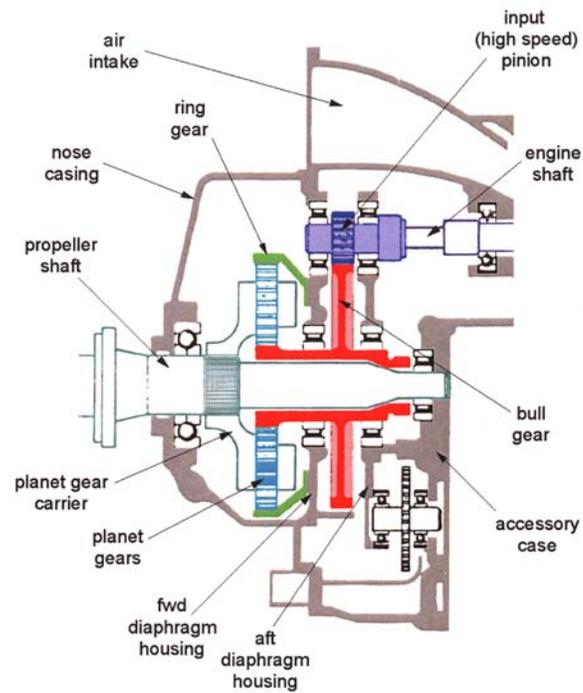
Figure 2:
Sectional view through gearbox (schematic)

Figure 2 shows a schematic sectional view through the reduction gearbox. The input pinion (coloured dark blue) and bull gear (coloured red) are supported within a split aluminium housing within the gear casing known as the diaphragm; the two halves are manufactured as a matched set. The epicyclic second stage occupies the front half of the gear case cavity, formed by the nose casing. The ring gear of the epicyclic stage is anchored to the forward face of the diaphragm.

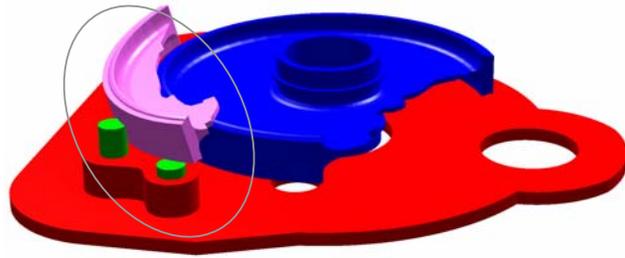
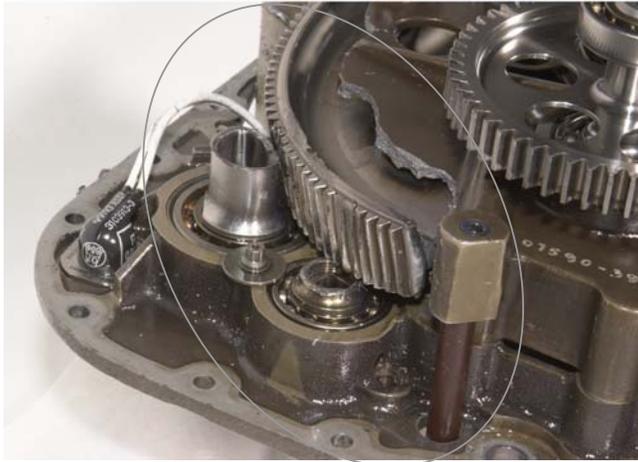
Figure 8:
**CAD model showing relative positions of
separated rim segment and remains of bull gear**

In order to resolve this issue a simple 3-D CAD model was constructed of the detached rim segment, together with the remains of the fractured gear and relevant parts of the adjacent gearbox casing. After setting up the model to match the observed position of the jammed rim segment, (see Figure 8), it was evident that the combination of its radial position, and tilted orientation relative to the surviving part of the gear, was such that it would not have interfered. Consequently, it would have been possible for post failure rotation of the bull gear to have taken place, and thus for it to have been the source of the severe vibration, provided the drive line from the engine, or alternatively from the propeller shaft, had remained intact following gear fracture.
