Aircraft Type and Registration:	Falcon 900EX, VP-BMS	
No & Type of Engines:	3 Garrett TFE 731-60-1C turbofan engines	
Year of Manufacture:	1999	
Date & Time (UTC):	9 February 2004 at 0130 hrs	
Location:	London (Stansted) Airport, Essex	
Type of Flight:	Private	
Persons on Board:	Crew - 2	Passengers - 2
Injuries:	Crew - None	Passengers - None
Nature of Damage:	Extensive damage to right wing and landing gear doors	
Commander's Licence:	Airline Transport Pilot's Licence (FAA) with Bermudan validation	
Commander's Age:	52 years	
Commander's Flying Experience:	20,954 hours (of which 700 were on type) Last 90 days - 105 hours Last 28 days - 35 hours	
Information Source:	AAIB Field Investigation

Aircraft Type and Registration:	DHC-8-311, G-BRYU	
No & Type of Engines:	2 Pratt & Whitney PW123 turboprop engines	
Year of Manufacture:	1997	
Date & Time (UTC):	21 December 2004 at 0723 hrs	
Location:	Edinburgh, Scotland	
Type of Flight:	Public Transport (Passenger)	
Persons on Board:	Crew - 4	Passengers - 49
Injuries:	Crew - None	Passengers - None
Nature of Damage:	None	
Commander's Licence:	Airline Transport Pilot's Licence	
Commander's Age:	43 years	
Commander's Flying Experience:	5,350 hours

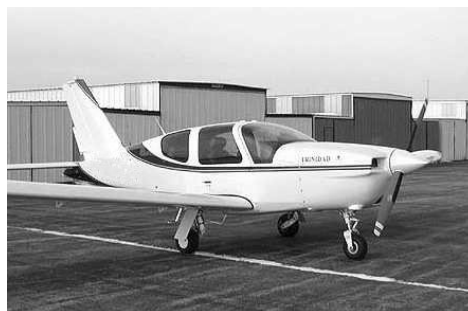
The aircraft was returning to Bournemouth Airport after a cross country flight from Cherbourg, France. When the pilot selected the landing gear down, only the nose gear 'down and locked' green light illuminated. The pilot recycled the landing gear up then down, but again only the nose gear indicated down and locked. The pilot then tried to lock the main gear down by pulling the emergency gear extension knob, but this was unsuccessful. After reporting the problem to the control tower he performed a low fly-by. During the fly-by the tower controller reported that the main landing gear appeared to be extended. The pilot carried out a normal circuit to the right to land on Runway 08. Upon touchdown the right main gear leg collapsed and the right wing tip struck the runway. The aircraft came to rest on the runway and the occupants vacated the aircraft unassisted. The airfield's fire and emergency services arrived on the scene soon afterwards but there was no fire.

An examination of the landing gear system was carried out by a maintenance organisation. The aircraft was raised on jacks and it was discovered that the left and right main gear hinged struts were stiff in operation. The nuts on the hinged struts were loosened and then gear retraction and extension tests were carried out. Even with the loosened hinges the electro-hydraulic generator appeared to be 'weak' and only barely able to extend and retract the gear. The electro-hydraulic generator was stripped and inspected but no obvious fault was found that would have reduced its effectiveness. The generator was cleaned and fitted with new O-ring seals prior to re-assembly. The left and right main gear hinged struts were removed, treated for corrosion, lubricated and then re-fitted. Following this work the gear retracted and extended satisfactorily. The emergency gear extension system was also tested and operated satisfactorily.

The maintenance engineer who examined the aircraft believed that the stiffness in the hinged struts was the primary reason why the landing gear did not lock down. Once the hinges were lubricated and the corrosion treated, the landing gear could be extended and retracted normally. According to maintenance records the hinges had been lubricated during the 50 hour check less than three months before the accident, but the aircraft was parked outside during this period so rain and lack of frequent use could have contributed to a deterioration of the state of the hinges.
