**CONTENTS****MESSAGE from the CHIEF INSPECTOR**

**COMMERCIAL AIR TRANSPORT****FIXED WING**

## MESSAGE FROM THE CHIEF INSPECTOR OF AIR ACCIDENTS

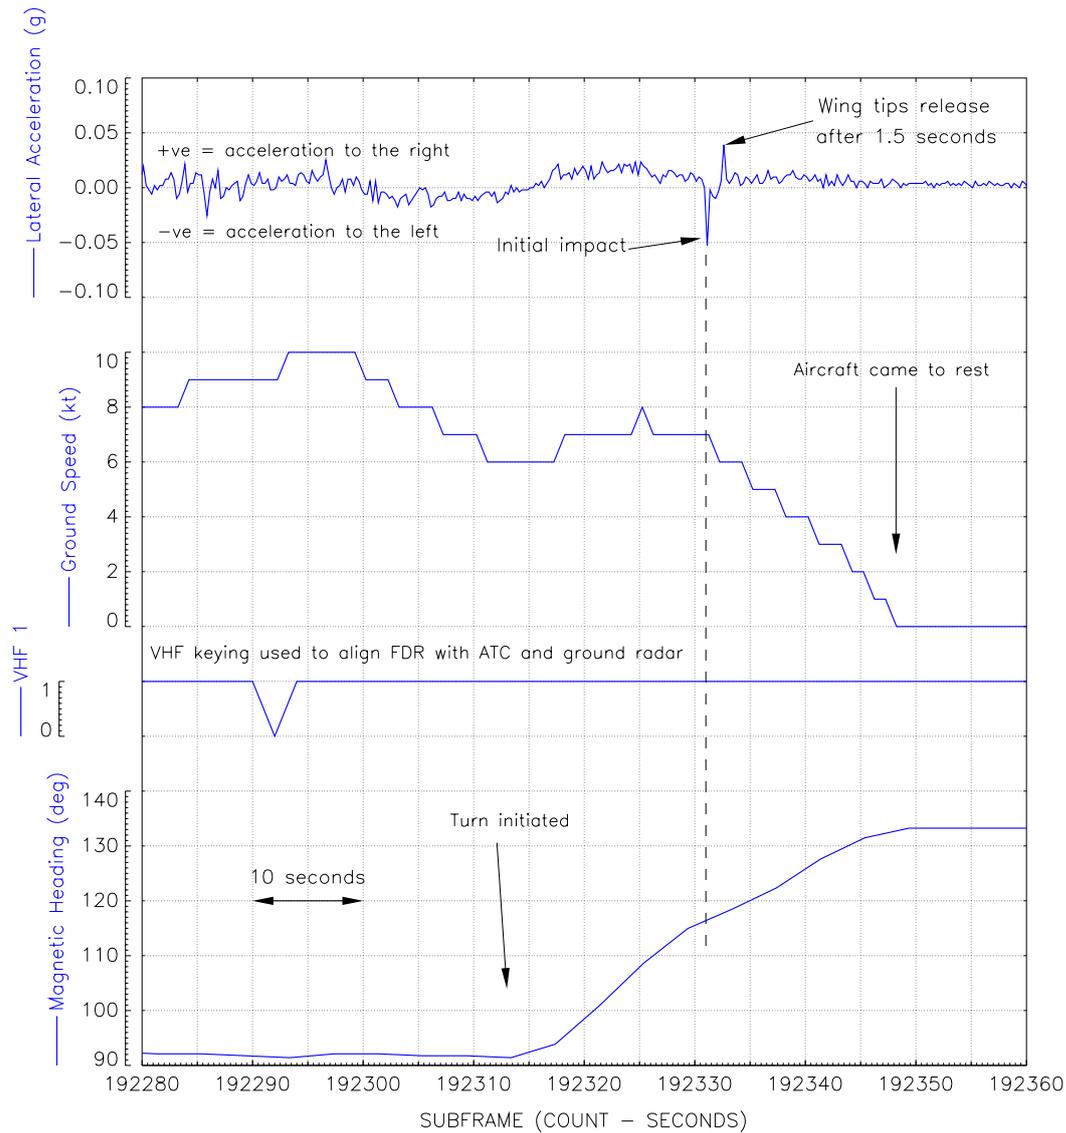
The different sources of recorded data all used separate timebases. However, matching the FDR recorded VHF keying with the ATC radio transmissions, along with NATS records of the differences between the ATC audio and ground radar time bases, allowed the different sources to be correlated. Figure 3 shows the main parameters from the FDR. The collision occurred at 12:53:51 hrs and three ground radar plots covering this time, each separated by 1 second, are presented in Figures 4 to 6.

**Figure 3**  
 Key FDR parameters from the B777.  
 Accident to N781UA / 6Y-JMP on 14 July 2004 at Heathrow

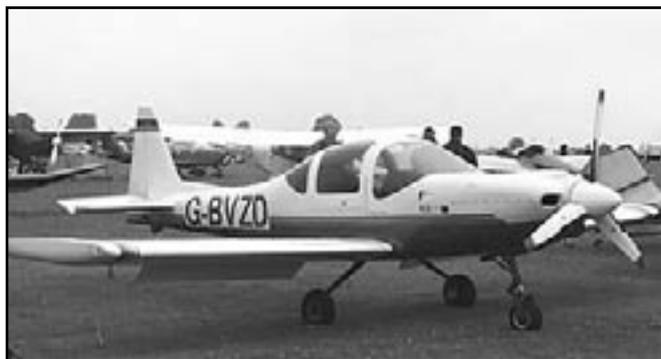
Returning from a flight to Leicester the aircraft was on approach to Runway 05 in good weather with a wind from 060° at 10 kt. During the flare the aircraft stalled at approximately two to three feet above the runway resulting in the aircraft touching down heavily on its tail and main gear. The aircraft bounced twice resulting in the nosewheel bursting and the propeller tips striking the runway surface. Despite the damage the pilot was able to taxi the aircraft off the runway and back to the flying club.

In a candid report the pilot admitted that he allowed the airspeed to reduce too low during the flare.

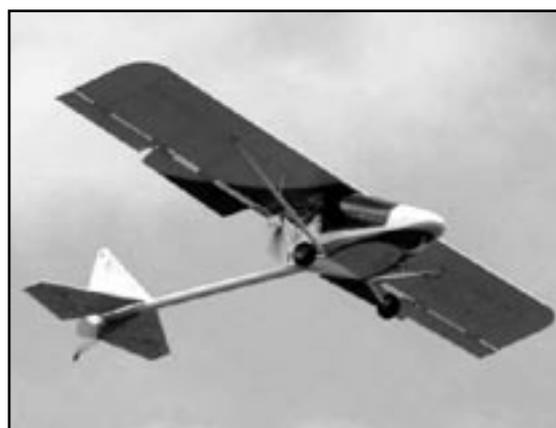
The pilot and his passenger were on a cross country flight from Horsley Brook Farm (Staffordshire) to Netherthorpe Airfield. The surface wind for the area near Netherthorpe had been reported as 10 mph (8.6 kt) from the south-west and visibility greater than 10 km. The pilot carried out an overhead join into the Netherthorpe circuit and was descending 'dead side' when another aircraft called 'long finals'. The pilot saw this other aircraft whilst on the base leg to Runway 24 grass and decided to initiate a go-around. During his second circuit he was lined-up on final approach when he experienced a 'huge lump of turbulence' that caused his aircraft to roll left to approximately 45° of bank. He rolled the wings level and because he was then a little low on the

approach he also applied some power. As the aircraft crossed the runway threshold the aircraft experienced more turbulence and sank. The pilot applied full power but it was insufficient to arrest the high rate of descent

resulting in a heavy landing that caused the left main landing gear leg to collapse. The engine continued to run with no damage to the propeller but the aircraft came to rest quickly. The pilot and his passenger were able to exit the aircraft unassisted but it was later revealed that the pilot had suffered a serious back injury.
