FLYER TO THE SHIPPING INDUSTRY

HILLI:

EXPLOSION DURING BOILER CHEMICAL CLEANING PROCEDURE

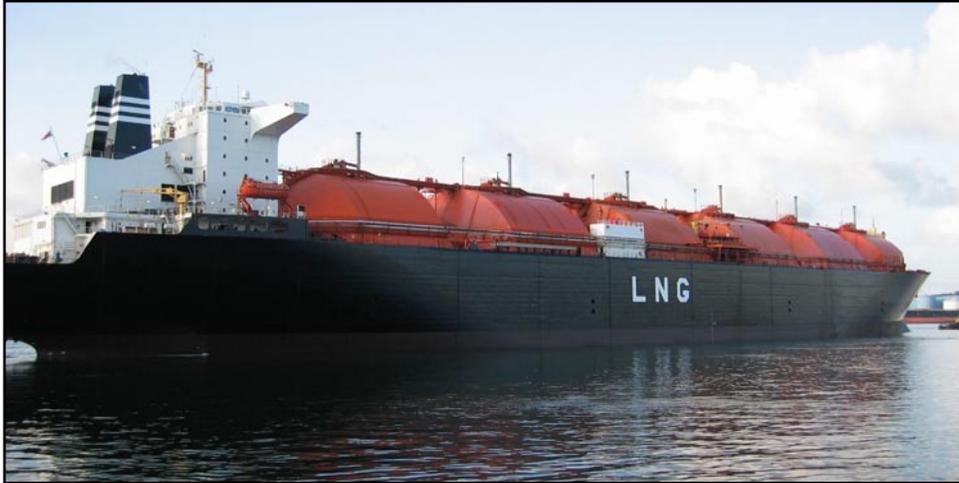
During the late evening of 10 October 2003, two boiler, chemical cleaning specialists were preparing to examine the starboard boiler of the LNG tanker, *Hilli*. A halogen lamp was introduced into the boiler steam drum. An explosion immediately followed, resulting in fatal injuries to one of the cleaning specialists and serious injuries to the other.

At 2145 the steam drum door was removed, and there was a noticeable suction as air was drawn into the drum from the outside. At 2200 both specialists approached the steam drum door. No tests were conducted to check the steam drum atmosphere for either toxic or flammable gases. One of the specialists picked up a conveniently close, non-intrinsically safe, halogen lamp and placed it just inside the steam drum. A small, blue flame or spark was seen and an explosion immediately followed. The

specialist who had positioned the halogen lamp inside the steam drum was thrown backwards by about 4.5 metres; he was unconscious and had suffered fatal burns. The other specialist was also burnt, but less severely. There was no fire or notable damage to either paintwork or structure.

- There was an acceptance that the boiler repairer's chosen chemical cleaning specialist was the "expert" and there was little need to evaluate his cleaning procedures. Had risk assessments and a Method Statement been submitted, and there had been greater involvement by ship's and technical staffs and the primary contractor, then it is possible that the need to adopt the well known confined space routines, including testing the steam drum atmosphere for toxic and flammable gases, would have made the accident far less likely.

- Those involved in repairs should be aware that non-intrinsically safe equipment will often be brought onboard. Indeed, in this case, a large amount of hot work had been authorised through Permit to Work procedures. The lamp had been used to illuminate the hot work areas and did not need to be intrinsically safe. However, a momentary lapse of concentration caused the close at hand lamp to be introduced into the steam drum, with devastating effect. Supervisors, ship's staff and contractors need to be vigilant to these risks.
