MARINE ACCIDENT INVESTIGATION BRANCH

## FLYER TO THE SHIPPING INDUSTRY

### *Pride of Canterbury*

#### Grounding of a passenger ferry on a chartered wreck while awaiting Dover port to reopen

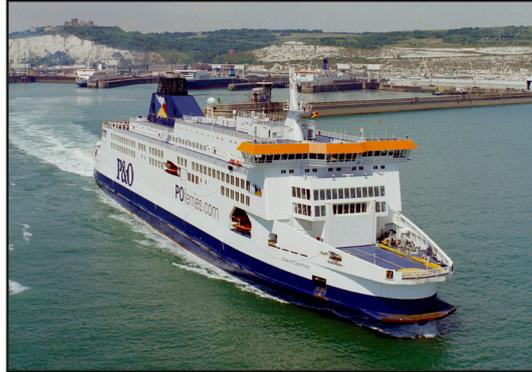
On the afternoon of 31 January 2008, while sheltering off the port of Dover in bad weather conditions, the passenger ferry *Pride of Canterbury*, with 275 passengers and 101 crew on board, grounded on a chartered wreck. She sustained major damage, including the total loss of her port controllable pitch propeller hub and a section of tail shaft.
