## PUBLISHED PROJECT REPORT PPR724

### Technical Assessment of Petroleum Road Fuel Tankers Summary Report (all Work Packages)

**B Robinson (TRL), D Webb (HSL), J Hobbs (HSL) & T London (TWI)**

**Prepared for:** Department for Transport, Dangerous Goods Division

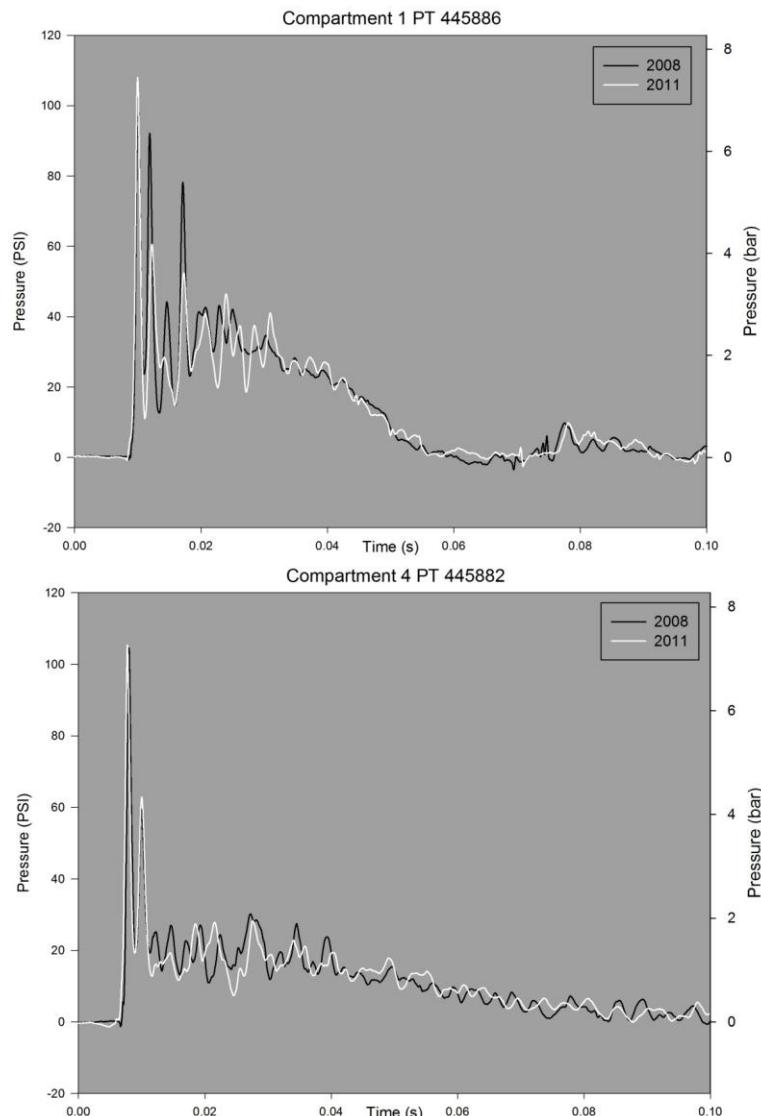
**Figure 10. Comparison - pressure measured at the centre of the impact area.**

The pressure data in both compartments were similar for both non-compliant tankers (Figure 10). Short duration pressure peaks between 2 and 7.7 bar (28.4 and 110 psi) were observed during the first 20 to 30 ms of the impact; these were above the 2-bar (28.4 psi) used in previous (pressure-impulse) rollover modelling by Bysh and Dorn, 1996. However, between around 20 and 40 ms after impact the pressures were around 2-bar, and after this the pressures reduced further.

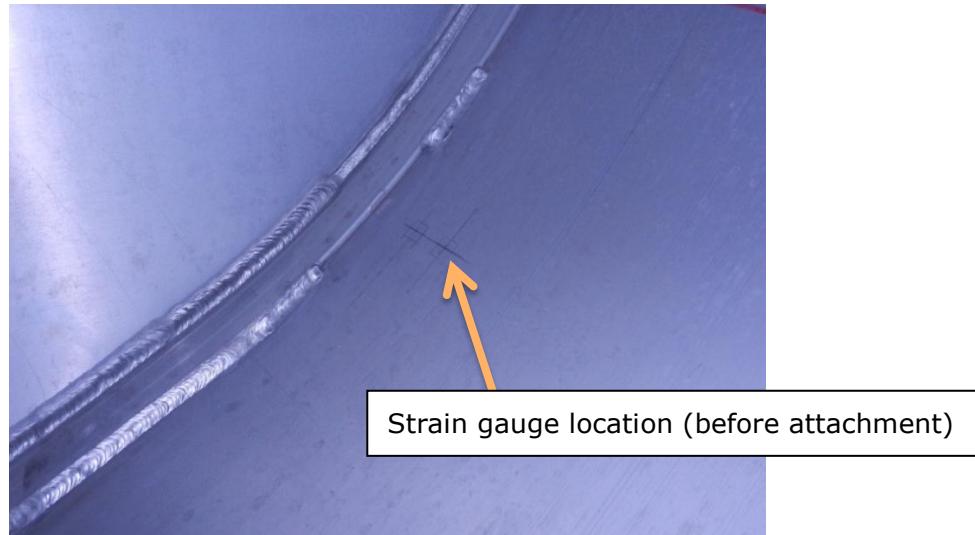
**Figure 16. Example of fillet welds, 2011 tanker**

Figure 16 illustrates the fillet welds in the 2011 tanker. A long fillet weld runs to the bottom left corner - long welds were also used on the 2008 tanker. A short (or 'stitch') fillet weld is above the strain gauge location point - these short welds were used extensively on the 2011 tanker but infrequently on the 2008 tanker.

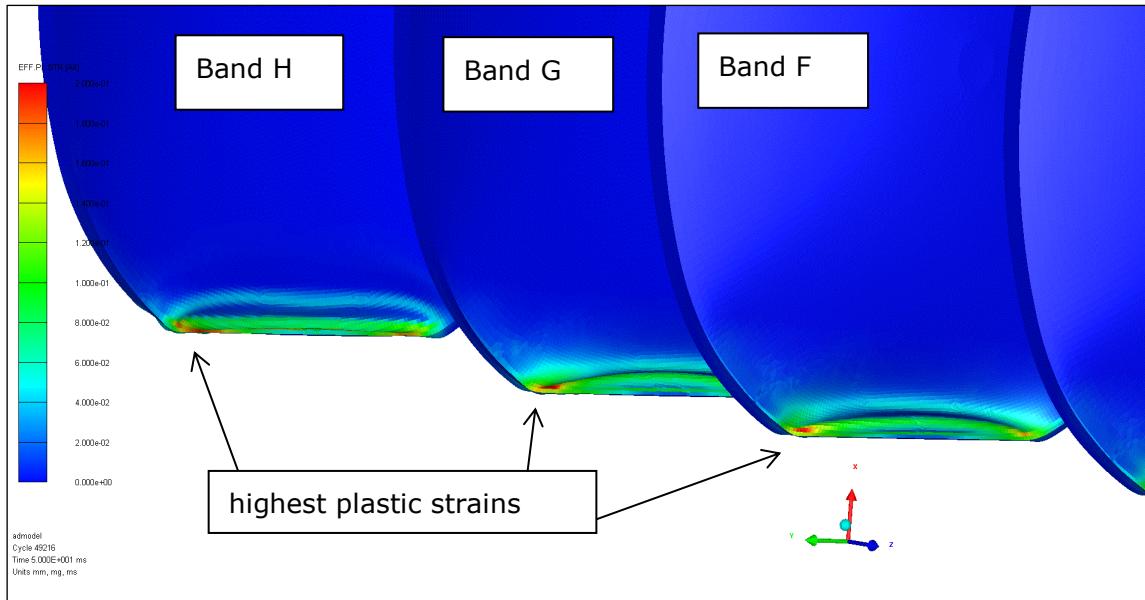
**Figure 22. Plastic strain in the bulkheads from the 2011 tanker modified model**

The highest levels of plastic strain were observed in the bulkheads, at the top and bottom of the flat chord generated by the impact (Figure 22). The magnitude of the peak plastic strains was in the order of 0.2 (or 20%), a level at which failure may be expected. It was at the top of this flat impact chord where ruptures in the toe of the weld and within the weld between the bulkhead and extrusion band occurred during topple tests on the 2008 and 2011 tankers, respectively.

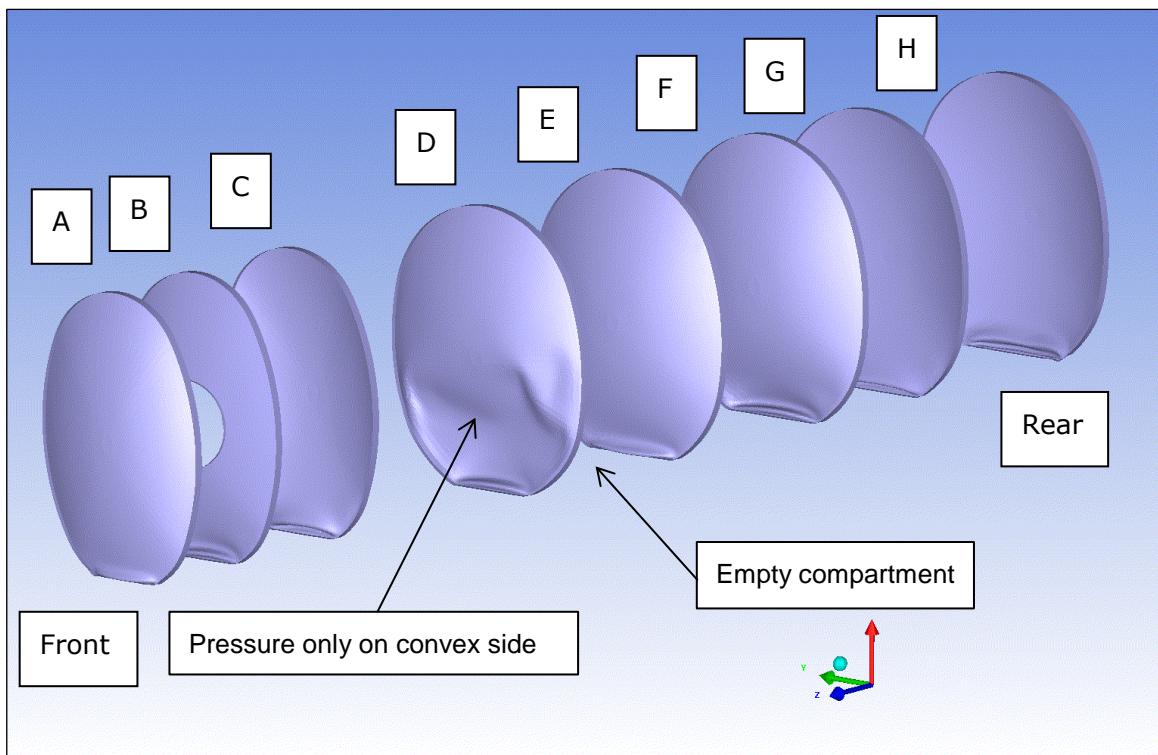
The empty compartment (in the fuel oil model) resulted in differences in the stresses in the tanker shell close to the bulkheads separating the filled and empty compartments. The deformation of the bulkhead on the front side of the empty compartment was significantly different in this model to that for water, as the pressure was only applied by fuel oil to the convex side of this bulkhead rather than to both sides by water. In contrast, deformation of the bulkhead on the rear side of the empty compartment, where pressure was only applied by fuel oil to the concave side of the bulkhead, rather than to both sides by water, was not significantly different in this model to that for water. This is illustrated in Figure 24. This type of deformation was not observed for the petrol model where no compartment was left empty.

**Figure 24. Deformed bulkheads for fuel oil model with impact at 2.6 rad/s clearly showing effect of pressure only on the convex side of bulkhead D**

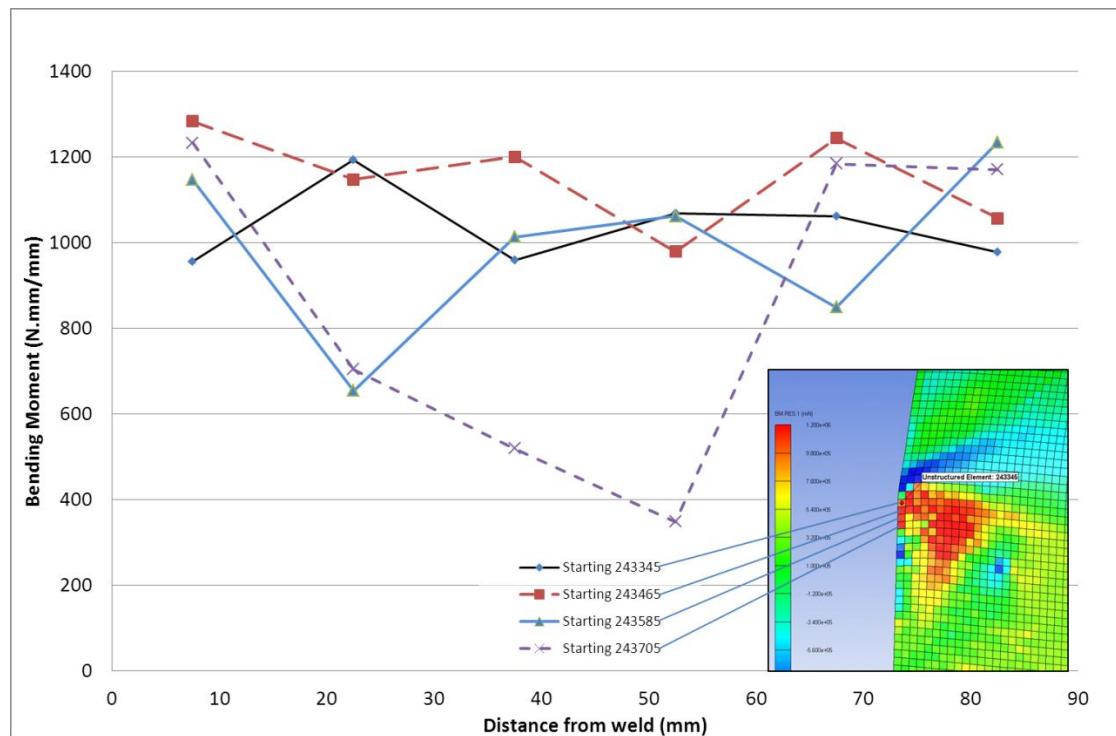
During post-mortem examination of the rear of the 2008 tanker as part of WP2, a through-wall crack along the circumferential weld at the top of the impact zone in Band H+ was examined. Values of the bending moments in this area were obtained by similar extrapolation from the modified finite element model (with a water load) using the same 1.89 rad/s impact velocity as in the 2008 tanker topple test. The results are shown in Figure 25. Bending moments at the band H+ weld plane for the locations assessed ranged from 1,350 Nmm/mm to 1,500 Nmm/mm. These values were supplied to WP2 for the ECA, and were similar to those obtained for the fuel cases modelled at Band F+.

**Figure 25. Variation in bending moments with distance from the rear weld (Band H+) for water at 1.89 rad/s**

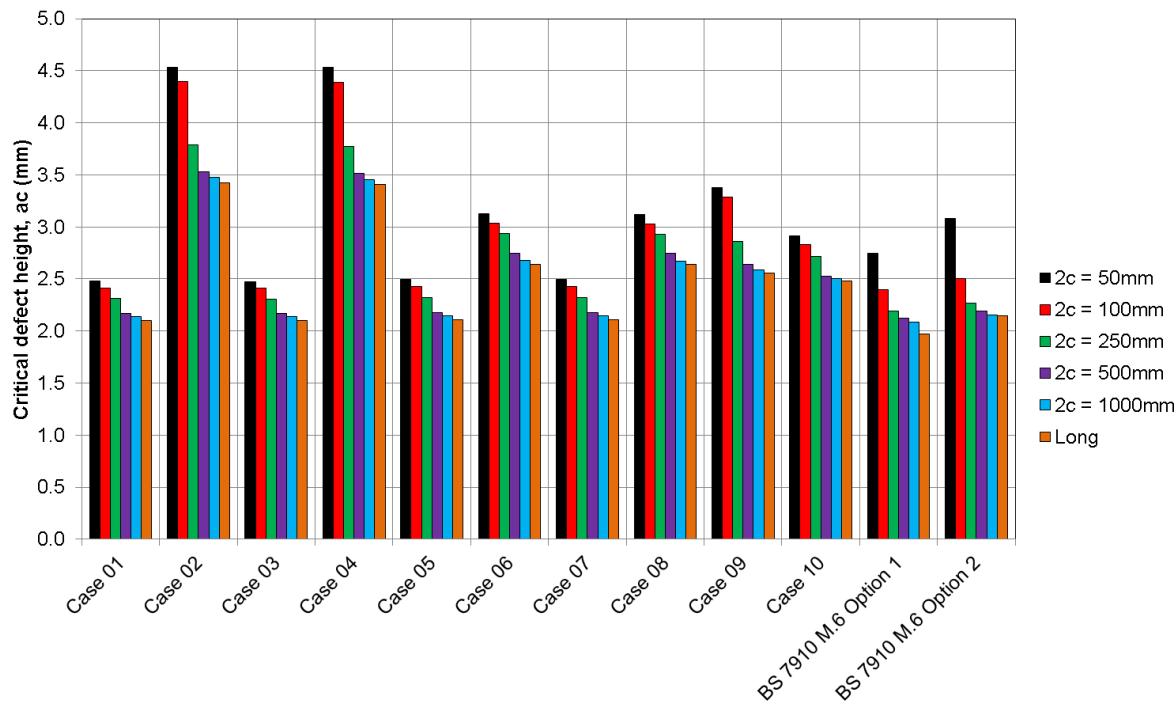
The critical defect sizes were determined by changing the crack size until the assessment point intersected the failure assessment line. For fully-circumferential flaws, the smallest critical defect amongst all geometry cases was 2.1 mm, and this occurred in a geometry in which significant misalignment was present. The critical defect size for a long surface flaw in the "average" geometry (Case 09) was 2.56 mm whereas it was 2.48 mm for the flush ground joint (Case 10). A chart of the results is shown in Figure 30, which includes the results for finite length flaws, as well as those obtained from using the curved shell solutions in BS 7910.

When the additional internal fillet weld is present, the critical defect size is almost always larger than the deepest flaw modelled. For this reason, it may be assumed that surface flaws under the ADR load case when the additional fillet weld is present are acceptable.

**Figure 30. Critical defect heights, ADR load case without internal fillet weld.**

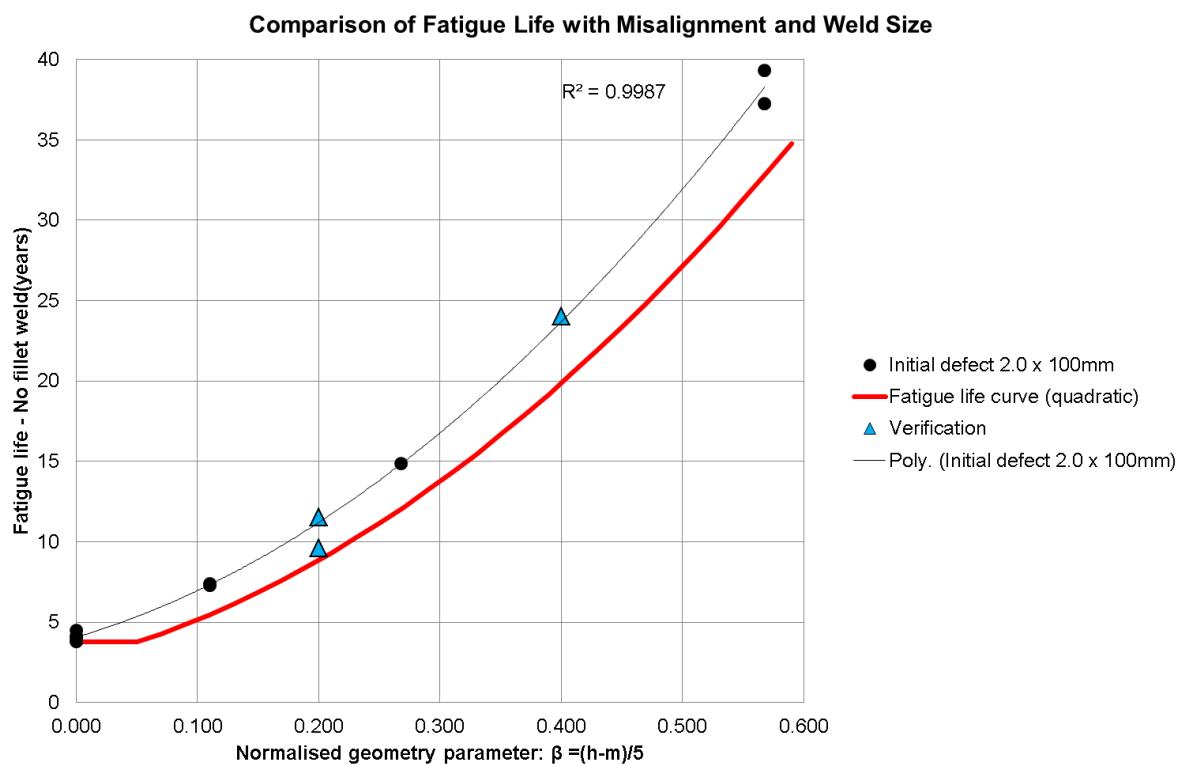
Using this approach, for example, if the weld cap height is 2.00 mm, and the misalignment is 1.00 mm, then the model suggests a fatigue life of 8.85 years (highlighted cell in the Table).

**Figure 31. Parabolic relationship between fatigue life (each year equivalent to 220,000 km) and non-dimensional geometry parameter  $\beta$ .**
