Published 11 September 2014

CONTENTS**SPECIAL BULLETINS / INTERIM REPORTS**

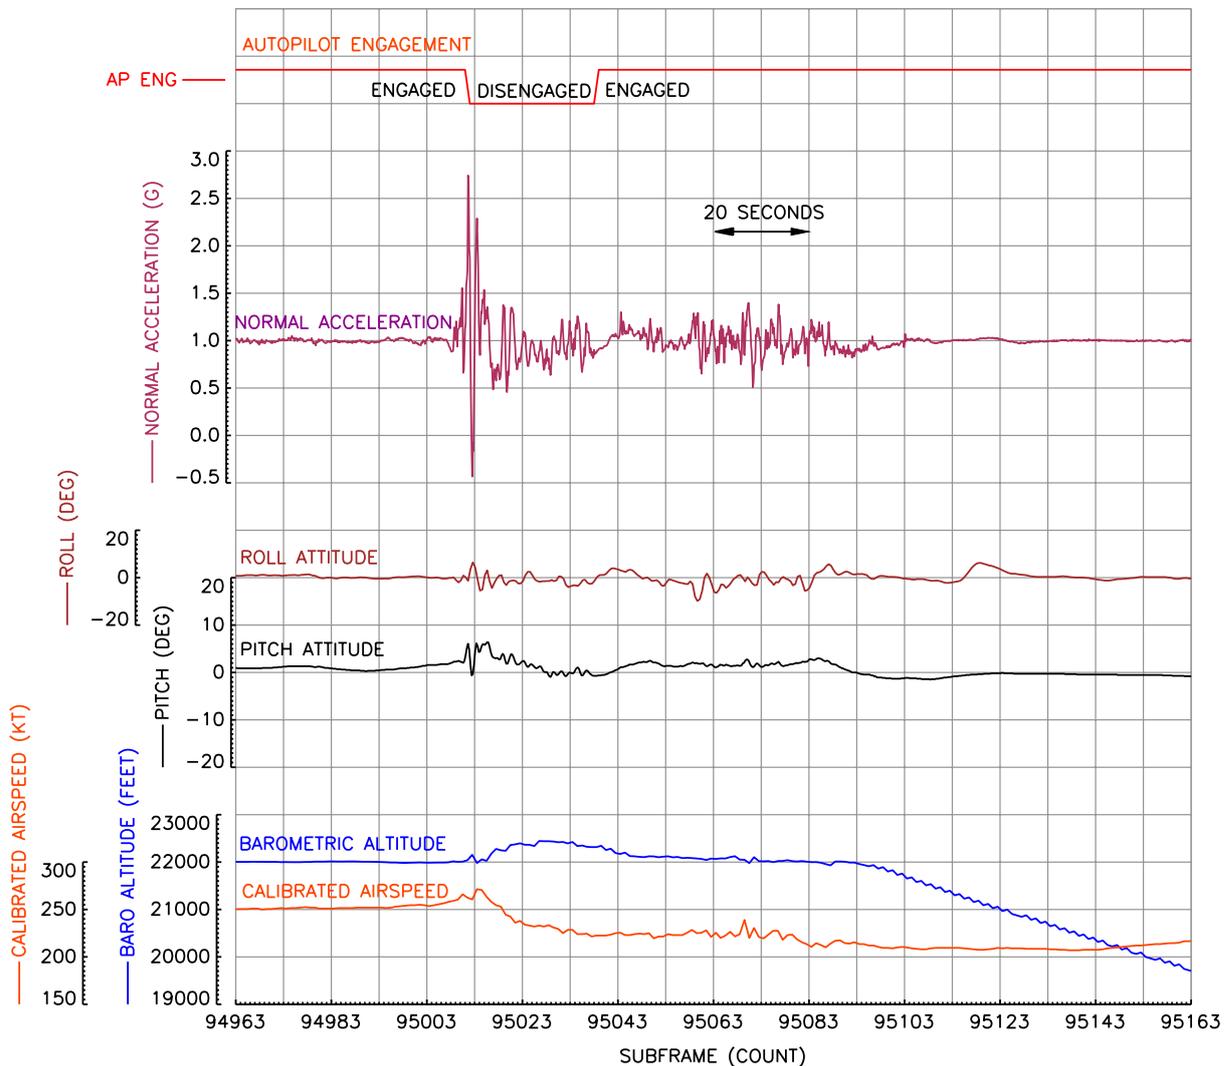
Figure 1

The event occurred on a scheduled flight between Birmingham Airport and Belfast City Airport. The aircraft was in the vicinity of the Isle of Man in VMC and had been in cruise flight at FL 220 for 17 minutes when there was a sudden onset of severe turbulence. The flight conditions until then had been smooth and the seatbelt signs were OFF. The airspeed increased rapidly, the autopilot disconnected and the aircraft climbed, reaching a maximum level of FL225. The co-pilot, who was the pilot flying (PF), assumed manual control, closed the power levers and descended back to FL 220. After 25 seconds he re-engaged the autopilot. The severe turbulence moderated after a few seconds (see Figure 1) but remained at a moderate level and the flight crew initiated a descent.

In the passenger cabin, one of the cabin crew members was thrown off her feet and sustained serious injuries. She was given medical assistance by a doctor, who was travelling as a passenger, and transferred to hospital after landing at Belfast. One passenger suffered a minor injury.

The aircraft was inspected after the incident, in accordance with requirements in the Aircraft Maintenance Manual, and no damage was evident.

Recorded parameters derived from FDR data

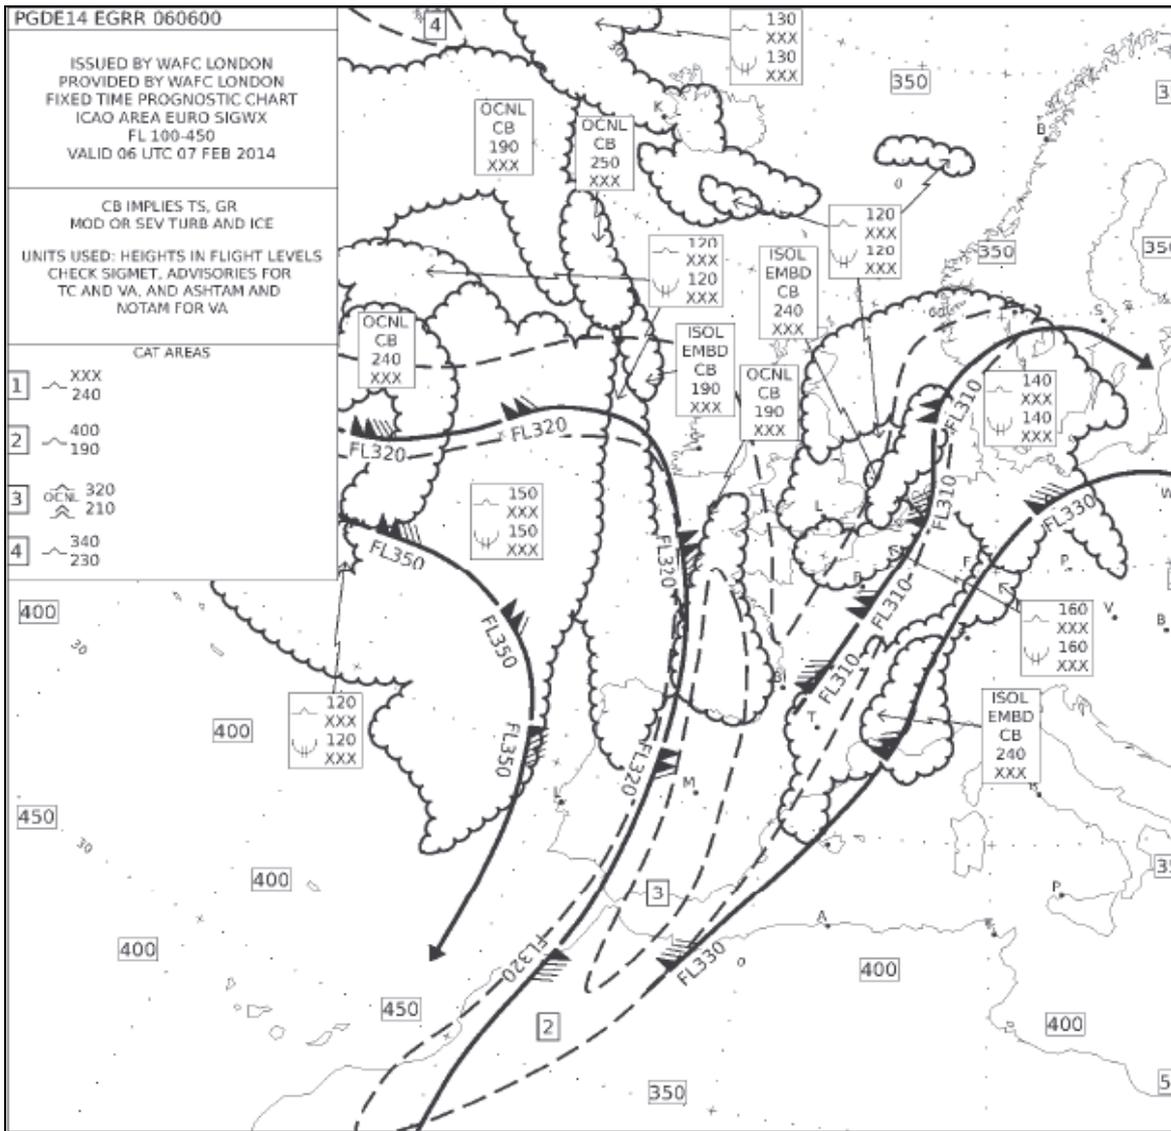
Figure 2

The *Fixed Time Prognostic Chart(s) ICAO Area EURO SIGWX* [Significant Weather] *FL100 to FL 450*, issued at 0600 hrs and 1200 hrs on 6 February 2014 and valid, respectively, at 0600 hrs and 1200 hrs on 7 February 2014, were available to the flight crew (see Figures 2 and 3). The charts present a confusing picture but showed the proximity of the two jetstreams. The area over the Isle of Man was not shown as a likely CAT area. However, it should be noted that these charts are produced 24 hours prior to their period of validity.

Significant weather chart valid 0600 hrs UTC 7 February 2014

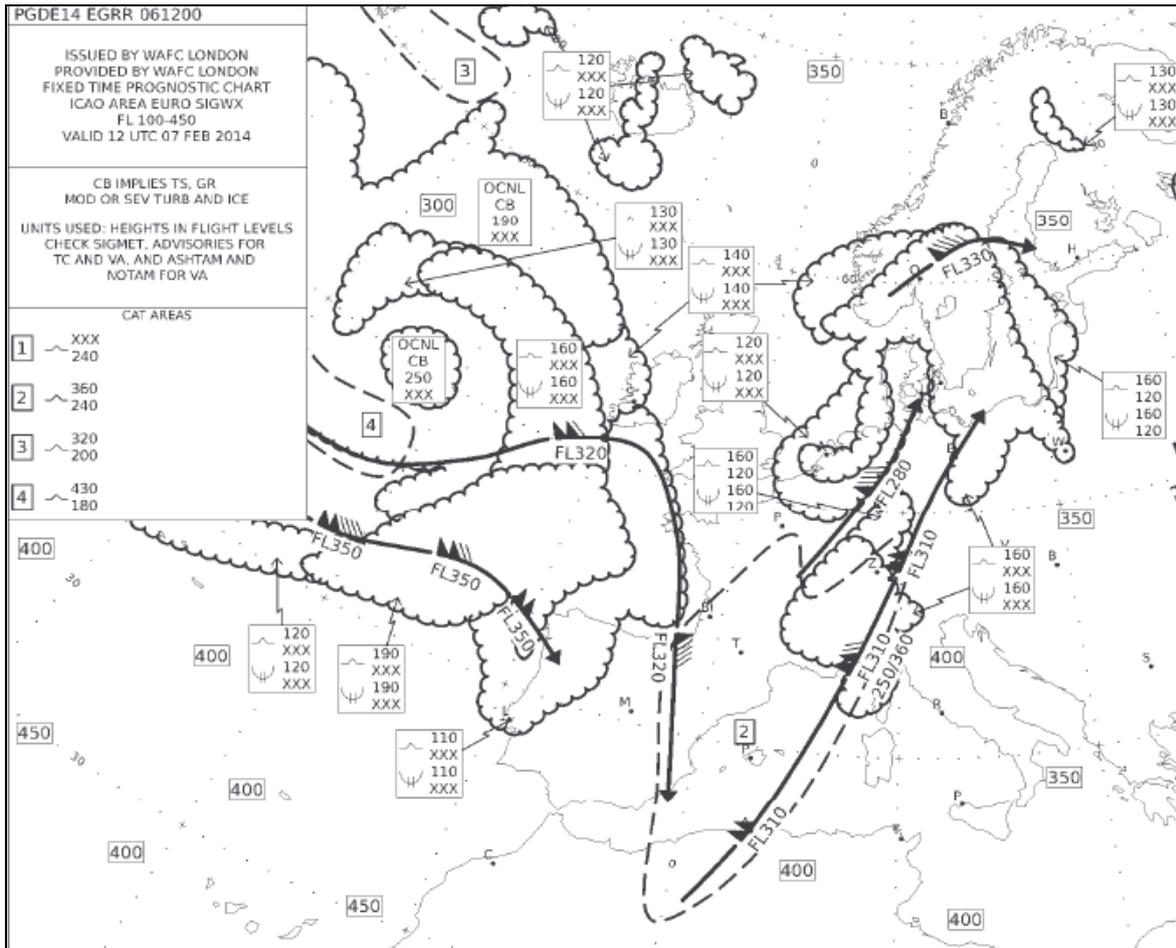
Figure 3

Significant weather chart valid 1200 hrs UTC 7 February 2014

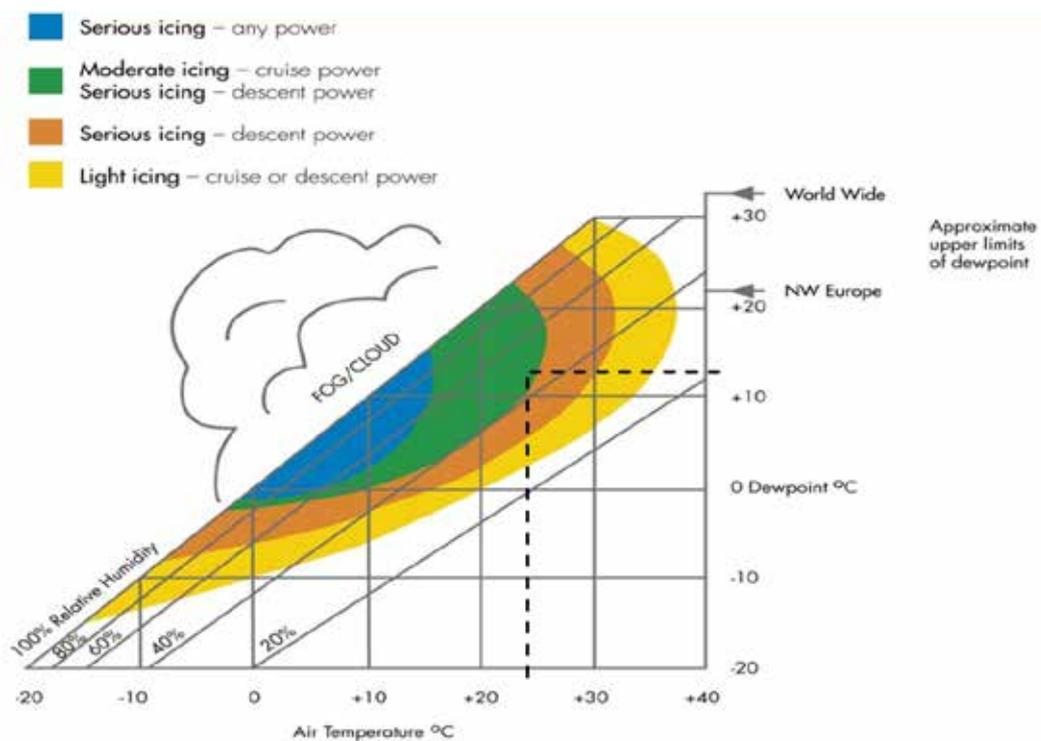
The pilot reported that the temperature and dew point were 24°C and 12°C and that 'FREDA' checks had been carried out frequently, during which the carburettor heat was applied by the passenger, who was also a qualified pilot, for 15 to 20 seconds. It is therefore unclear whether carburettor icing was the cause of the engine power loss.

CAA Safety Sense Leaflet 14 provides advice on carburettor icing and at the temperature and dew points reported at the time of the accident there would have been a moderate risk of icing during the cruise. Figure 1 shows the CAA Carburettor icing chart. The CAA advise that carburettor heat should be applied for at least 15 seconds in order to prevent and clear any carburettor icing.

Figure 1
CAA Carburettor icing chart
