# ***AAIB Bulletin***

***6/2014***

<b>Aircraft Type and Registration:</b>	Piper PA-28-140 Cherokee, G-ATRR	
<b>No &amp; Type of Engines:</b>	1 Lycoming O-320-E3D piston engine	
<b>Year of Manufacture:</b>	1966 (Serial no: 28-21892)	
<b>Date &amp; Time (UTC):</b>	19 May 2013 at 1018 hrs	
<b>Location:</b>	Caernarfon Airport, Gwynedd	
<b>Type of Flight:</b>	Private	
<b>Persons on Board:</b>	Crew - 1	Passengers - 2
<b>Injuries:</b>	Crew - 1 (Serious)	Passengers - 1 (Fatal) 1 (Serious)
<b>Nature of Damage:</b>	Aircraft destroyed	
<b>Commander's Licence:</b>	Private Pilot's Licence	
<b>Commander's Age:</b>	61 years	
<b>Commander's Flying Experience:</b>	90 hours (of which 72 were on type) Last 90 days - 9 hours Last 28 days - 2 hours	
<b>Information Source:</b>	AAIB Field Investigation

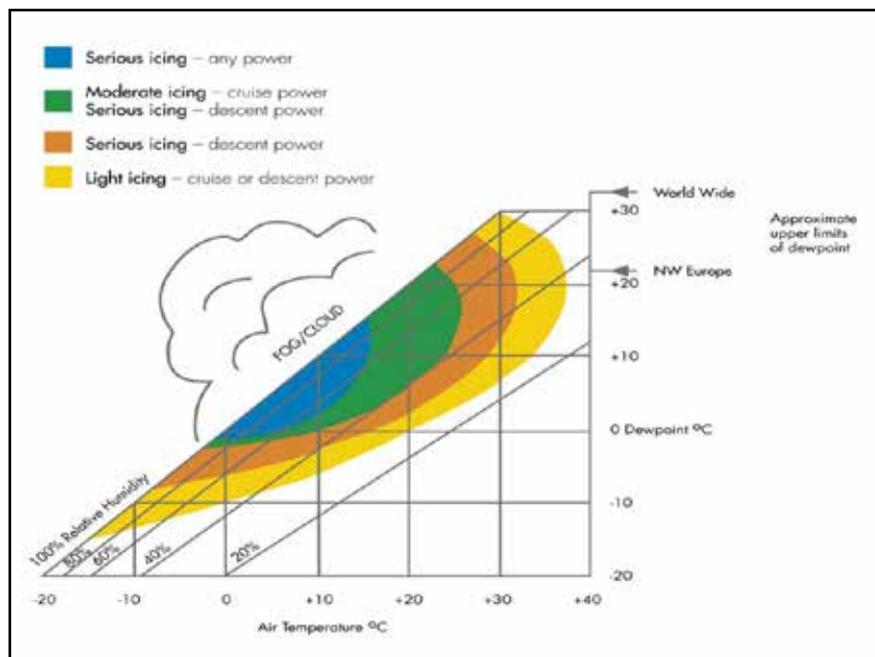
**Figure 2**

Carburettor icing probability chart

Figure 2 illustrates the probability of carburettor icing for values of air temperature and dewpoint. Assuming a reducing temperature and similar dewpoint above the surface, this would indicate that the latter part of the flight was operating in the blue sector: 'serious icing at any power'.

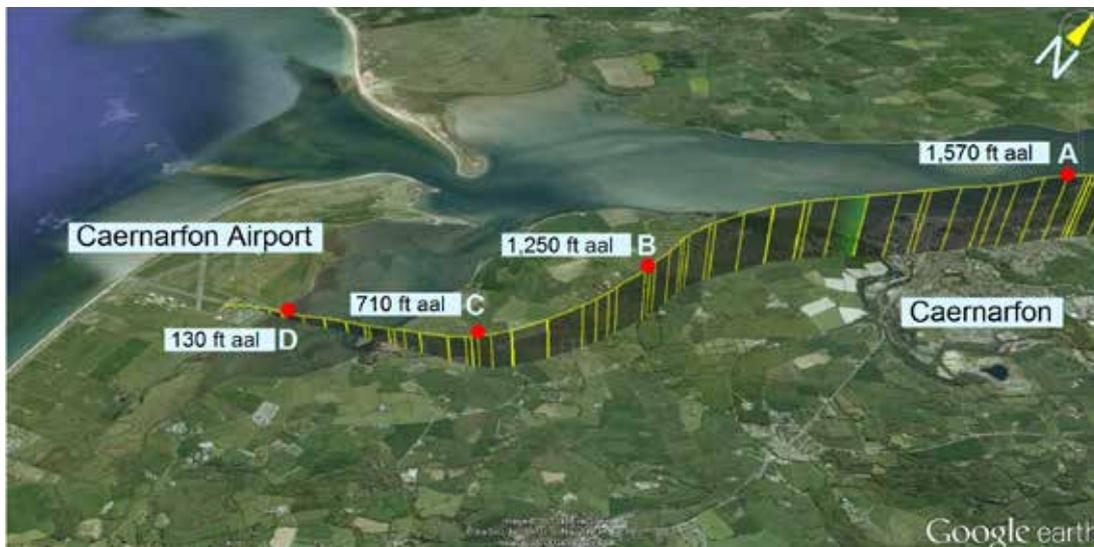
**Figure 3**

towards the final approach track for Runway 26, initially at about 300 ft/min, then at about 960 ft/min (Point B, groundspeed 103 kt, 2.2 nm from the runway threshold).

GPS track of approach to Caernarfon

There were a number of witnesses, both aural and visual, to the later stages of the approach of the aircraft. They all reported that the aircraft was lower than usual, some noted that the nose attitude was high and several commented that the flight path appeared flat and the aircraft very slow.

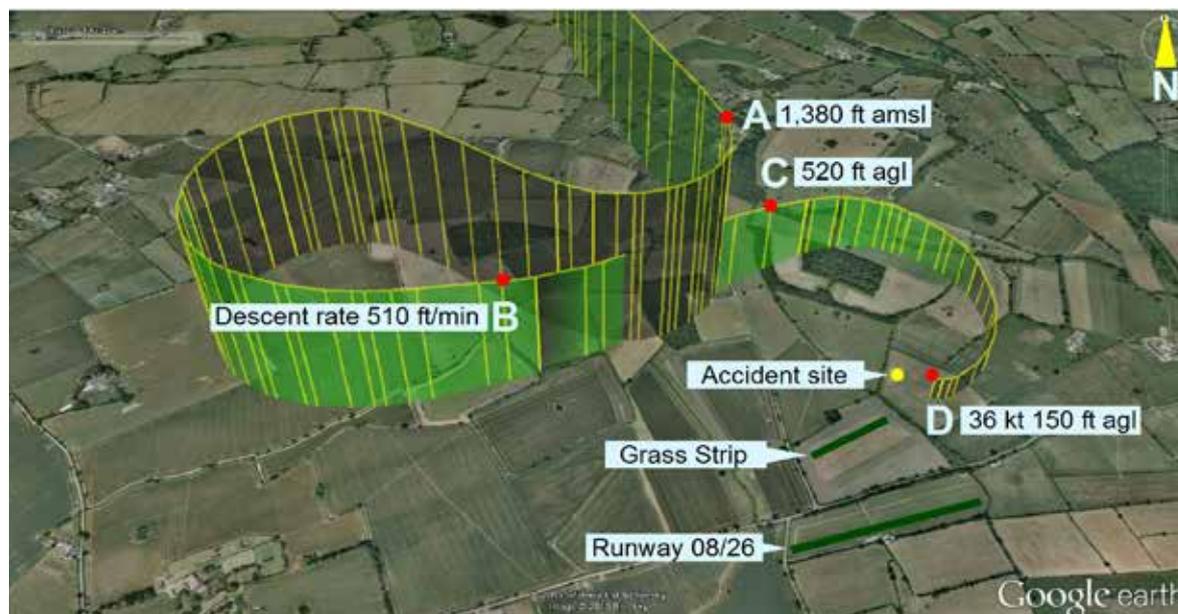
**Figure 2**

GPS track of approach to Stoke Golding Airfield<sup>2</sup>

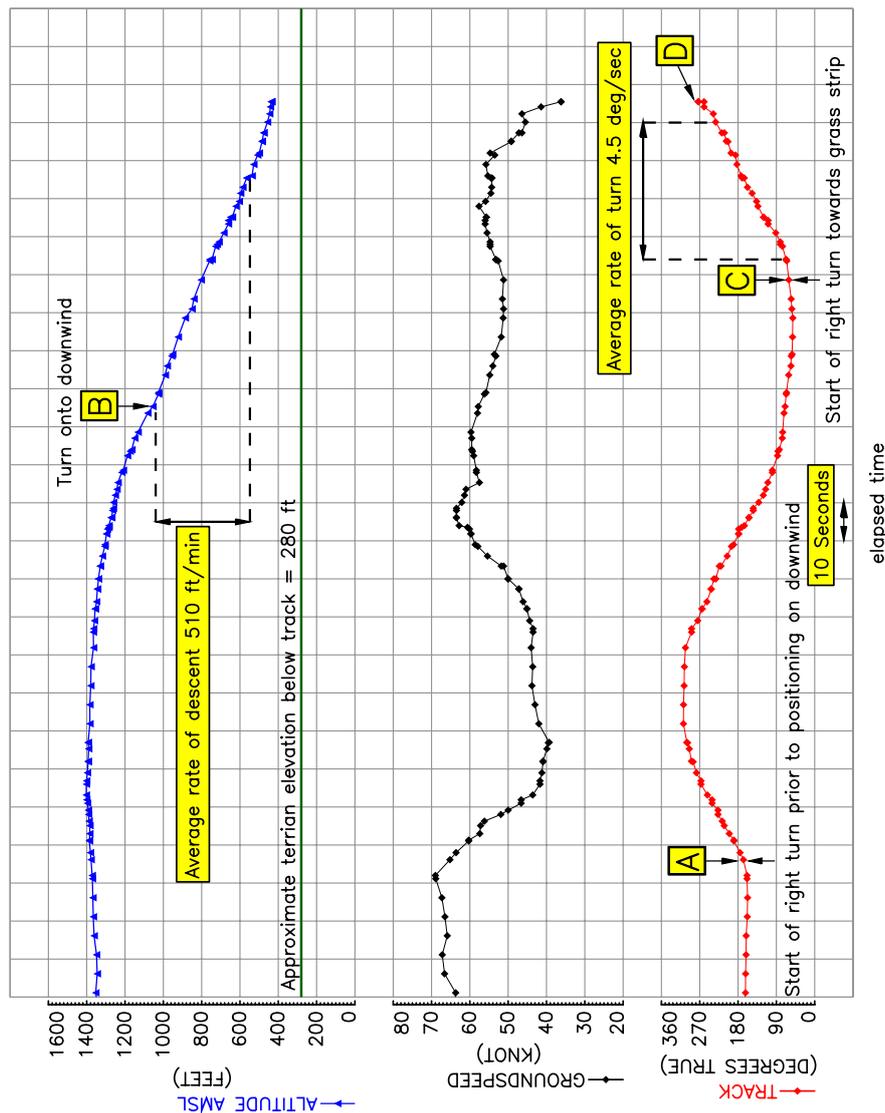
**Figure 3**

Time history plot of approach
