AAIB Bulletin

4/2014

Published 10 April 2014

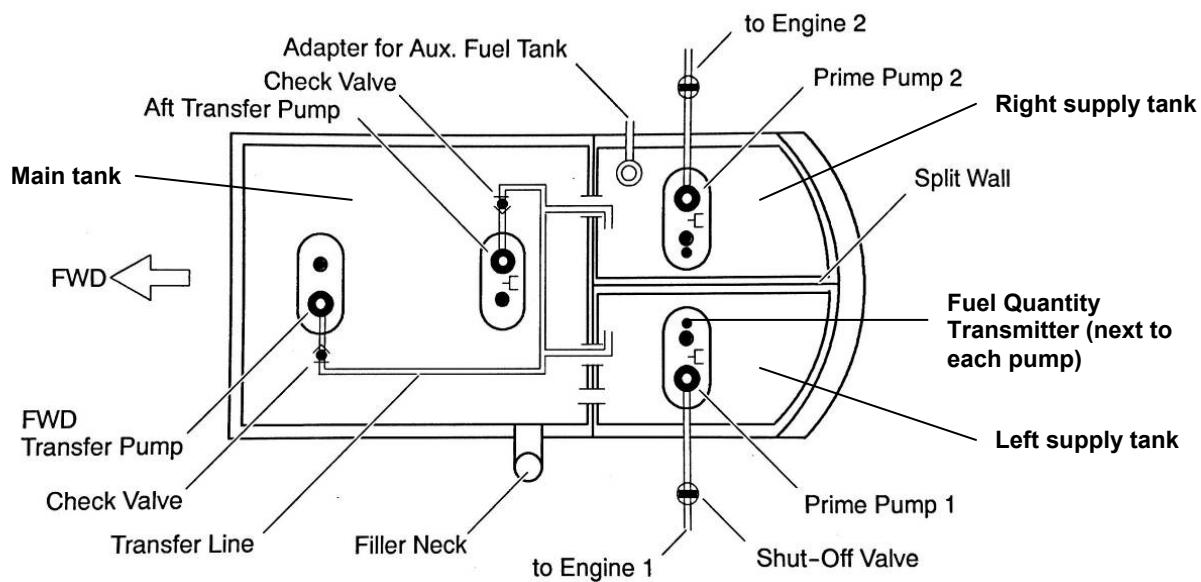
Figure 2
Fuel Tank Group Schematic

Since the helicopter's recovery to the AAIB facility, a very close examination of the fuel system has continued. It has been determined that the fuel tank group suffered sudden elastic compression during the impact, whilst retaining its basic shape. The compression was sufficiently severe to collapse all four internal fuel quantity transmitters, as they are designed to do, and the tank group bladders remained fuel-tight. Examination of all internal pipe work and transfer passages has not revealed any pre- or post-impact failure and all paths still permit uninterrupted fuel flow. It has been established that unrestricted flow was also available from each supply tank to the corresponding engine fuel control unit, through the relevant fuel shut-off valves which were found set to the OPEN position.

The forward and aft transfer pumps, situated in the main fuel tank, and the prime pumps in the No 1 and No 2 supply tanks were tested and found to operate correctly in accordance with their factory specification. The pump inlets and outlets were free from blockage or contamination. The No 2 prime pump and aft transfer pump housings had suffered minor damage, attributable to the tank compression during impact, but this had no effect on their operation under test.

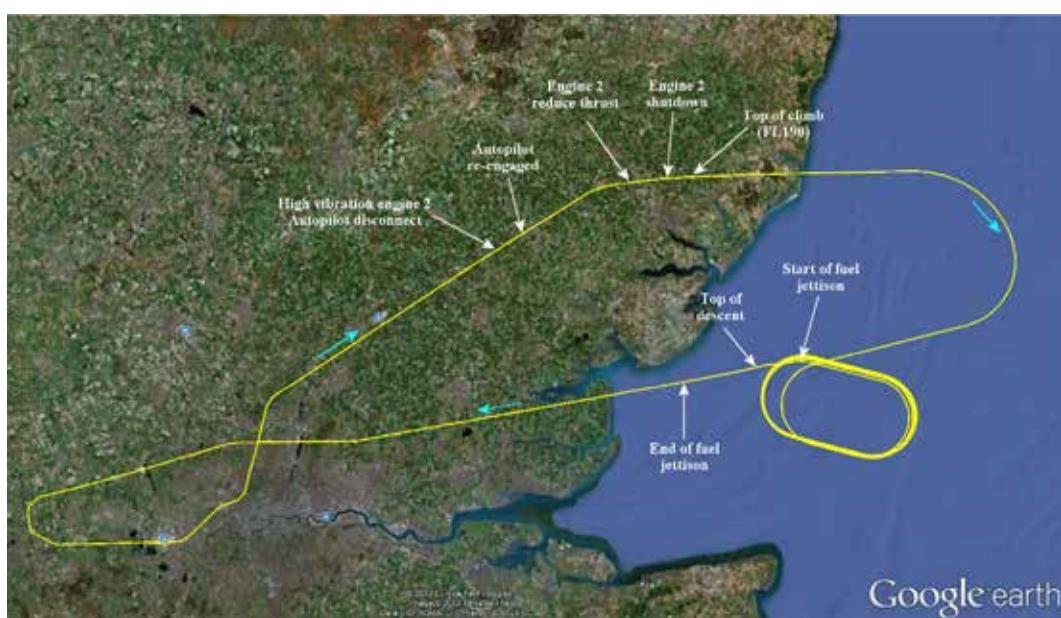
Figure 1
9M-MPL Ground radar track

At 2140 hrs, as the aircraft was climbing through FL130, the No 2 engine oil temperature started to increase markedly. At the same time there was a step increase recorded in the level of broadband vibration and the vibration levels associated with the N₂ stage of the same engine; no change in engine thrust was evident with all engines indicating an engine pressure ratio (EPR) of about 1.4. The status of the left autopilot, which had been the only one engaged, changed to disengaged but was re-engaged 26 seconds later.

As the aircraft levelled at FL190, the pilots reduced thrust on engine No 2, initially to an EPR of 1.17 and then to idle before shutting it down. The DFDR recorded engine No 2 peak values of 159.5°C for oil temperature, 4.06 units for broadband vibration and 2.14 units for the vibration associated with N₂.

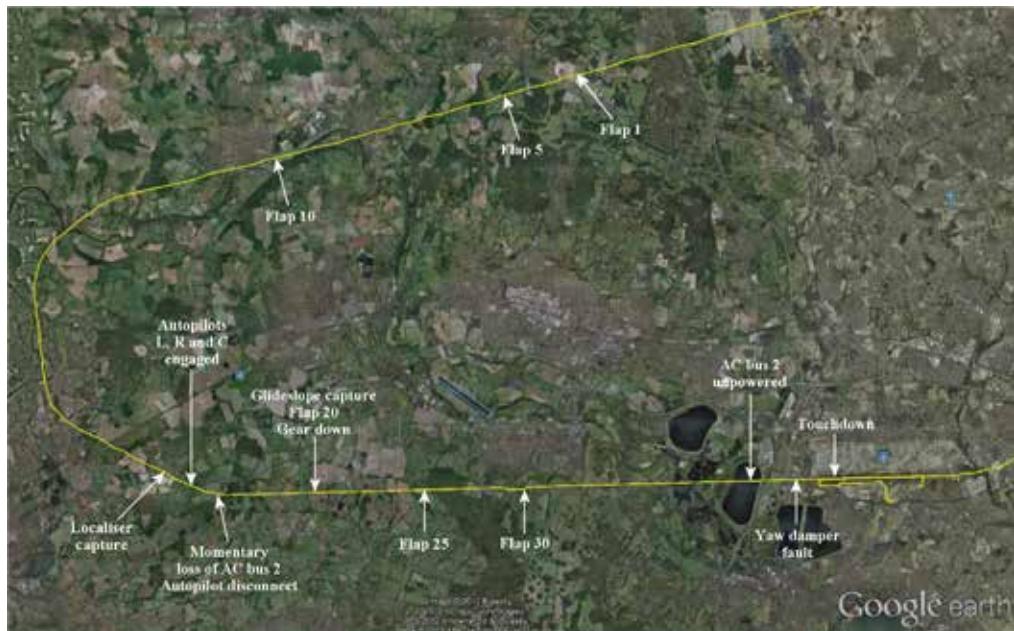
Figure 2
9M-MPL Ground radar track

At 426 ft agl, 35 seconds before touchdown, AC Bus 2 lost power and remained in that state until after the landing. Following the loss of AC Bus 2, some other parameters showed anomalies: hydraulic system 2 indicated low pressure and the recorded positions of the left inner and left outer trailing edge flaps changed instantaneously to zero. Seventeen seconds later the lower yaw damper also reported a fault. The approach ground track is shown in Figure 2.

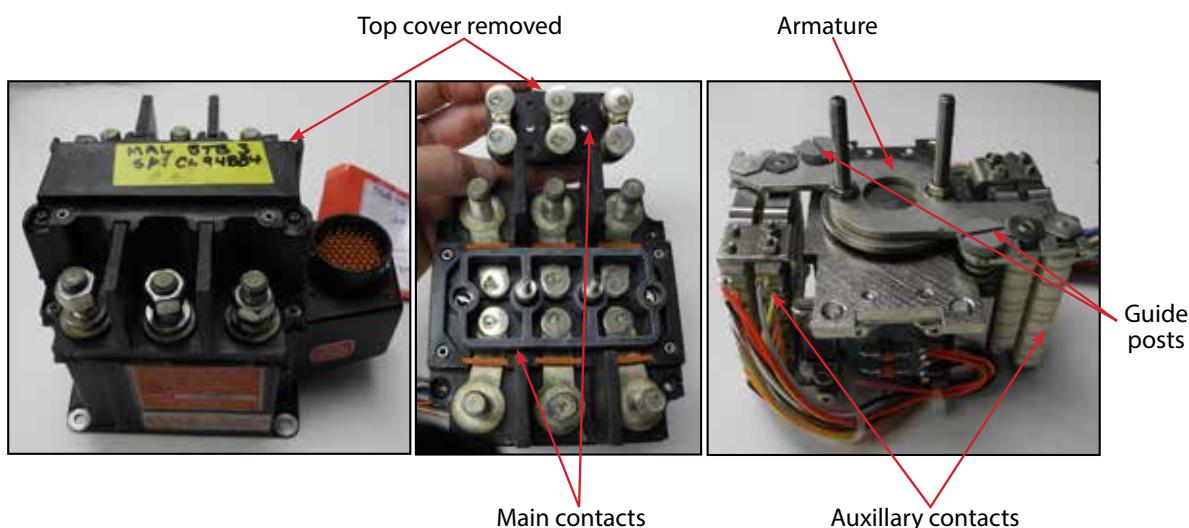
Figure 6
B430Z Contactor

Circuit breakers, or contactors, are used extensively throughout the B747-400 electrical system and include the BTBs, GCBs and SSB. These identical components, Part Number B-430Z, are also used on the B747-8 aircraft. The contactors have three main contacts: T1 L1 for Phase A current; T2/L2 for Phase B; and T3/L3 for Phase C. There are also 26 pairs of auxiliary contacts (1/2, 3/451/52) which fulfil a variety of functions within the electrical system (Figure 6).

The contactor can be in one of two states, ‘closed’ or ‘tripped’ (open). In normal parallel operation of the electrical system, the main contacts of the BTBs, GCBs and SSB are closed. They are said to be ‘normally closed’. When the main contacts are closed, half of the auxiliary contacts are ‘normally open’ and the other half are ‘normally closed’, depending on their specific function within the electrical system. All of the main and auxiliary contacts are mechanically attached to a single armature, which moves in response to the magnetic field created by energising an electrical coil within the contactor. When the contactor is energised the armature moves and magnetic forces hold it in the closed position. When the contactor is de-energised, the armature returns to the tripped position and is held in position by spring force.

Auxiliary contacts 51/52 on the BTBs, GCBs and SSB are used for the Difference Current Protection circuit. They are ‘normally open’; that is, when the main contacts are closed, this set of auxiliary contacts will be open, and vice versa. BTB auxiliary contacts 15 /16 provide status information to BCU 1 and auxiliary contacts 31/32 provide status to BCU 2.

After tightening the loose nut and replacing the washers, the contactor operated correctly.

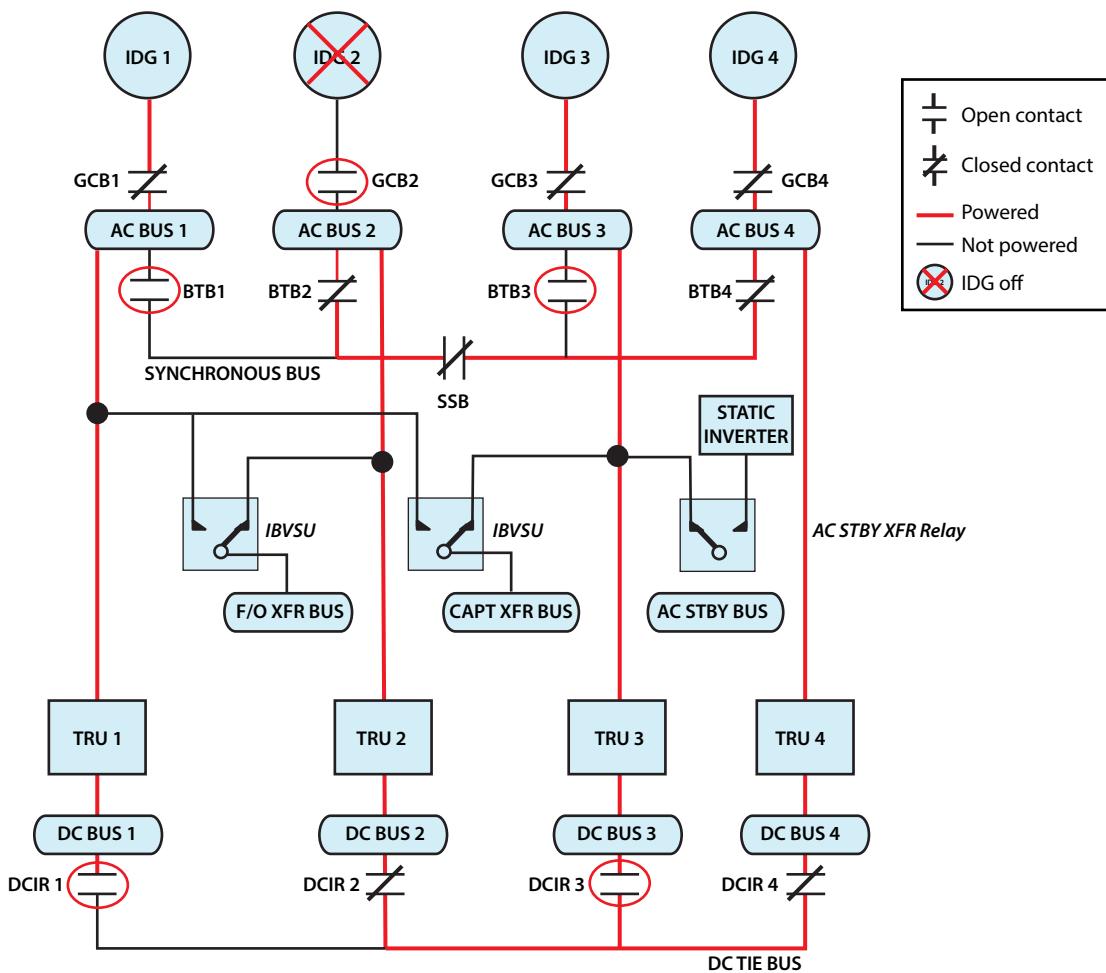
As IDG 2 was offline during the approach on the incident flight, in order to achieve three separate power sources BCU 1 would have commanded BTBs 1 and 3 to trip to isolate their respective channels. BTB 4 and BTB 2 would have remained closed so that IDG 4 supplied power to AC Bus 2 via the sync bus. Figure 7 shows the configuration of 9M-MPL’s electrical system at the commencement of the autoland.

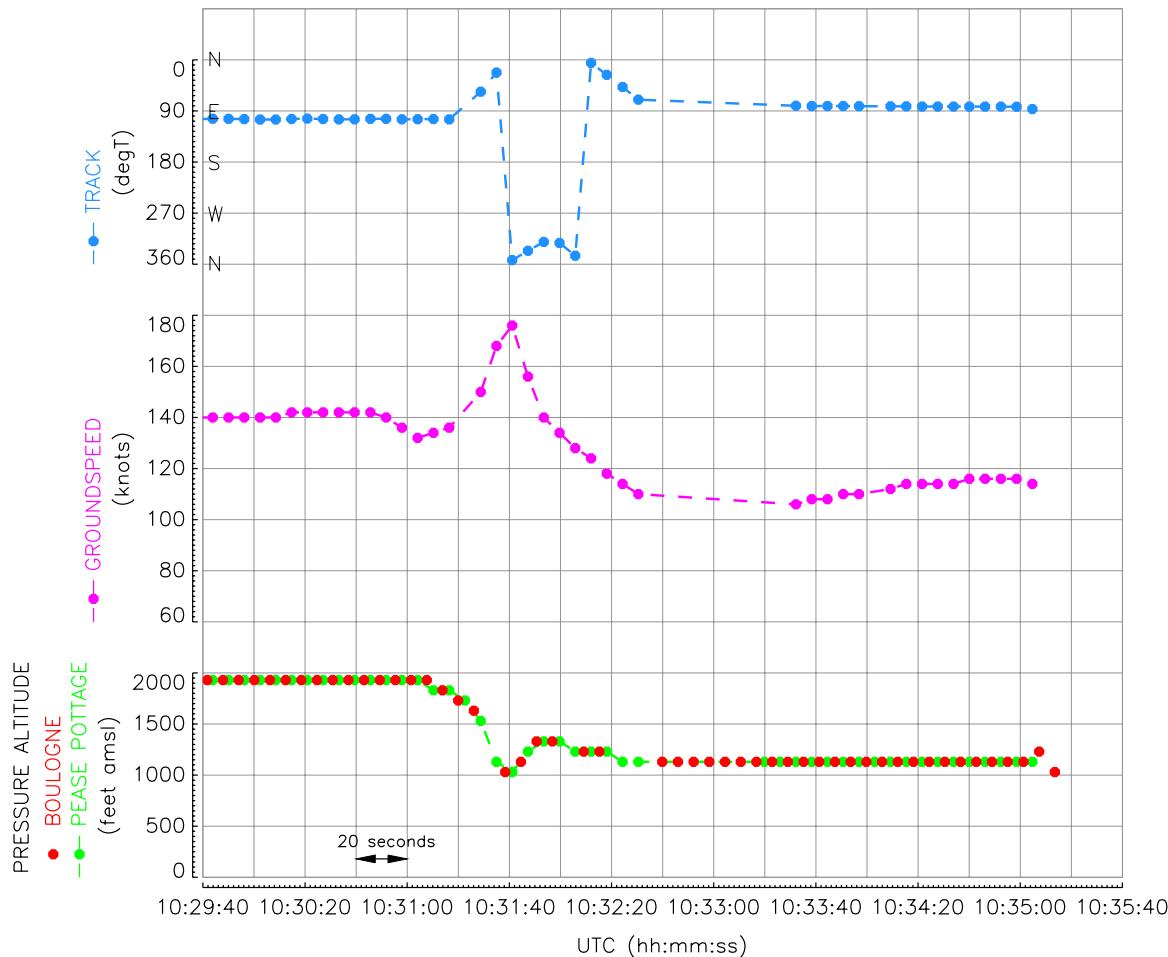
**Figure 4**

At 1030:45 hrs, about 25 nm from Beachy Head, the groundspeed began to reduce from a nominal 140 kt. Shortly afterwards the aircraft began to descend and, at 1031:16 hrs, turned left from a track of 105°T. The minimum altitude recorded in the turn was 1,030 ft amsl on a track of 22°T. The aircraft continued the turn to about 320°T before turning back to the right onto a track of 81°T towards Boulogne-sur-Mer. The descending turn is illustrated in Figure 4.

Recorded data showing the track, groundspeed and altitude of the aircraft during the descending turn through to the last contact.

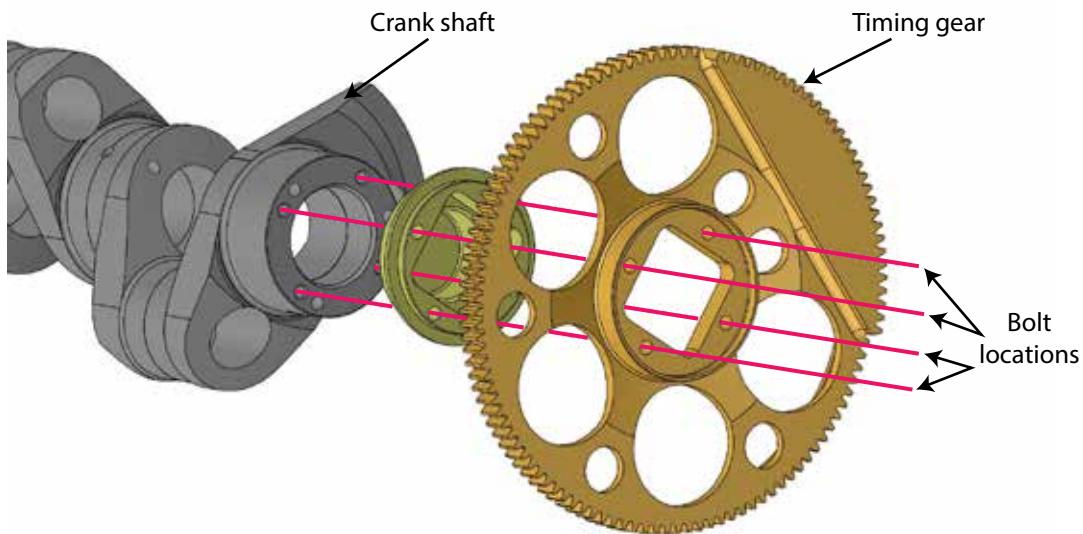
Figure 1

The engine was removed and returned to its manufacturer for examination. It is an indirect-injection two-stroke diesel engine with three inverted cylinders and is designed to run on AVTUR fuel. It does not require electrical power to continue running after starting, and the fuel injection system is entirely hydro-mechanical. The exhaust valves are the only conventional valves and these are opened and closed by a camshaft which is driven from a timing gear bolted to the end of the crankshaft (Figure 1). If the timing is lost, the valves will invariably make contact with the pistons.
