# Rail Accident Report

**Derailment of a freight train at Barrow upon Soar,  
Leicestershire  
27 December 2012**

Report 22/2013  
December 2013

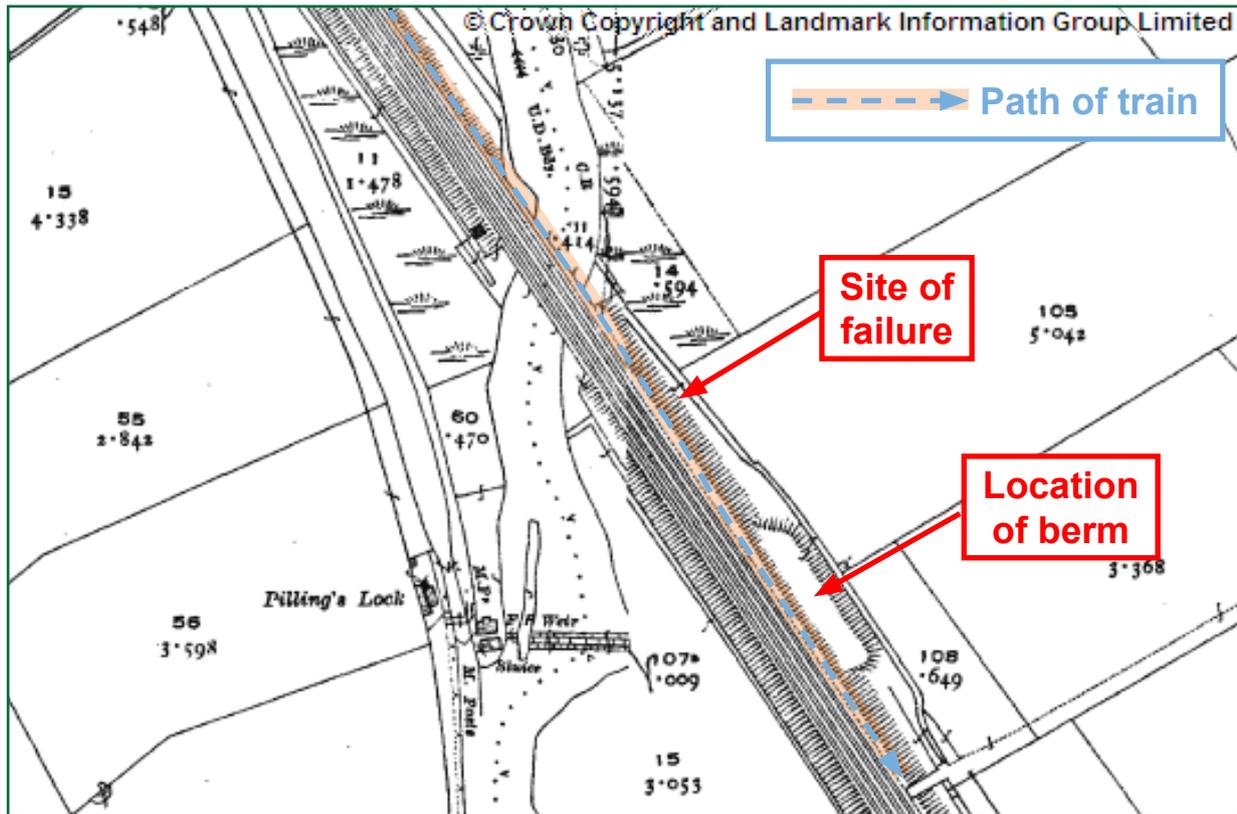
Figure 17: Map from 1921

- 96 The earthwork that failed near Barrow upon Soar had no history of scour and no signs of scour were reported during previous examinations. Network Rail had no record of it ever failing and being repaired, although there is a *berm* from a previous embankment repair located about 120 metres south of the failure. Trees growing out of this berm indicated it had been there for a long time and this was confirmed by a map dating back to 1921 (figure 17). Based on its knowledge of the earthwork, the Route geotechnical team had no concerns about it failing from the effects of water.

- 98 In the two months before the earthwork failed, the River Soar was flooded on several occasions, during periods of persistent wet weather (paragraphs 48 to 50). The persistent rainfall onto the top of the earthwork, and the way its construction allowed rainwater to flow through it, increased the probability that the earthwork would fail (paragraphs 42 to 46).
