Rail Accident Investigation Branch

Rail Accident Report

Freight train derailment near Gloucester 15 October 2013

Report 20/2014
October 2014

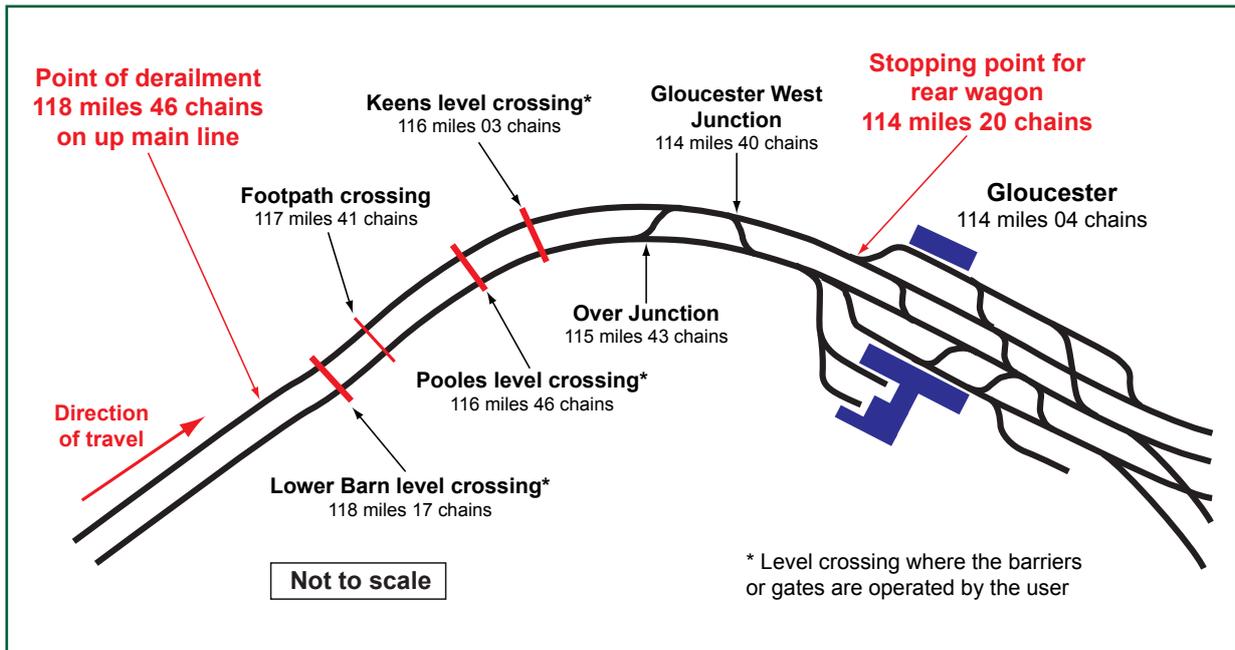
Figure 2: Track layout from the point of derailment through to the train's stopping point

- 7 The train driver was unaware of the derailment and the train continued with one wheelset derailed for a distance of around 3.8 miles (6.1 km) until, at Gloucester West Junction (figure 2), the derailed wagon collided with a set of *facing points* while travelling at 22 mph (35 km/h). Here both wheelsets were torn from the rear *bogie* and the empty container on the rear of this wagon was thrown off into the *cess* (figure 3).

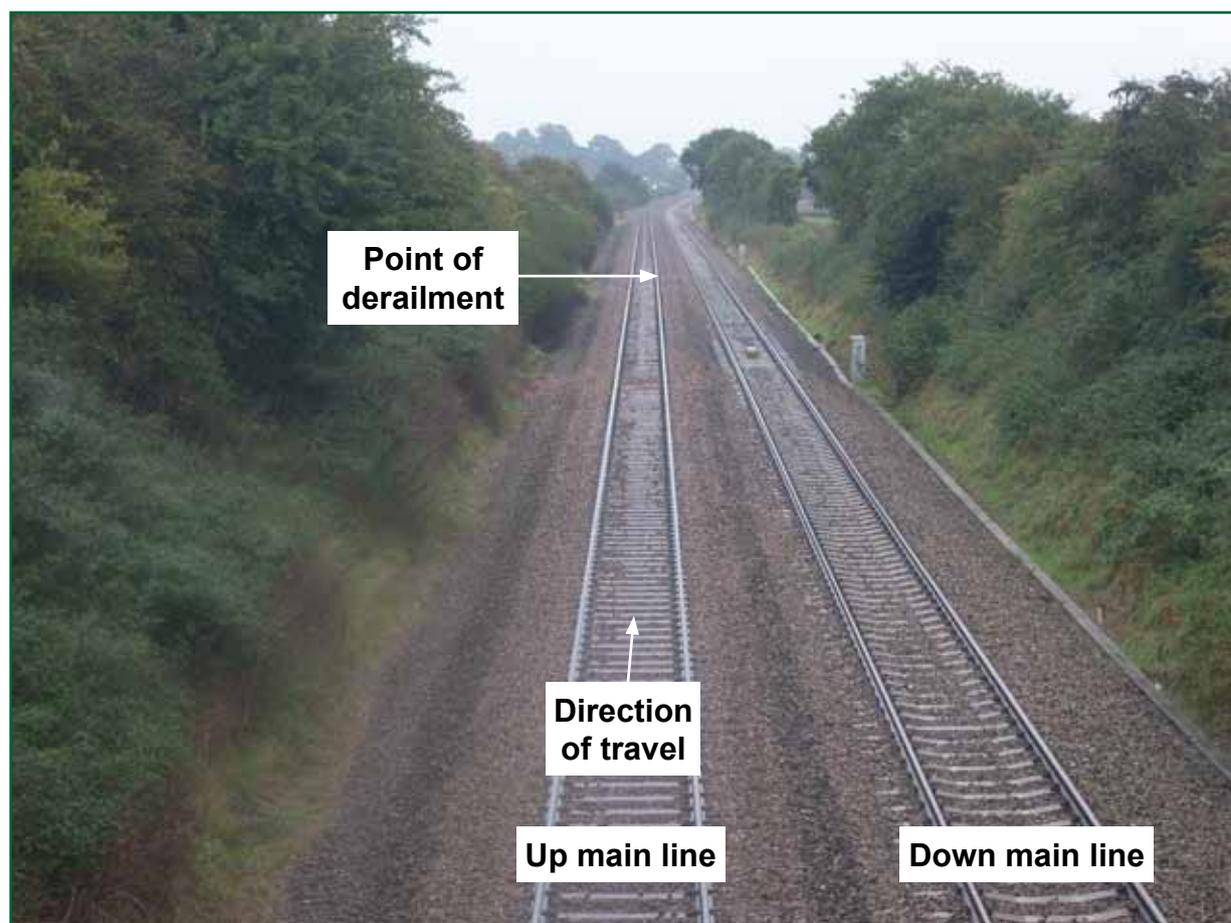
Figure 4: Location of the derailment

- 10 The derailment occurred on the *up main* line between Lydney and Gloucester, at 118 miles and 46.64 *chains* (from a zero reference at London Paddington station), which is part of Network Rail's *Western Route*.
- 11 At this location, the two track railway comprises the *up main* and *down main* lines (figure 4). The permitted speed for trains on both lines is 90 mph (145 km/h), although the maximum speed for the train that derailed was 75 mph (121 km/h). The derailment happened in a cutting, where the track is straight and on a gradient of about 1 in 370 (0.27%), rising in the train's direction of travel.

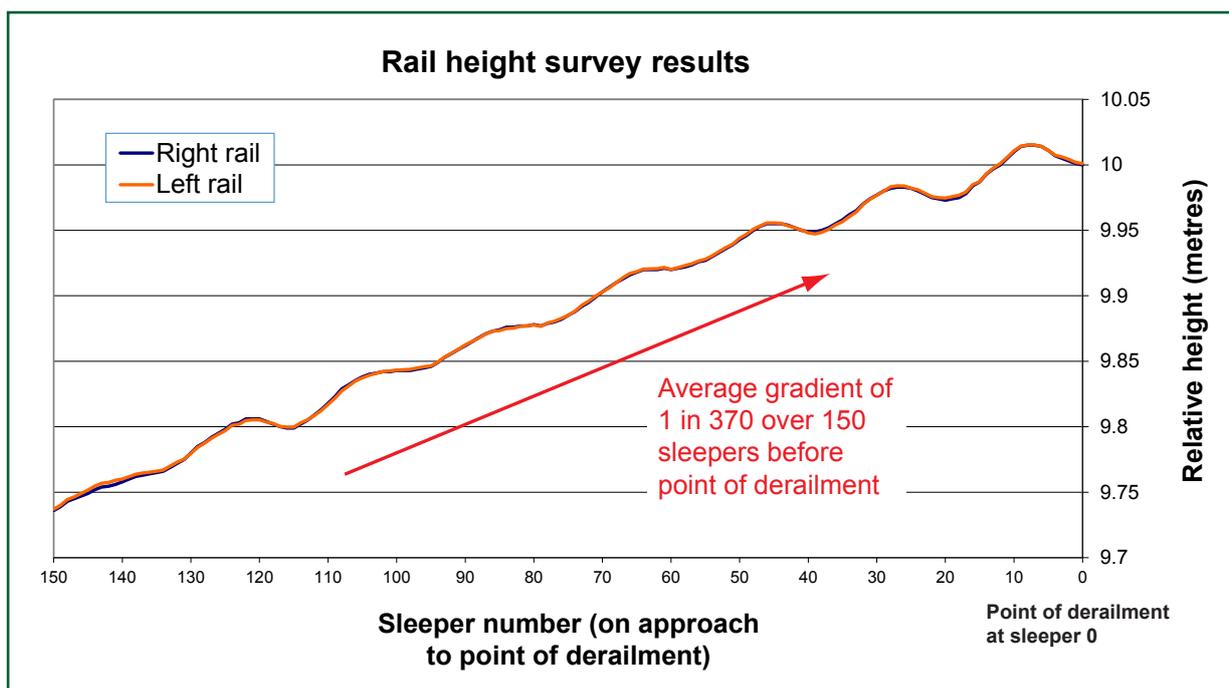
Figure 10: Graph showing the changes in vertical height of the rails

- 59 The point of derailment was located on the up main line. A visual examination and survey of the track at this location identified regularly spaced variations in the vertical height of both rails, consistent with cyclic top (figures 9 and 10). Analysis of the survey data found the cyclic top fell into the track defect category requiring immediate action according to NR/L2/TRK/001/mod11 (table 1).

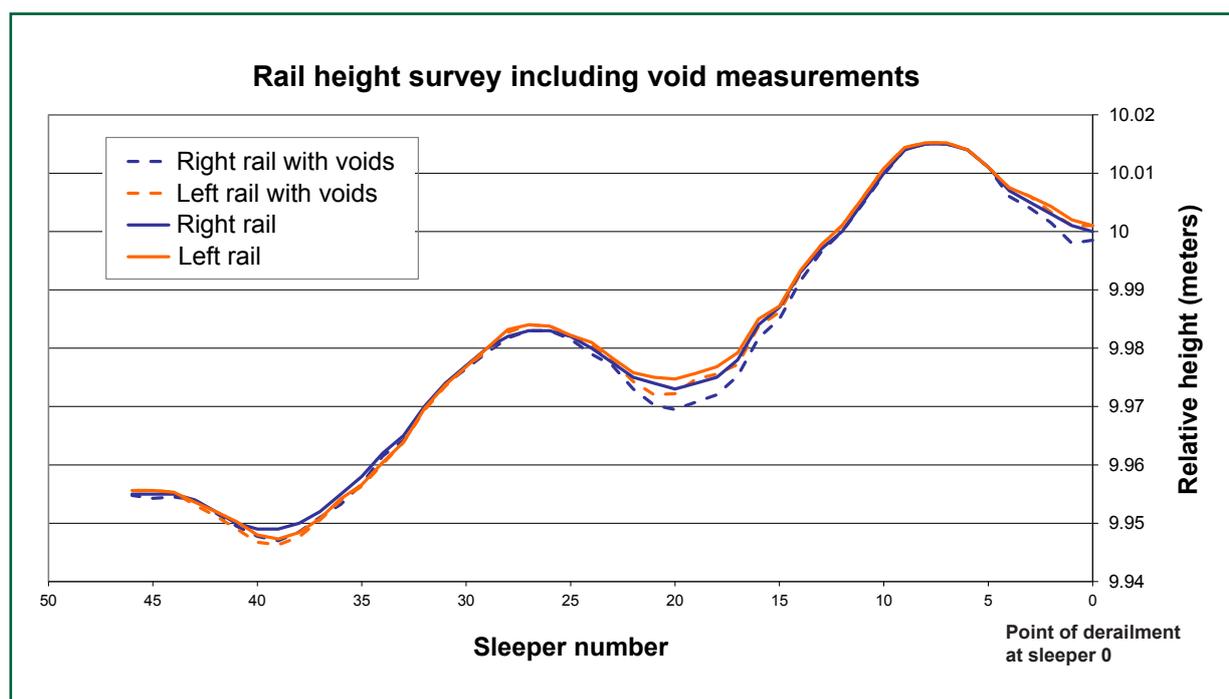
Figure 12: Graph showing the changes in vertical height of the rails with the void measurements included

- 64 Regularly spaced dips in the height of both rails, at a wavelength of about 13 metres, could be seen by eye on the approach to the point of derailment. In addition to the track geometry survey (paragraph 61), the RAIB also surveyed the height of the rails over 150 sleepers before the point of derailment (figure 10) to measure the size of these regular dips. Voiding under the sleepers was measured over 46 sleepers before the point of derailment to obtain data to understand the effect of the weight of a passing train. The highest void measurements coincided with locations of dips, whereas no voiding was found elsewhere (figure 12), indicating that the dips were bigger when the track was loaded by a passing train.

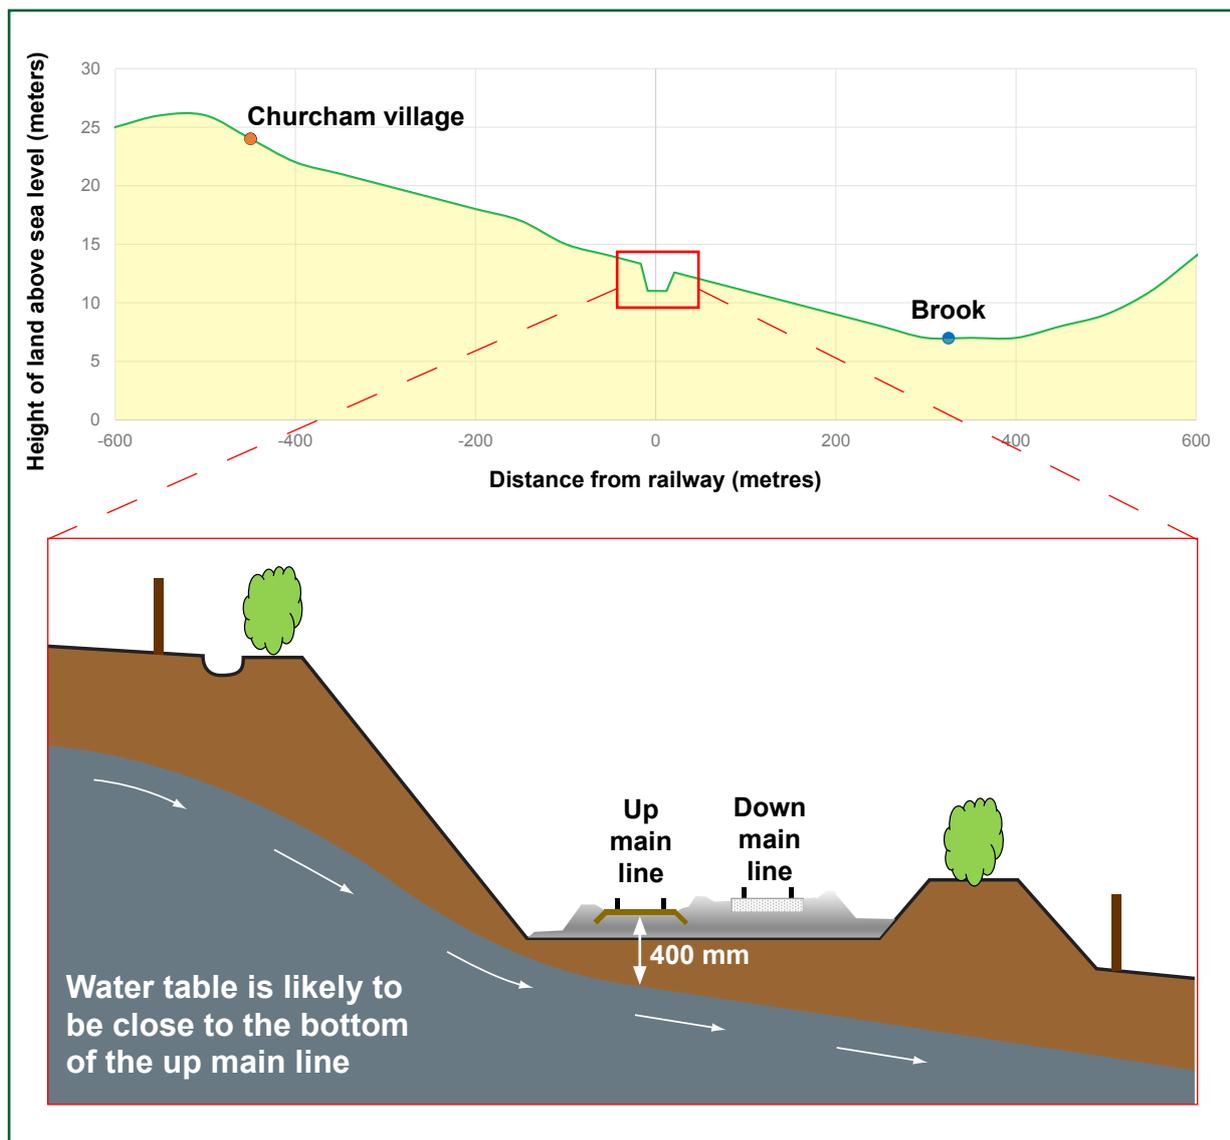
Figure 13: Profile of the land perpendicular to the railway and side view of the cutting

- 68 **The cyclic top track defects had formed as a result of water flowing in the formation under the track.**
- 69 The track where the cyclic top track defect was found was in a cutting (figure 4). Water was draining into the adjacent land, flowing under the cutting and beneath the track (figure 13). There was no track drainage installed along the cess to intercept the water flowing under the cutting before it reached the up main line.

- 71 The profile of the land perpendicular to the railway line on which the train derailed is shown in figure 13. This shows the height of the land falls steadily over a distance of about 800 metres, from 26 metres above sea level near to Churcham village, to 7 metres above sea level, where a brook flows from east to west before reaching the River Severn. The railway is located about 500 metres from the high point, about 13 metres above sea level. When the railway was built, it was cut through the side of this slope, with the deepest point cut into the slope coincident with the bottom of the cutting slope on the up main line. It is likely that following periods of heavy rainfall, water permeated into the ground above the railway and flowed downhill through the ground towards the brook, causing the local water table to rise. This meant the raised water table was close to the bottom of the track bed on the up main line as shown in figure 13.

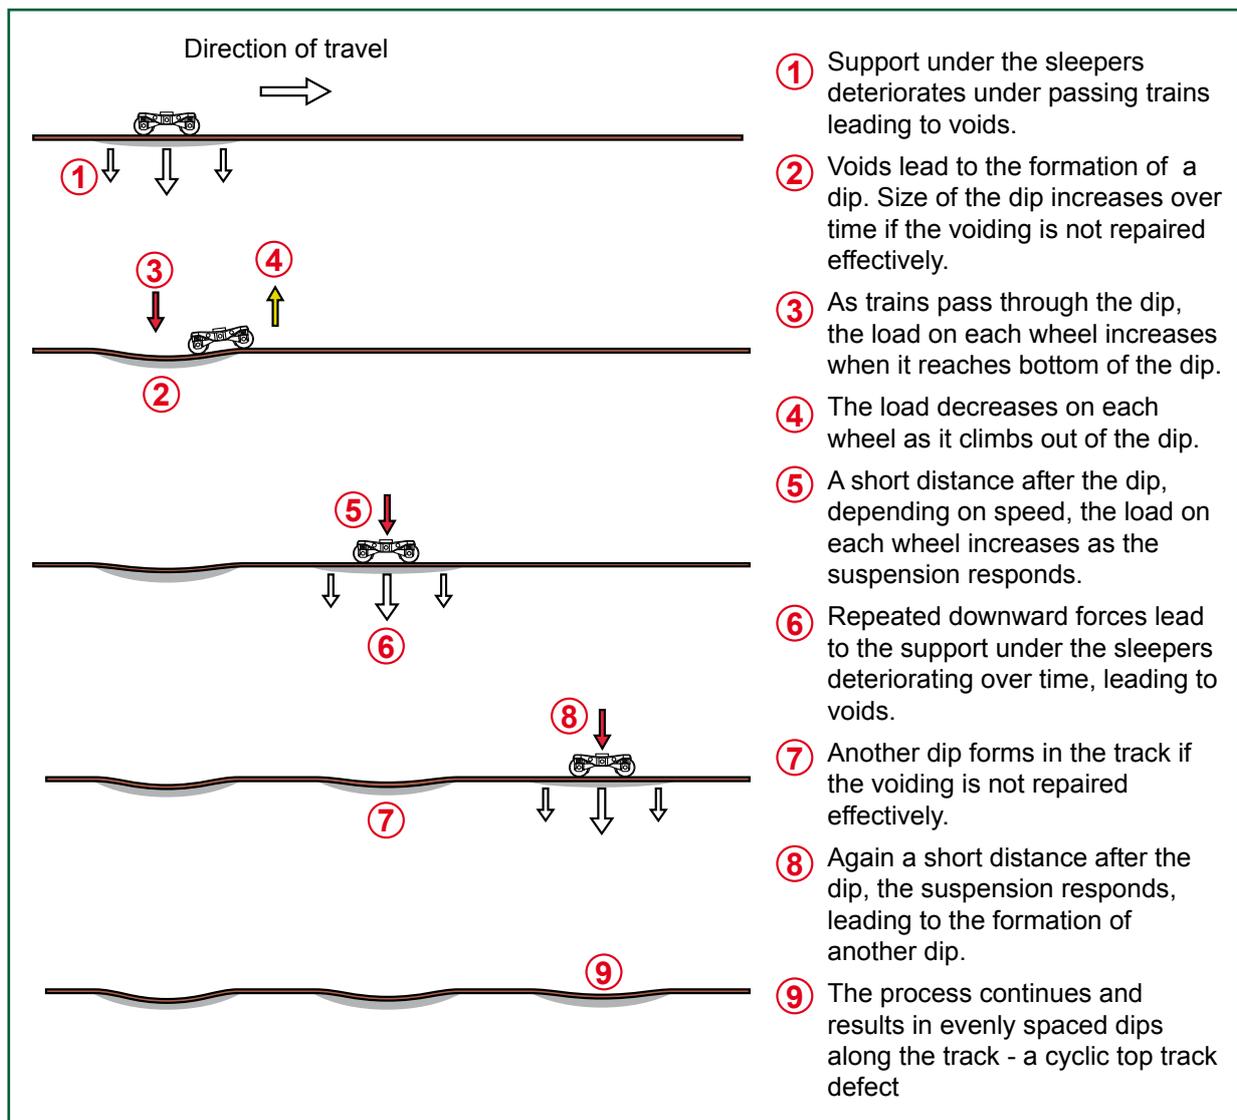
Figure 17: Formation of a cyclic top track defect

76 Over time, water flowing under track had softened the soil in the formation. The softened soil then mixed with water to create mud. The weight of passing trains had caused this mud to seep up through the ballast, forming a feature commonly known as a 'wet spot'. The wet spot coincided with a loss of support under the sleepers due to the softened formation, resulting in a dip in the track. One dip can then be the trigger for the formation of a cyclic top track defect. Figure 17 shows that when a wheelset passes through the dip, its suspension responds to the change in rail height, so after the wheelset exits the dip the load on its wheels is decreased. Further along the track the suspension will respond again and the load on the wheels will increase, exerting a downward force on the track. If the speed of each passing train is similar, these repeated downward forces will be in the same place and will eventually cause the support under the sleepers in that location to deteriorate. This deterioration leads to voiding and the formation of a new dip. Trains passing over this new dip cause another dip to form and so on. Therefore as trains continued to pass over the up main line, more and more dips had formed at regular intervals, resulting in a cyclic top track defect. Data from Network Rail's track geometry recording train shows that the cyclic top grew in size from 2010 onwards (paragraph 82).

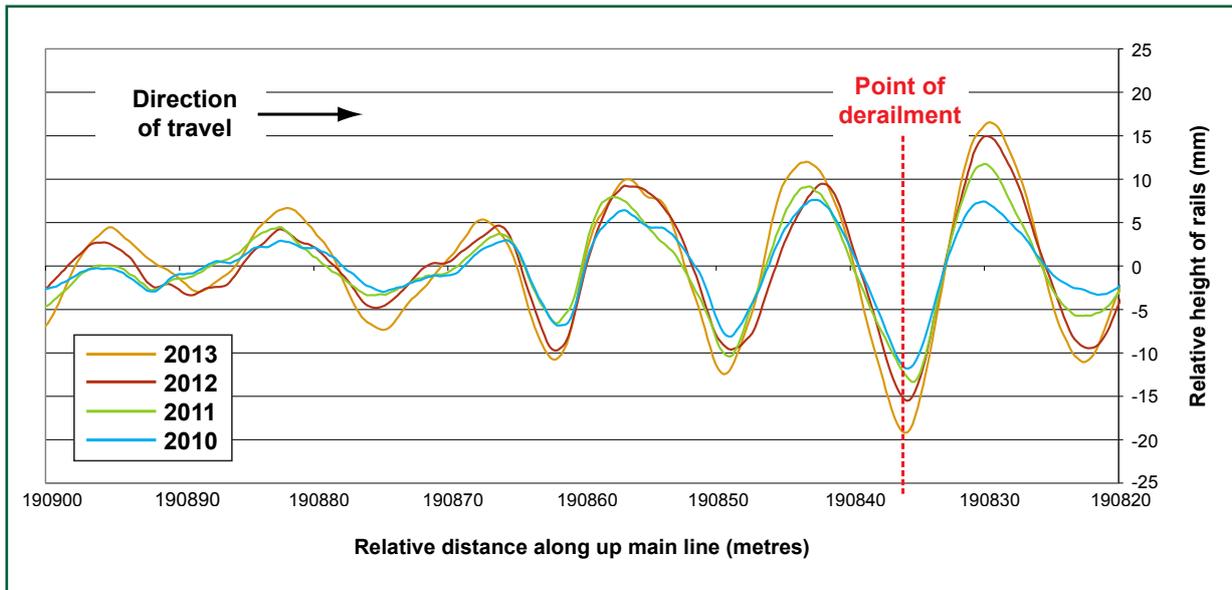
Figure 18: Track geometry recording data from 2010 to 2013

82 Following each inspection, work orders were raised for the defects that were found and each work order was given a time within which the work was required to take place. Records show that the local Network Rail maintenance team were responding to these faults by carrying out short term repairs. However, none of this work was effective or long lasting as the cyclic top, and therefore track quality too, continued to worsen. This can be seen from the data recorded by track geometry recording trains since September 2010 (figure 18). At the same time, medium term work to repair these defects was planned and carried out in October 2013 and a longer term solution was planned from August 2013. The short, medium and long term activities are now considered in turn.

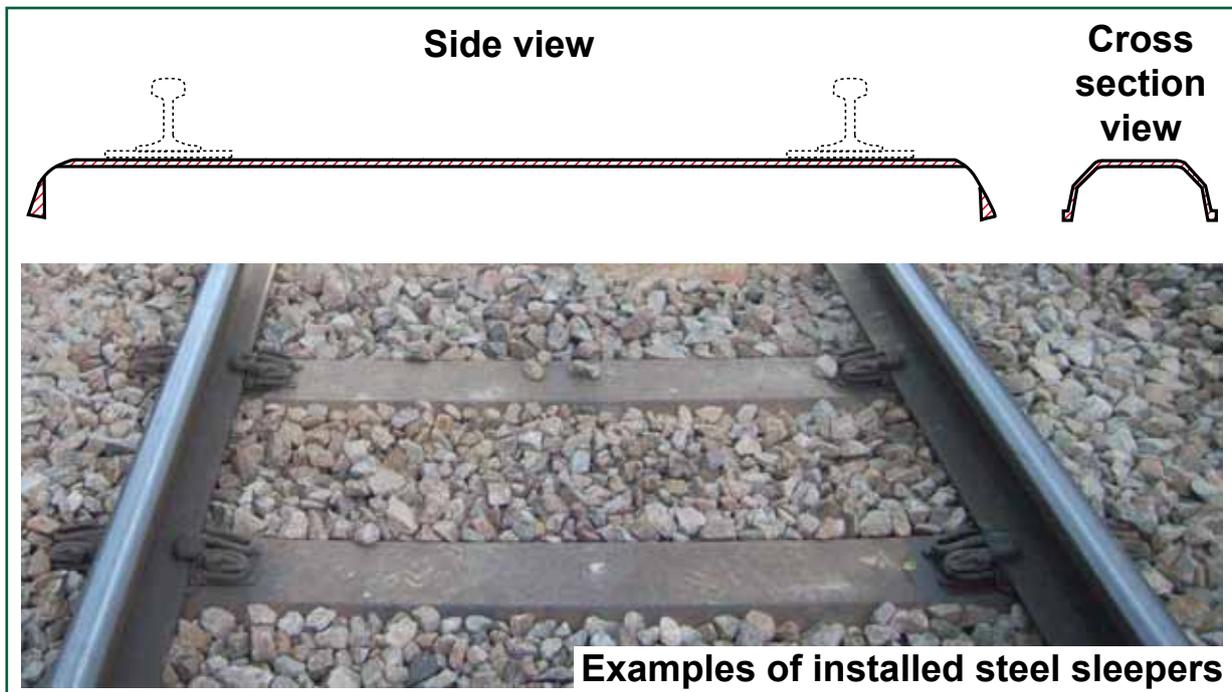
Figure 19: Steel sleeper profile

83 For track with poor vertical track geometry, the standard repair method used by track maintenance teams is measured shovel packing (paragraph 44) using small stones or chippings. However, Railtrack had installed steel sleepers on the up main line at this location in 2002¹³ and their hollow shape (figure 19) meant that measured shovel packing could not be used (paragraph 46).

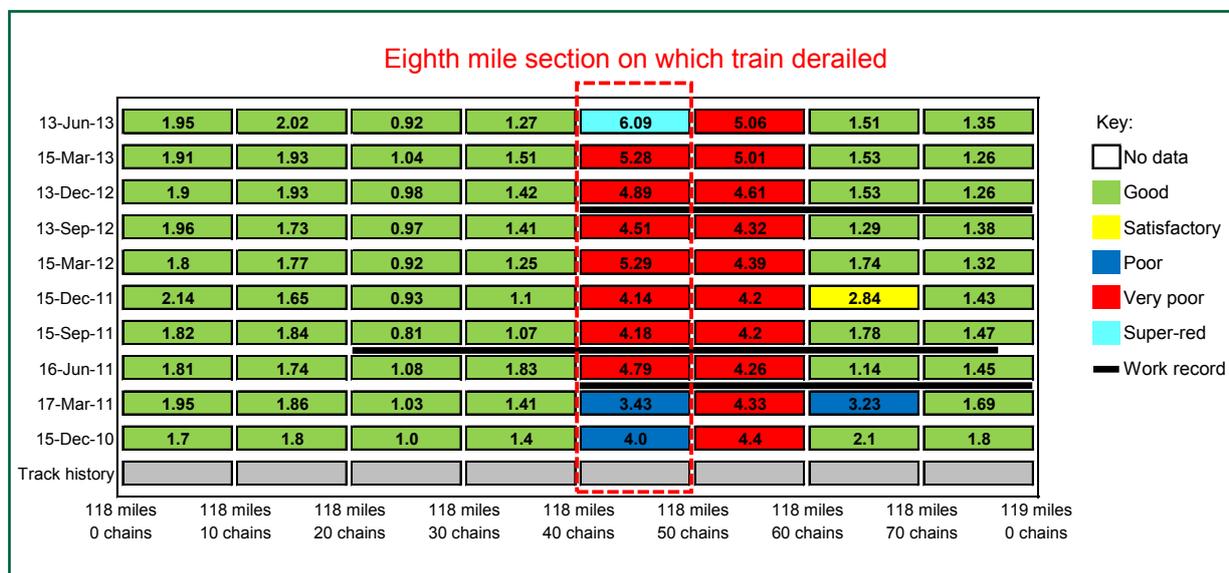
Figure 20: SD chart for the up main line

106 The overall poor quality of the vertical track geometry also meant that Network Rail should have imposed a speed restriction to comply with NR/L2/TRK/001/mod11. Figure 20 shows the SD chart (paragraphs 42 to 43) covering the point of the derailment after the last ten track geometry recording runs up until June 2013. It shows how the eighth of a mile section where the derailment happened had worsened over time.

107 By June 2013, its SD value was in the maximum band, the 'super-red' category. Once it became a super-red site, NR/L2/TRK/001/mod11 required the Track Maintenance Engineer to take action to improve its quality. NR/L2/TRK/001/mod11 also states that if the action undertaken is not sufficient to move the SD value out of the maximum band then a speed restriction must be imposed.

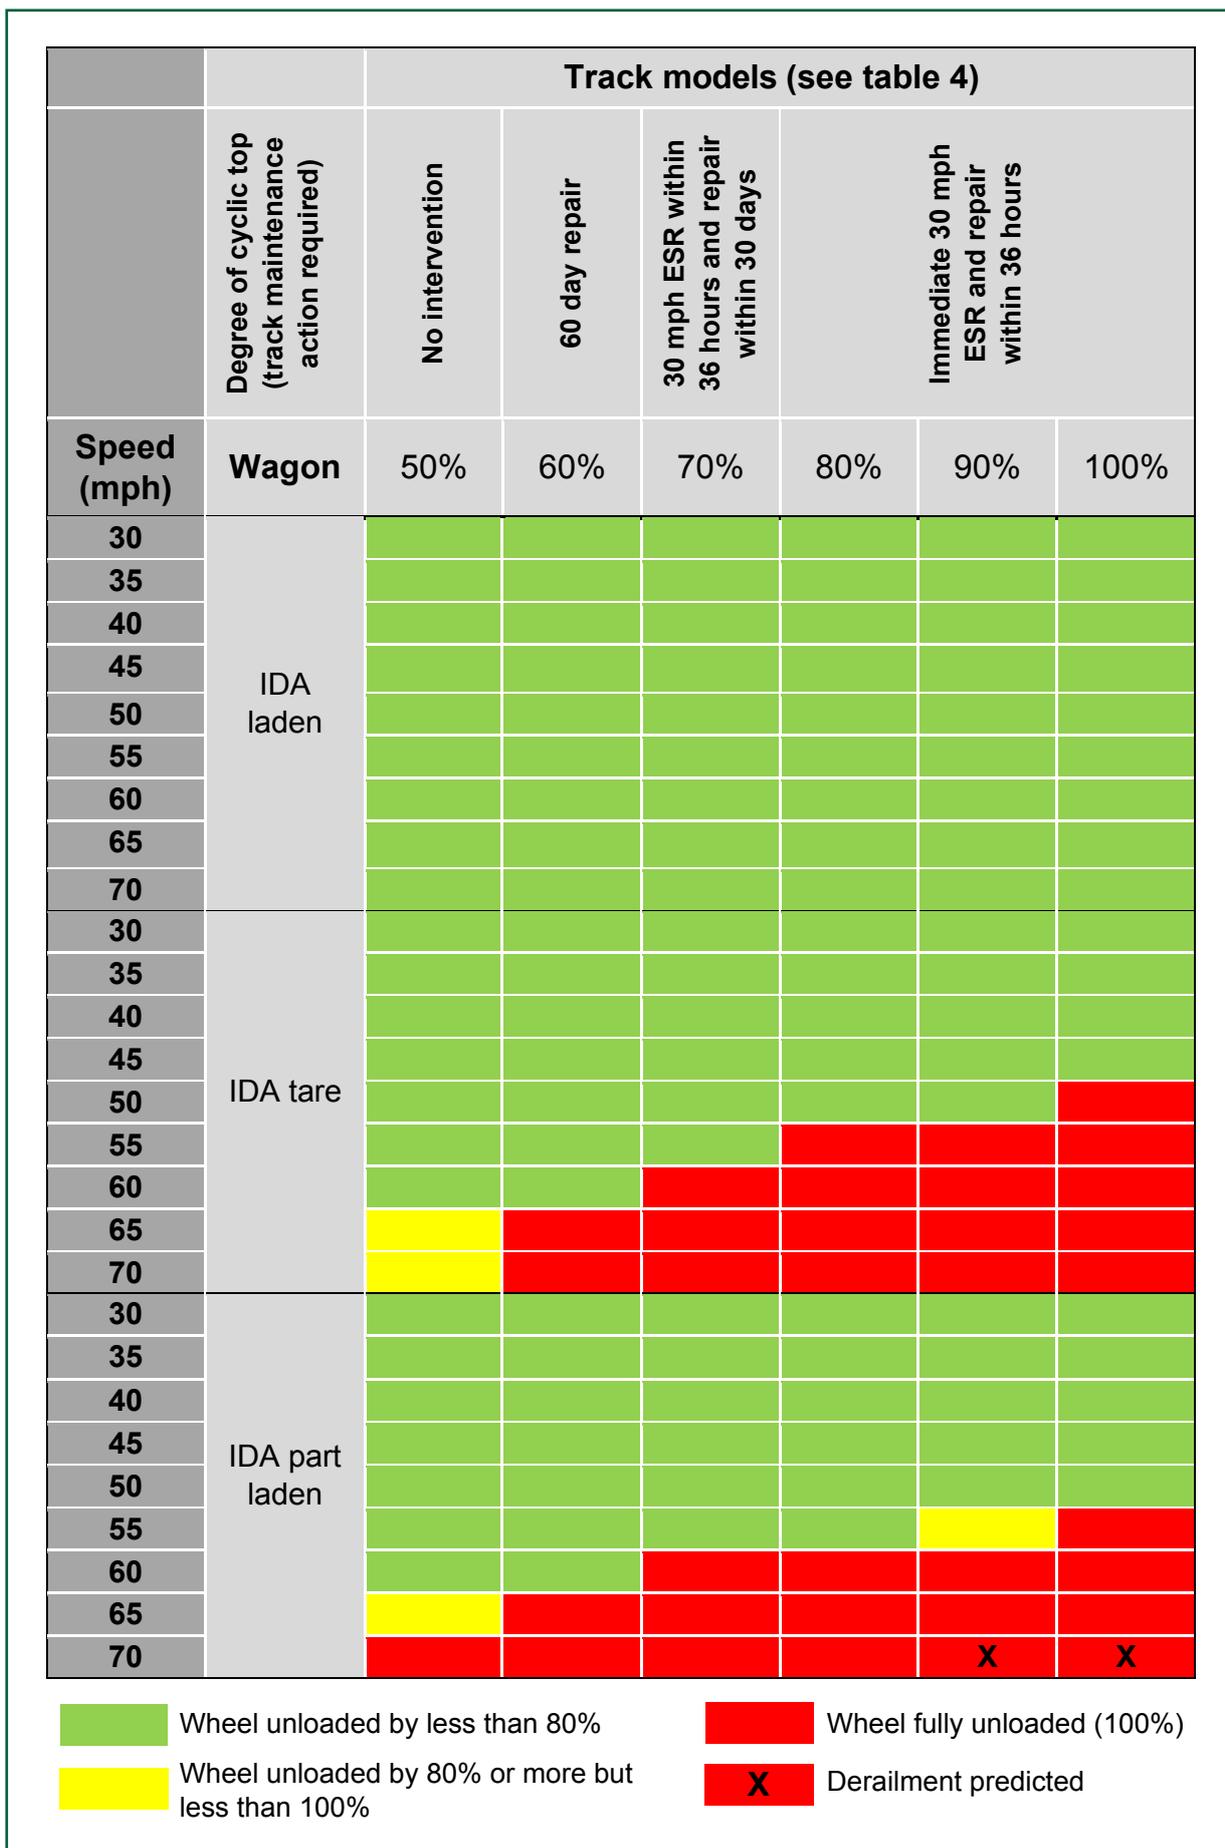
Figure 21: Simulation results for IDA wagons

- 120 Figure 21 shows that in its fully laden condition, the IDA wagon is not at risk of derailing at any speed on any of the track models. This is because the predicted amount of wheel unloading is low and there is no wheel lift.

- 121 Figure 21 shows that in its tare condition, at least one of the IDA wagon's wheels is predicted to completely unload when passing over the cyclic top in the 60% track model at a speed of 65 mph (105 km/h) or greater. Table 4 shows that cyclic top level of this magnitude would not require a speed restriction to be imposed, and could remain un-corrected for up to 60 days. However, the predicted wheel lift is 5 mm, so the risk of derailment is relatively small. As the level of cyclic top increases, the predicted amount of wheel lift increases with a corresponding increase in the risk of a derailment¹⁴. For the 80, 90 and 100% track models, at the higher speeds, the wheel lift becomes great enough for a flange to pass over the rail head (for these track models, a 30 mph (48 km/h) speed restriction should be in place and at this low speed the predicted amount of wheel unloading is low with no wheel lift). The greatest predicted wheel lift is 44 mm on the 100% track model at 70 mph (113 km/h). Although derailment is not predicted by this simulation, the amount of predicted wheel lift means that only a small lateral force is needed for a derailment to occur.

- 122 When the wagon is partially loaded, as at the time it derailed, figure 21 shows that the simulations predict complete wheel unloading at 70 mph (113 km/h), even on the 50% track model; table 4 shows this track model requires no maintenance intervention so an IDA wagon would be permitted to run over it at this speed. However, the amount of wheel lift is not sufficient to allow a flange to pass over the rail until the size of the cyclic top track defect reaches the level found in the 80% track model. The amount of wheel lift predicted is greater when partially loaded; the greatest amount is 82 mm on the 100% track model at 70 mph (113 km/h). The simulations also predicted the rear bogie at the rear of the wagon derailing on both the 90% and 100% track models at 70 mph (113 km/h).

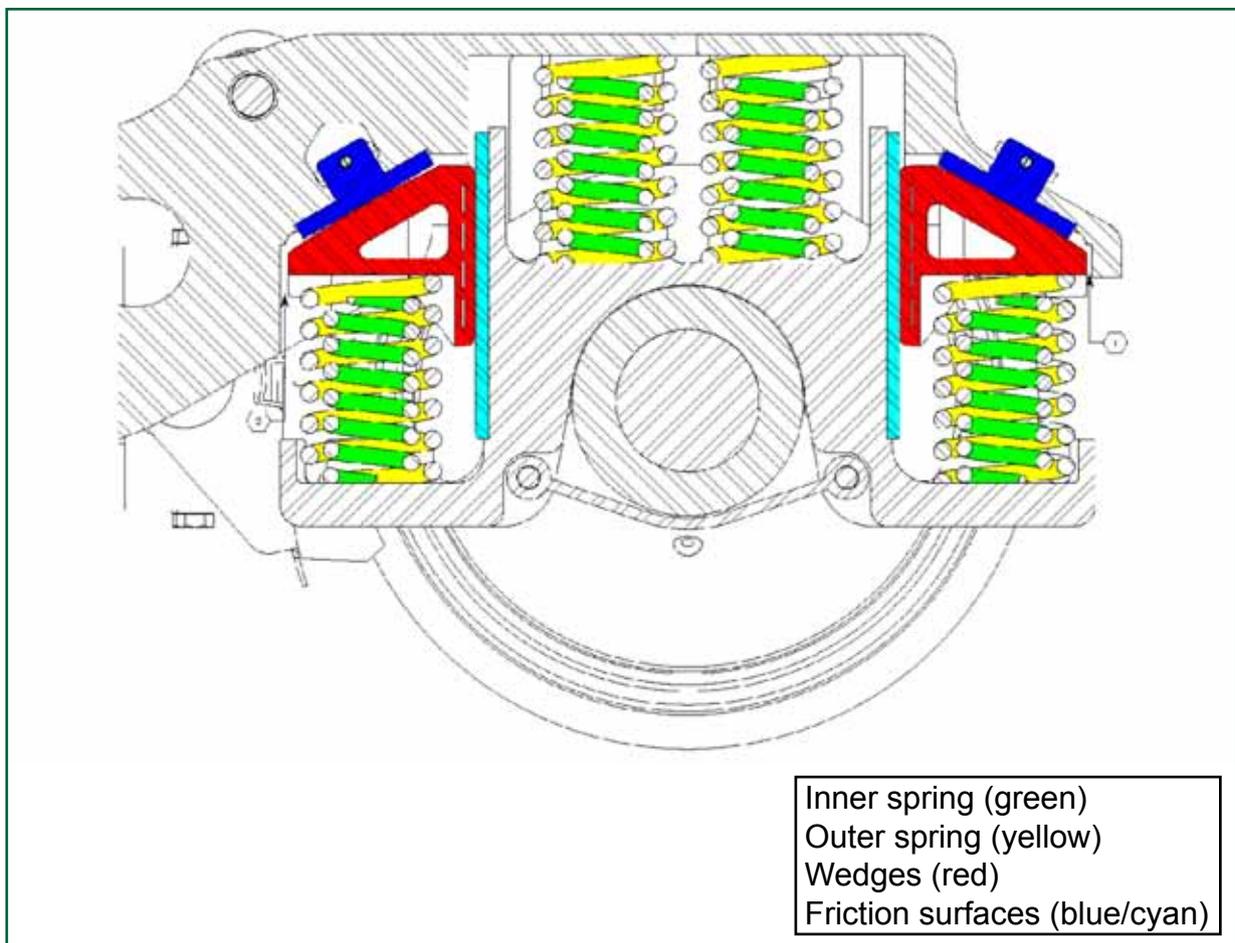
Figure 23: The primary suspension on an IDA wagon

127 The suspension on the IDA wagon uses friction to provide its damping. The *primary suspension* at the end of each axle has four sets of springs, each comprising an inner and an outer spring (figure 23). With no load other than the weight of the wagon itself (ie tare), only the outer spring is in contact between the axlebox and the bogie frame. As the load on the wagon is increased, the inner spring also comes into contact and this increases the vertical stiffness of the suspension. Figure 24 shows that the inner spring comes into contact with a load of 5.76 tonnes on the wagon (2.88 tonnes on each bogie). When the wagon has a partial load on it, such as an empty curtain-sided container which weighs 5.99 tonnes, the inner spring is just in contact but with a comparatively light load. This is generally the worst condition for vertical ride performance as vertical inputs from the track then cause the inner springs to move into and out of contact leading to rapid changes in the suspension stiffness. These changes in stiffness, combined with the light load and the commensurately small amount of friction damping, give rise to a bigger response to vertical track inputs than is seen for either the tare or fully laden wagon.

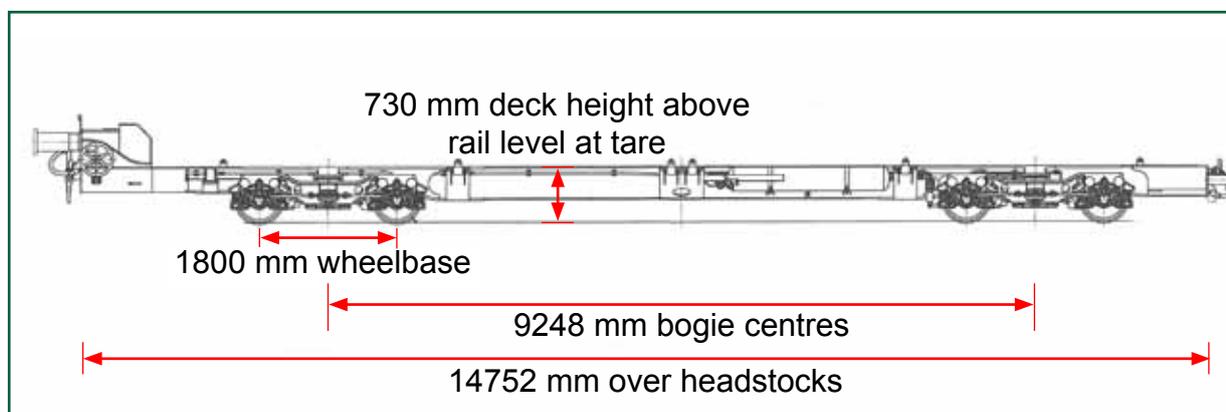
Figure 25: Dimensions of an IDA wagon (courtesy of W H Davis)

186 The dimensions of the IDA wagon are shown in figure 25. The distance from the centre of one bogie to the other on a vehicle is 9.25 metres. The wavelengths of cyclic top track defects are commonly derived from 60 foot (18.29 metres) rail lengths (paragraph 40). One of these wavelengths is about 9.14 metres, and being very close to the bogie centre spacing, cyclic top at this wavelength will cause the wagon to bounce. Other common wavelengths for cyclic top are 18.29 metres, 12.19 metres and 6.10 metres, which will cause a wagon with this bogie centre spacing to pitch (figure 32). Therefore the likelihood of the IDA wagon being excited by cyclic top track defects is greater than most other wagons, because the cyclic top wavelengths it will encounter match those which tend to stimulate pitching or bouncing due to its bogie centre spacing.

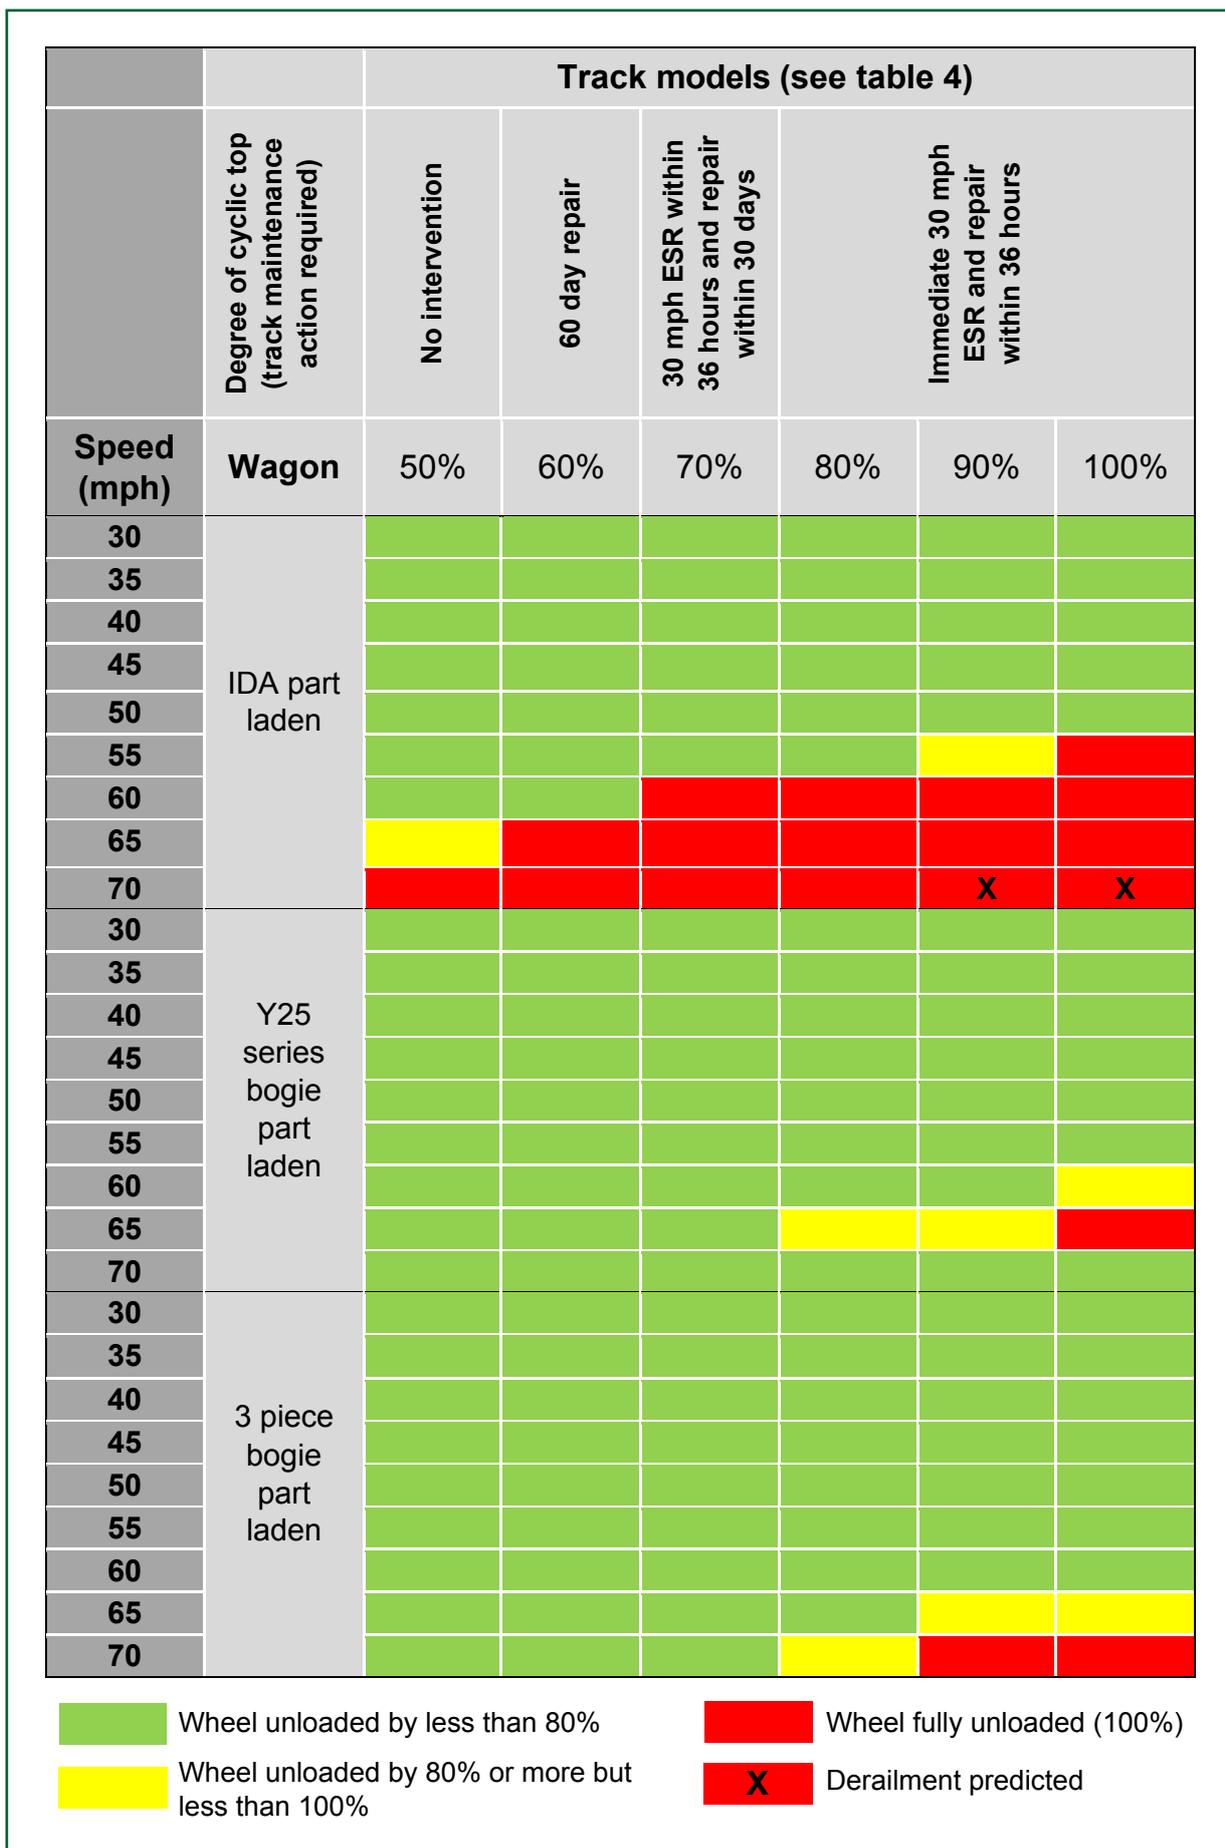
Figure 26: Simulation results for different wagons in their part laden condition

- 130 Vehicle models in tare, part laden and fully laden were used for both. The part laden condition that was chosen placed the suspension just in contact with the inner springs. The results of simulations in their part laden condition are summarised in figure 26.

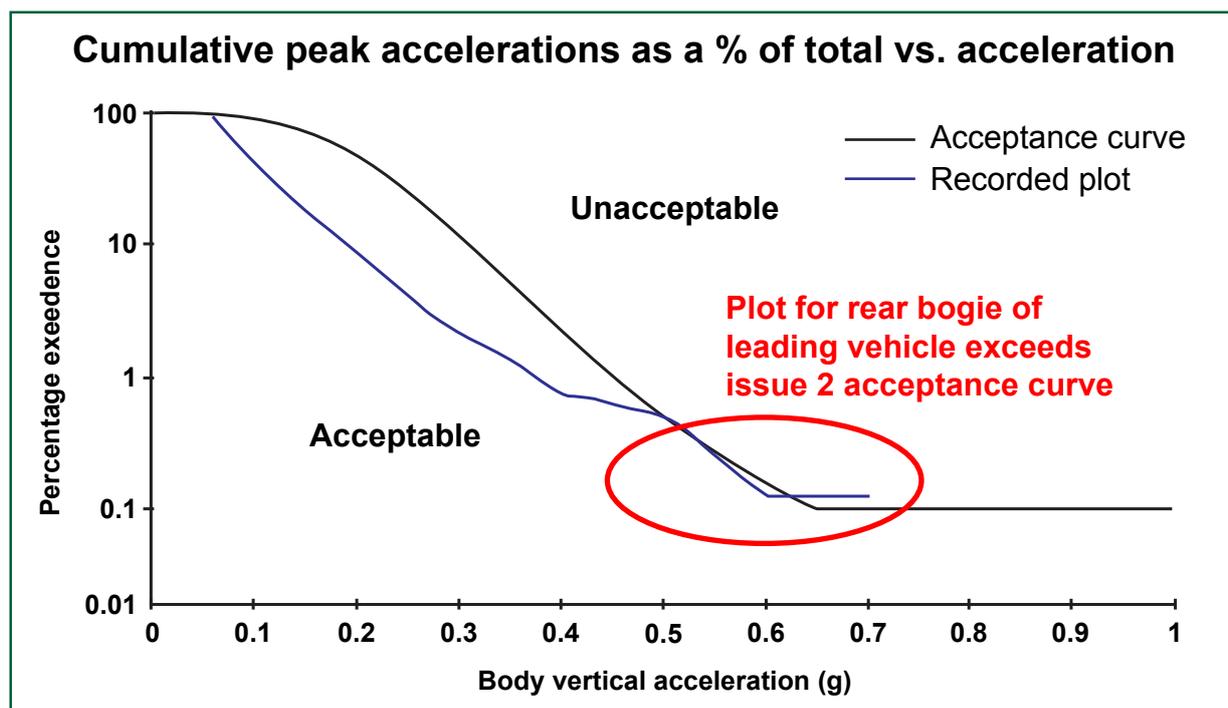
Figure 27: Peak counting plot for tare IDA wagon at 54 mph (87 km/h) on jointed track (from actual on-track tests)

138 The measurements for each on-track test run were analysed, looking for the number of peak accelerations above defined values. The results were then plotted on a graph and compared with an acceptance curve as defined in issue 2 of GM/RT2141. The results showed ride performance was marginally non-compliant to the acceptance curve at times, both in its tare and fully laden conditions. On sections of jointed track between Crewe and Derby at speeds above 50 mph (80 km/h), the distribution of vertical accelerations peaks exceeded the acceptance curve at the trailing bogie of the leading vehicle and the trailing bogie of the rear vehicle. An example of one of the recorded non-compliances is shown in figure 27.

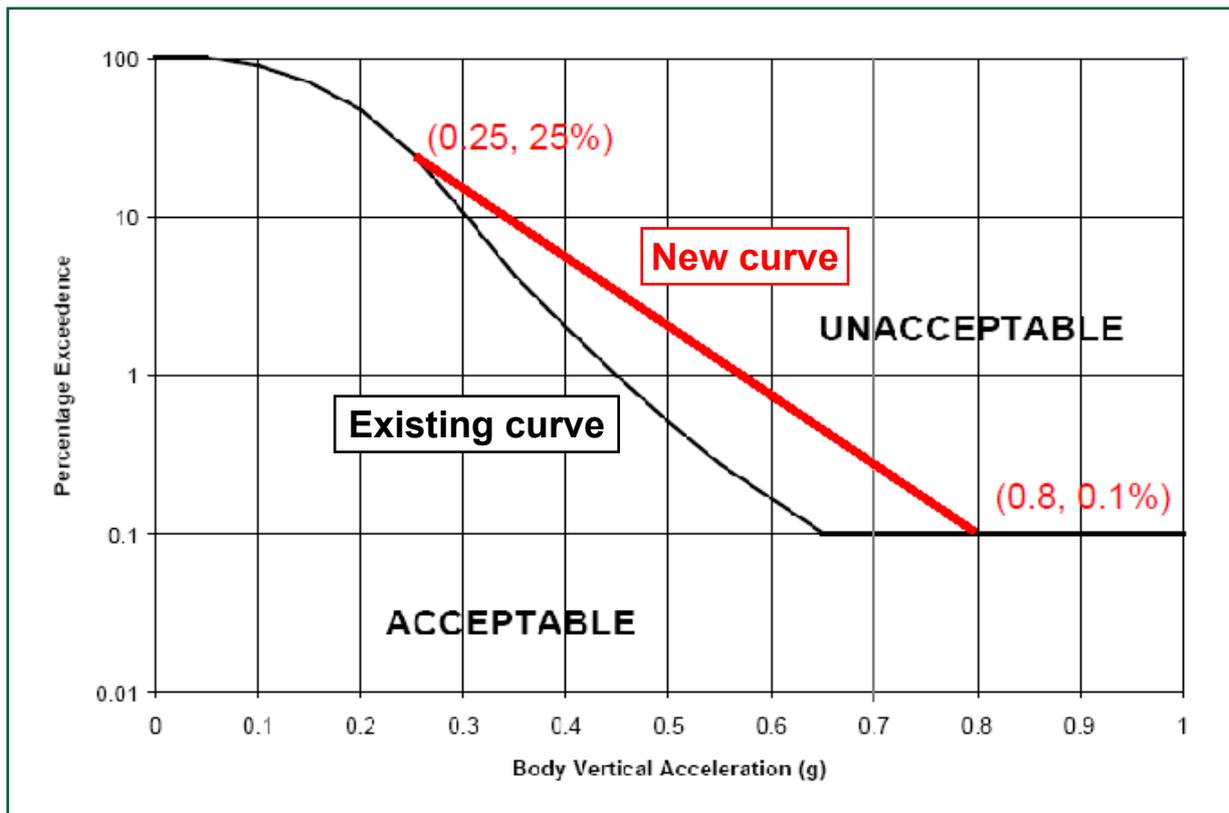
Figure 28: New acceptance curve for bogie freight vehicles on jointed track

- 140 In 2007, RSSB had commissioned a study to review the acceptance curve in GM/RT2141 as a number of bogie freight wagons had not met its requirements when tested on jointed track, but had subsequently been seen to operate satisfactorily. This work led to RSSB introducing a new acceptance curve specifically for bogie freight wagons on jointed track as shown in figure 28. RSSB based the new acceptance curve on the existing curve and changed the margin of safety only in areas where it considered it had existing experience, such as where the ride performance of wagons with derogations against the existing curve had been shown to be acceptable for some time. The new acceptance curve for bogie freight wagons on jointed track was published in issue 3 of GM/RT2141 in June 2009.

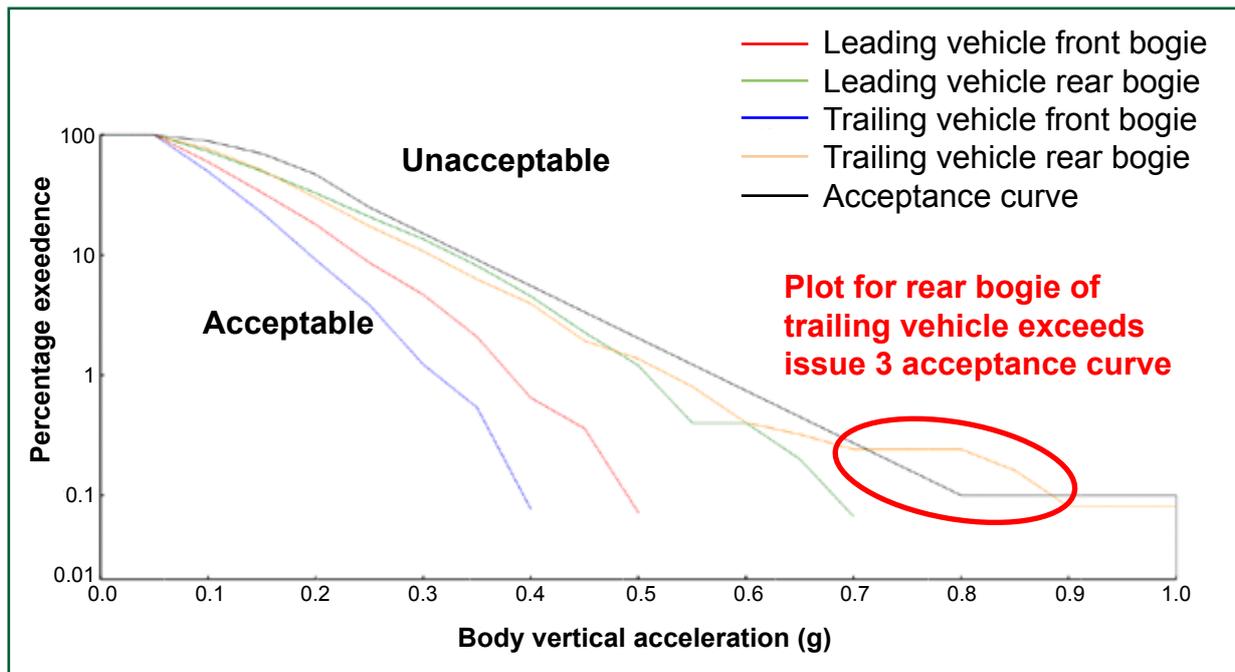
- 148 The results for the partially laden simulations found that the ride performance did not meet the GM/RT2141 issue 2 acceptance curve on twelve occasions. Each exceedance was recorded while running on jointed track, at a range of speeds between 50 mph (80 km/h) and 70 mph (113 km/h). Seven exceedances were at the rear bogie of the trailing vehicle and five at the rear bogie of the leading vehicle. When the results were compared against the issue 3 acceptance curve, there were still four exceedances at the rear bogie of the trailing vehicle, at a range of speeds between 60 mph (97 km/h) and 70 mph (113 km/h). One of the exceedances recorded at 60 mph (97 km/h) is shown in figure 29. Therefore these test results did not meet the revised ride performance criteria in issue 3 of GM/RT2141. Similar to the simulation results for the track geometry at Gloucester (paragraph 123), the worst ride performance was recorded at the unrestrained rear bogie of the trailing vehicle.

Figure 29: Peak counting plot for a part laden IDA wagon at 60 mph (97 km/h) on jointed track (from simulated on-track tests)

149 The study concluded that if the actual on-track testing had included a test with a wagon partially loaded so the suspension was at its stiffness change point, it is probable that the wagon would not have passed the acceptance tests.
