Rail Accident Investigation Branch

Rail Accident Report

Freight train derailment near Gloucester 15 October 2013

Report 20/2014
October 2014

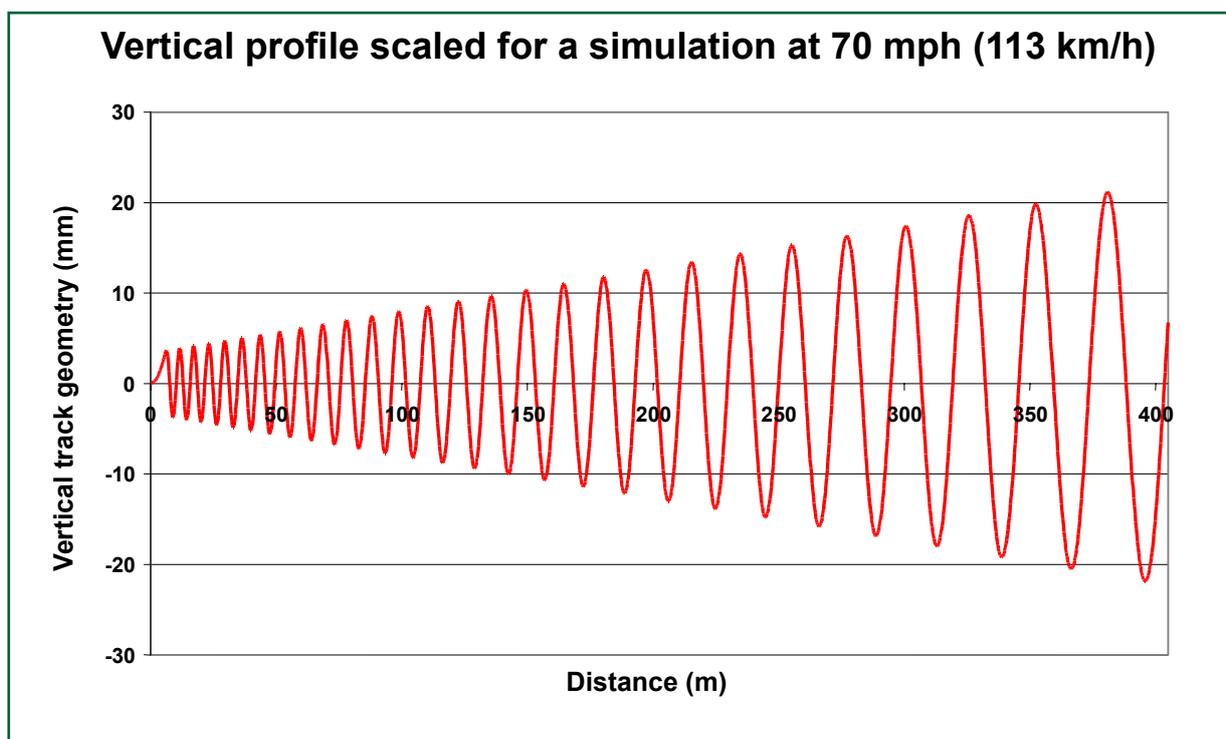
162 The test that was proposed in the draft GM/RT2141 was a computer simulation to evaluate a vehicle's response to defined cyclic top input from the track. The track input was 405 metres long and the wavelength of its vertical geometry altered throughout, from 5 metres at the start to 31 metres at the end (figure 30). The amplitude of input is adjusted as the wavelength changes over the length of the track to maintain a constant amount of energy from the track into the vehicle. The track input is also scaled depending on the speed of the vehicle being run over it.

Figure 30: The vertical track geometry used to evaluate a vehicle's response to a defined cyclic top input

- 163 Each vehicle is run over this track at speeds ranging from 40 mph (64 km/h) to 10 mph (16 km/h) above its maximum operating speed, in 5 mph (8 km/h) increments. The amount of wheel unloading is predicted at each wheel and to pass it must not be greater than 80%. The RAIB's study carried out this evaluation on the IDA wagon vehicle model in its tare, partially laden and fully laden conditions.

- 164 The results found that the fully laden vehicle passed this test but wheels on the tare wagon were completely unloaded at 50 mph (80 km/h) and above. Wheels on the partially laden vehicle were completely unloaded at 35 mph (56 km/h) and above. The maximum amount of wheel lift found was 33 mm during the test at 65 mph (105 km/h).

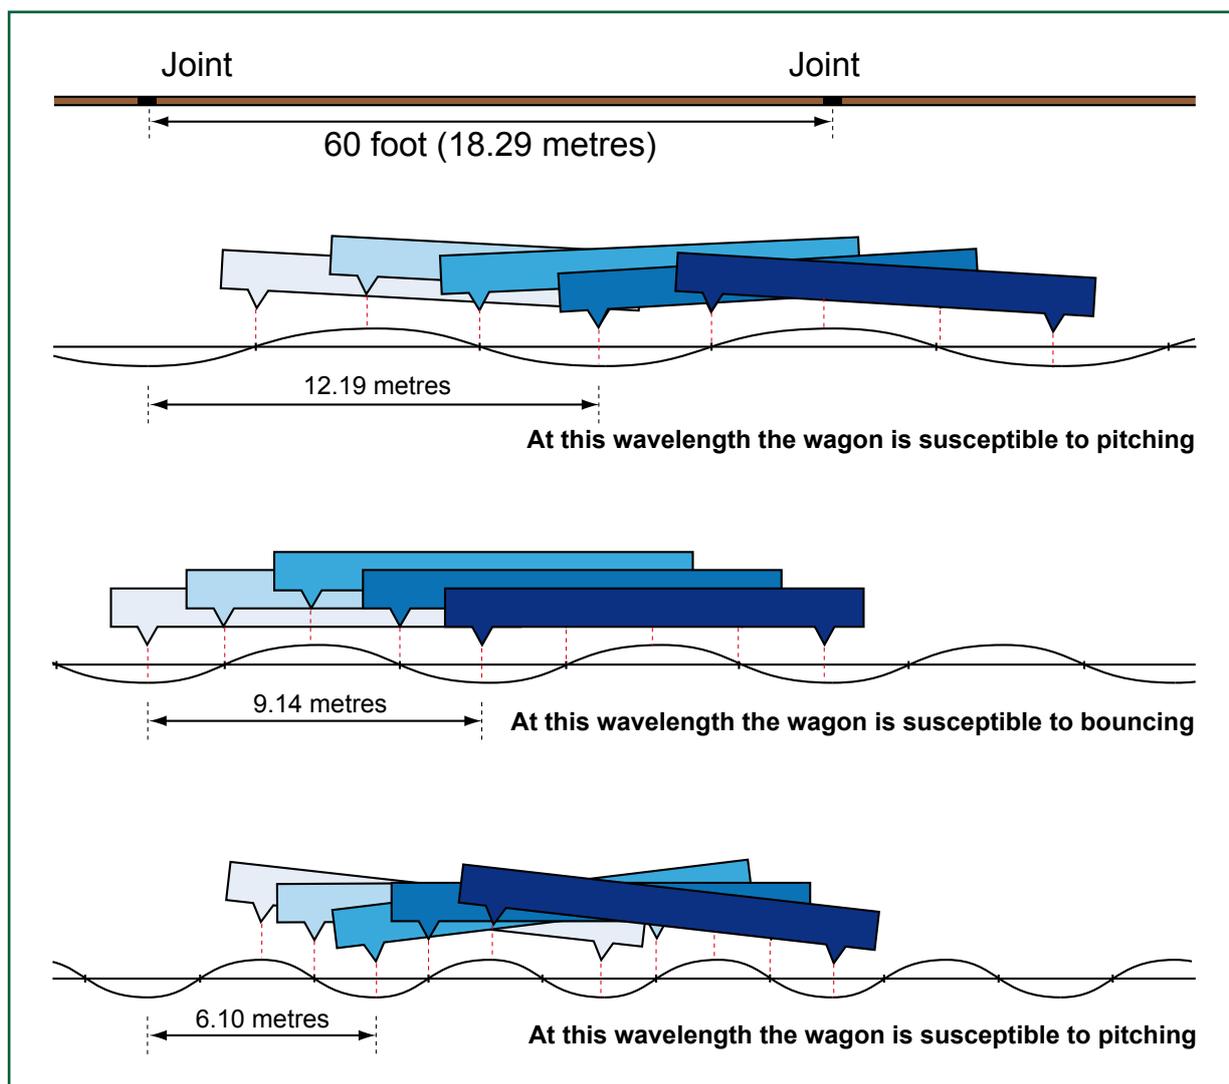
186 The dimensions of the IDA wagon are shown in figure 25. The distance from the centre of one bogie to the other on a vehicle is 9.25 metres. The wavelengths of cyclic top track defects are commonly derived from 60 foot (18.29 metres) rail lengths (paragraph 40). One of these wavelengths is about 9.14 metres, and being very close to the bogie centre spacing, cyclic top at this wavelength will cause the wagon to bounce. Other common wavelengths for cyclic top are 18.29 metres, 12.19 metres and 6.10 metres, which will cause a wagon with this bogie centre spacing to pitch (figure 32). Therefore the likelihood of the IDA wagon being excited by cyclic top track defects is greater than most other wagons, because the cyclic top wavelengths it will encounter match those which tend to stimulate pitching or bouncing due to its bogie centre spacing.

Figure 32: Cyclic top wavelengths derived from 60 foot (18.29 metres) rail lengths that cause the IDA wagon to bounce or pitch

187 The report for the on-track ride performance testing (paragraphs 137 to 141) also noted that the wagon's bogie centre spacing was about half the length of rails used on jointed track and that wagons with dimensions which are exact divisions of rail lengths are susceptible to resonance when running over jointed track.
