Rail Accident Investigation Branch

Rail Accident Report

Locomotive failure near Winchfield 23 November 2013

Report 13/2014
June 2014

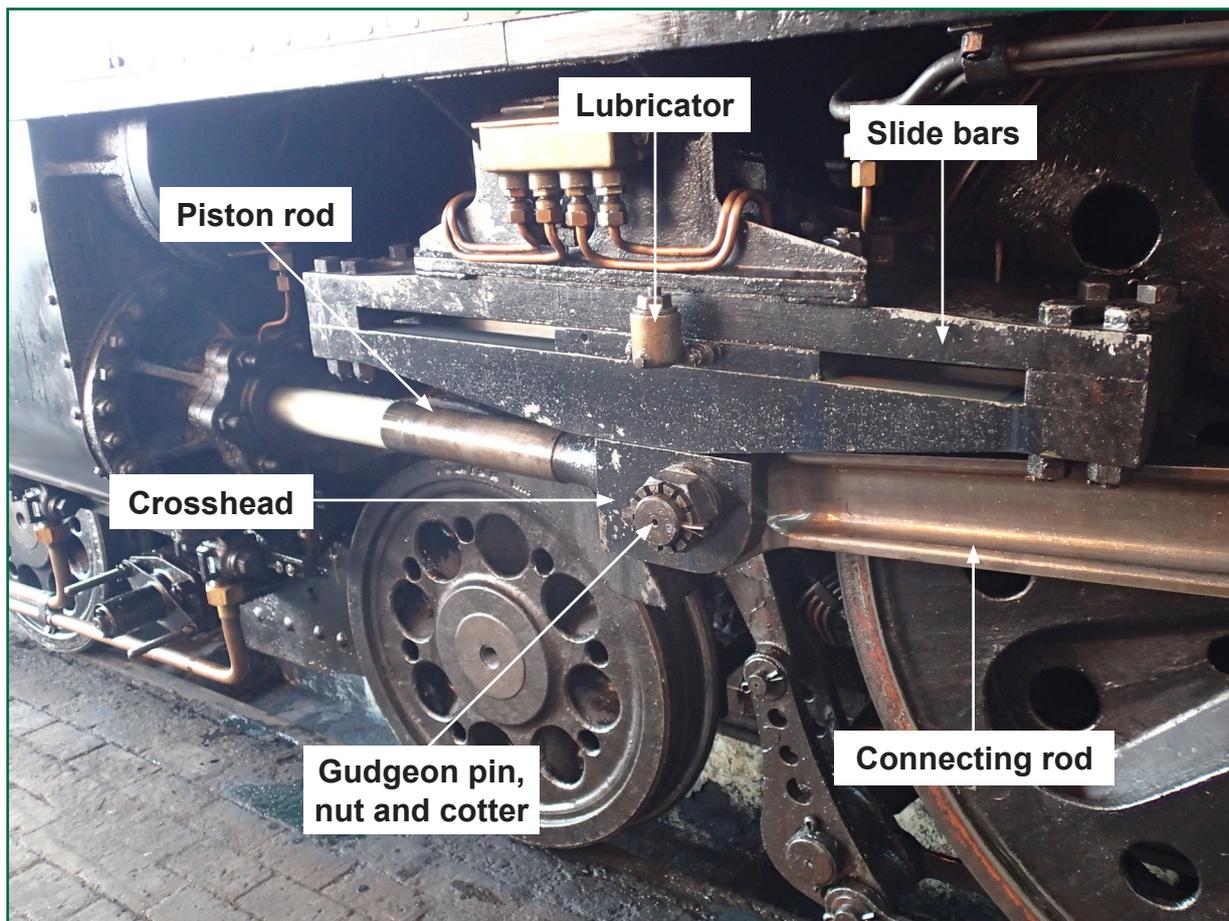
Figure 3: Left-hand side of 'Tangmere', showing principal components

- 27 Under the protection of the isolation and line blockage taken for the dismantling work, the support crew searched the immediate area for detached components. The gudgeon pin was found lodged on the locomotive near the *bogie*, and pieces of the *brake gear* were recovered from the track. However, the nut and *cotter* from the small end assembly (figure 4), and the crosshead lubricator (figure 3), could not be located (see paragraph 31).

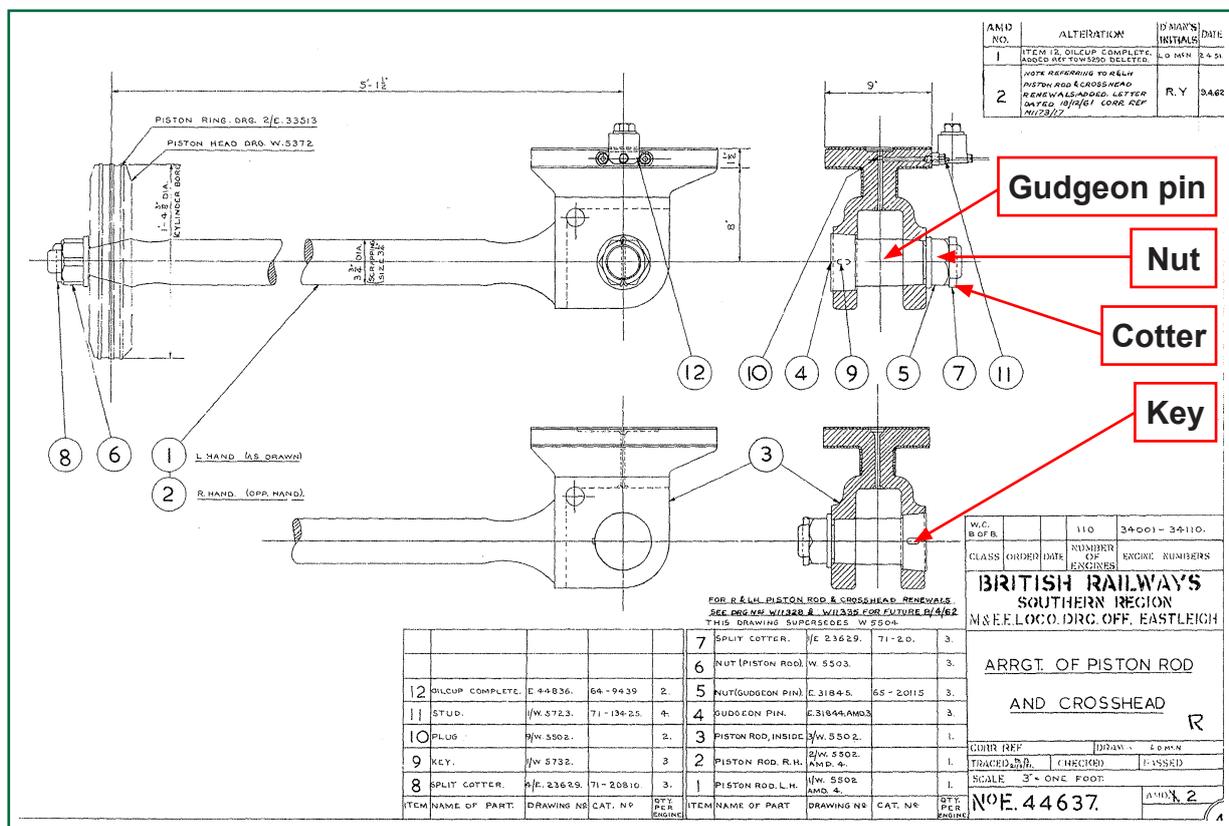
Figure 4: Crosshead and piston assembly (British Railways (Eastleigh) drawing E44637). Drawing reproduced by courtesy of the National Railway Museum/Science & Society Picture Library

- 39 The connecting rod is linked to the crosshead (and thus to the piston rod) by the gudgeon pin. This allows the connecting rod to oscillate relative to the piston rod, as the locomotive's wheels turn. The gudgeon pin is tapered (1 in 6 on diameter) and mates with a similar taper in the crosshead. A key in the larger portion of the gudgeon pin mates with a slot in the crosshead bore to orient the gudgeon pin and prevent it from rotating. The gudgeon pin is pulled into the taper by the gudgeon pin nut⁷. If the two tapers have been machined correctly, they will lock together (see paragraph 46) and the gudgeon pin will be hard to separate from the crosshead, even when the securing nut has been removed⁸. A split cotter⁹ is then driven through a slot in the gudgeon pin to further secure the nut (figure 4).

- 50 The original design of the Bulleid pacific small end had the cotter in a vertical plane, ensured by the keyway slot and cotter slot in the gudgeon pin being at right angles to each other (figure 4). When 'Tangmere' was restored from scrapyard condition, new gudgeon pins were manufactured which had the two slots in line. RAIB has not been able to establish whether the restorer intended to make this modification to the design, or if it arose from a misreading of the only available detail drawing (figure 7). The effect of this was that when the components were assembled on the locomotive, the cotters lay horizontally. RAIB's examination of other steam locomotives now used on the main line and on heritage railways shows that vertical cotters predominate, but there are many examples of horizontal ones, and some locomotives have a vertical cotter on one side and a horizontal one on the other. At least one other Bulleid pacific has had new gudgeon pins made with the same modification to the design, during restoration from scrapyard condition.

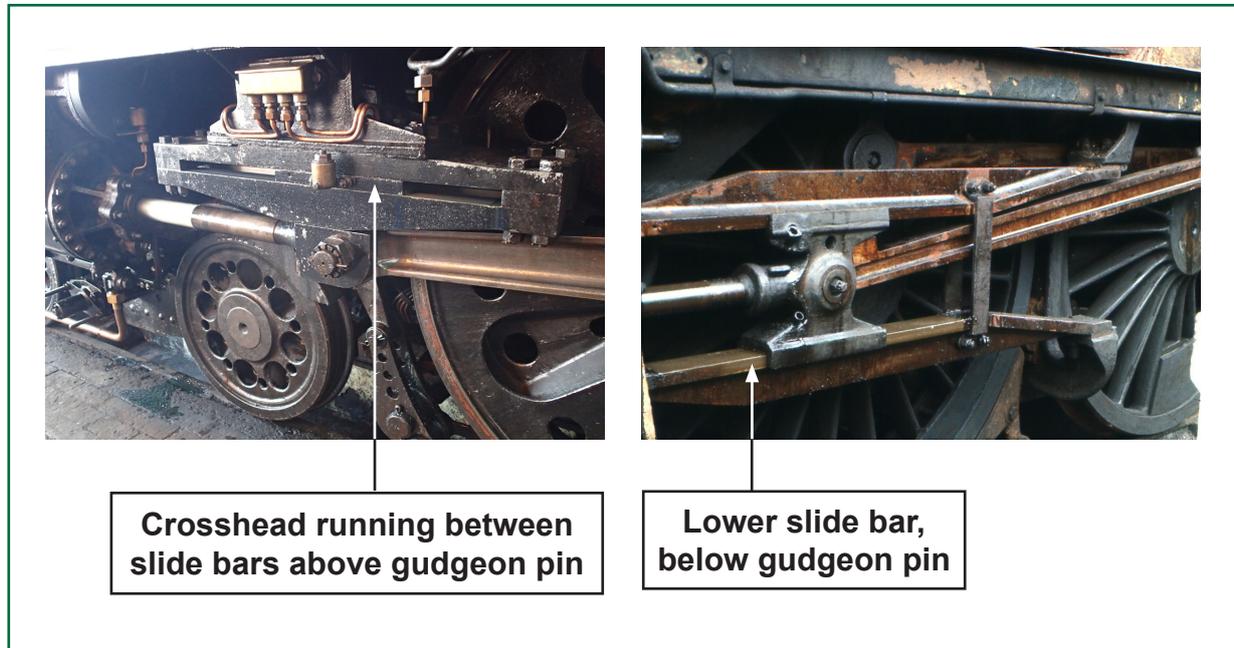
Figure 5: Comparison of single and double type slide bar arrangement

- 38 The T-shaped upper part of the crosshead runs in the *slide bars*, which are bracketed off the locomotive frames above the piston rod. There is thus nothing to prevent the connecting rod from dropping to ground level if it becomes detached at the small end, unlike other designs of locomotive which have a crosshead which runs between upper and lower slide bars (figure 5).

- 86 **There was nothing to prevent the connecting rod dropping to the ground after the small end joint came apart.**
- 87 The design of the Bulleid small end uses slide bars only above the gudgeon pin, so that there is no lower slide bar to restrain a connecting rod if the small end becomes detached (figure 5). This arrangement was first used in Britain in 1918 on the Great Northern Railway (GNR) and from 1925 on the Southern Railway. It has been generally accepted for over 90 years.
