Rail Accident Investigation Branch

Rail Accident Report

Class investigation into landslips affecting Network Rail infrastructure between June 2012 and February 2013

Report 08/2014
April 2014

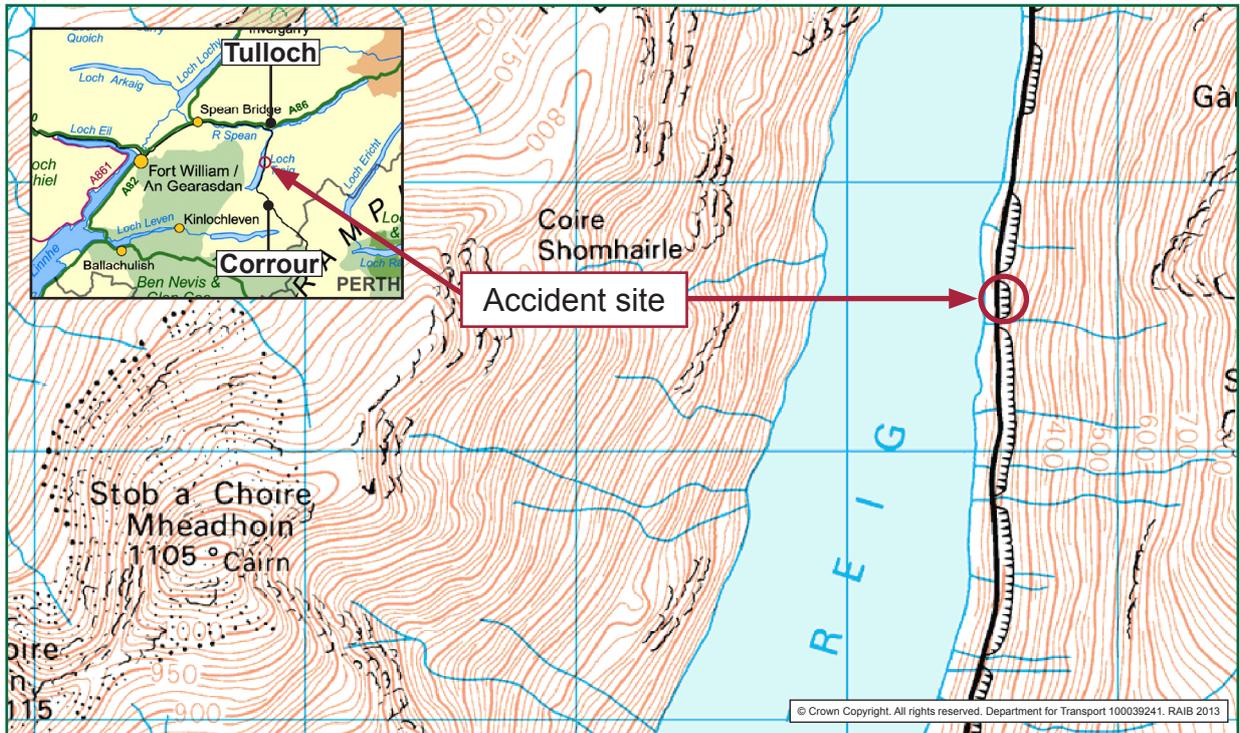
Figure 2: Loch Treig: accident location

- 9 At approximately 19:05 hours on Thursday 28 June 2012 a locomotive and five wagons were derailed when a freight train running on the West Highland line between Corroul and Tulloch hit a landslip alongside Loch Treig (figure 2). There were no injuries but three of the derailed wagons overturned and the locomotive ran part way down the *natural slope* leading to the loch (figures 3 and 4).

- 12 The debris had come from a landslip which had occurred in the natural slope about 35 metres upslope of the railway boundary (figure 6). RAIB noted that the slip had developed in a shallow valley area which was waterlogged. RAIB (and Network Rail) consider that the slip was triggered by water accumulating in this valley and destabilising the soil.

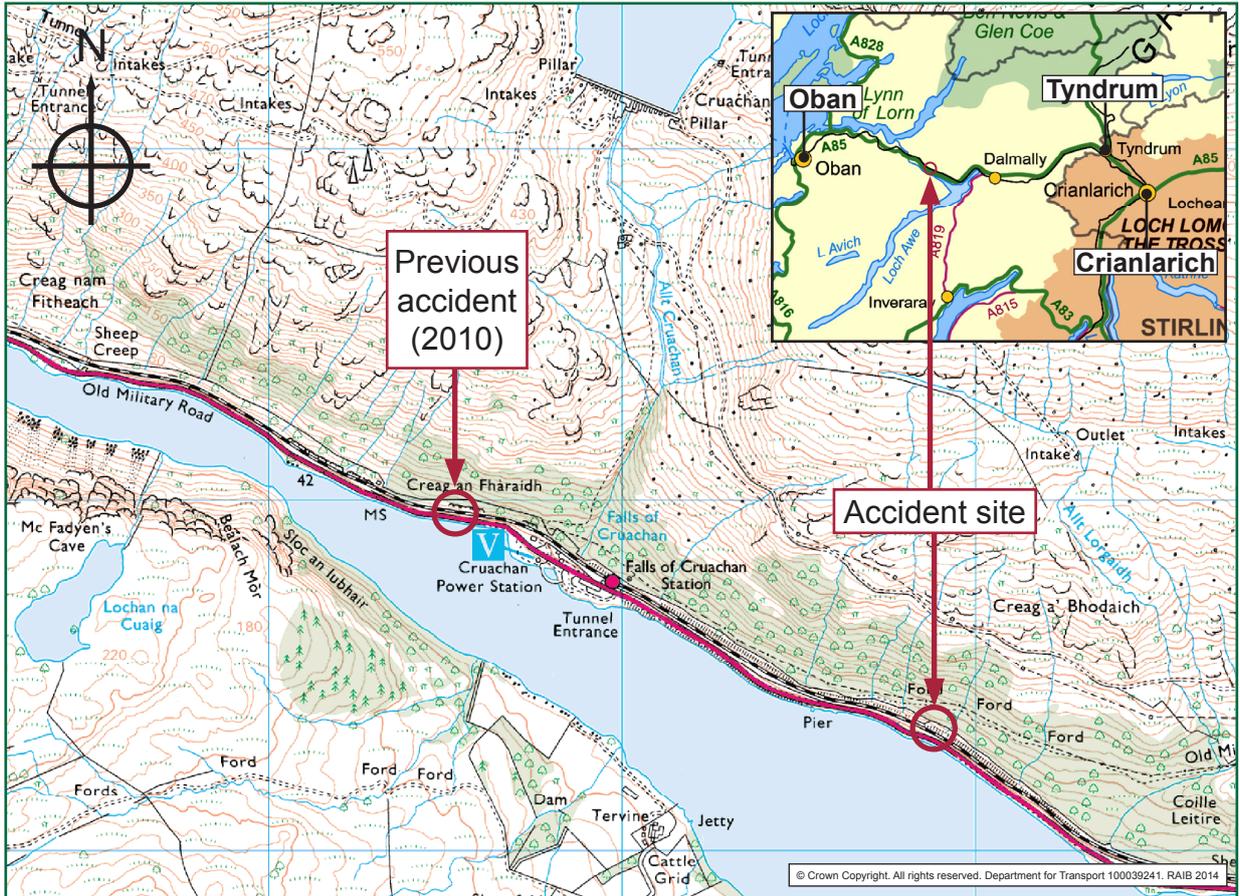
Figure 7: Falls of Cruachan: accident location

- 23 At 13:35 hrs on Wednesday 18 July 2012, the 12:56 hrs Oban to Glasgow First ScotRail passenger service, reporting number 1Y24, struck landslide debris near Falls of Cruachan but did not derail (figure 7). There were no reported injuries but the train suffered minor damage. If the train had been derailed by the landslide debris, it is possible that it would have fallen down an adjacent slope (paragraph 26).

- 25 The accident occurred at 52 miles 22 chains⁶ on the Crianlarich to Oban line where the maximum permissible speed for trains had been reduced from 45 mph (72 km/h) to 30 mph by a temporary speed restriction imposed to mitigate the risk associated with falling rocks (this is the reason given by a member of Network Rail geotechnical staff although the formal instruction to train drivers⁷ states it is due to '*condition of embankment*').

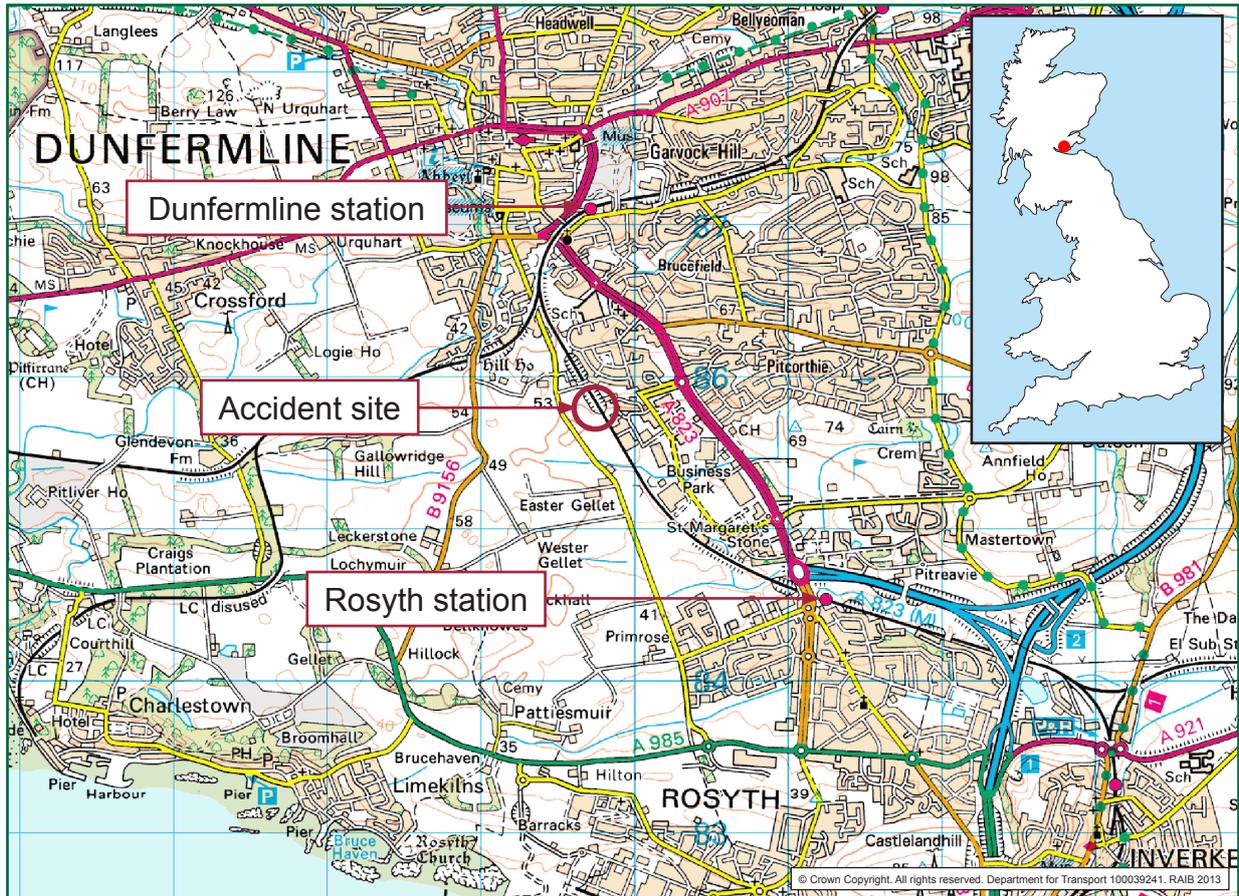
Figure 13: Rosyth: accident location

- 37 At about 16:10 hrs on Wednesday 18 July 2012, the 14:17 hrs First ScotRail service from Newcraighall to Edinburgh, reporting number 2K05, was derailed when it struck landslide debris between Rosyth and Dunfermline (figure 13). There were no injuries. The track and train suffered minor damage.

- 39 At this location the railway comprises two tracks with a maximum permissible speed of 65 mph (104 km/h). The railway is running in a northwest-southeast direction through a cutting which is about five metres deep and with a side slope of about 1 in 1.7. The slip occurred on the northeast side of the cutting at 15 miles 68 chains⁹, adjacent to the boundary between an area of waste ground and a recent commercial development (figures 15 and 16).

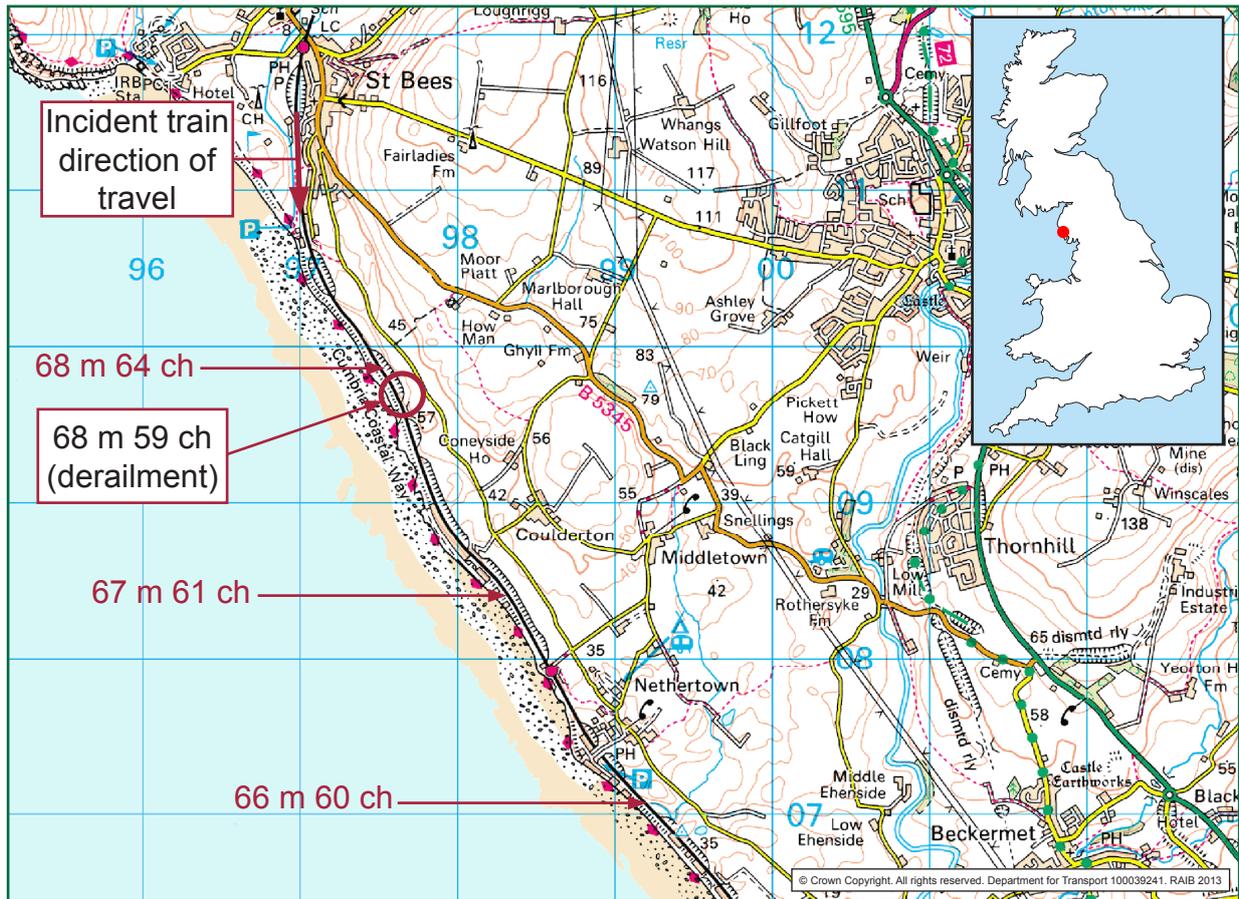
Figure 17: St Bees: accident location

- 48 At approximately 06:43 hours on Thursday 30 August 2012 the leading bogie of a passenger train derailed when it hit a landslip between St Bees and Nethertown on the Cumbrian coast (figure 17). There were no reported injuries and only relatively minor damage to the train. If the train had derailed to a greater extent, it is possible that it would have fallen down an adjacent slope (paragraph 50).

- 51 The accident occurred after exceptionally heavy overnight rainfall which RAIB and Network Rail believe triggered both landslips, when water percolated into the predominantly sand and gravel soil causing a loss of soil strength, possibly accompanied by water washing out soil. There were no major drainage channels in the vicinity of the landslips. Site inspections, information provided by Network Rail and aerial photographs indicate that, at 68 miles 64 chains, it is probable that ditches, local topography and permeable ground concentrated water in the area of the landslip. The same sources of evidence indicate that, at 68 miles 59 chains, water was probably concentrated in the landslip location by a combination of local topography and permeable ground.

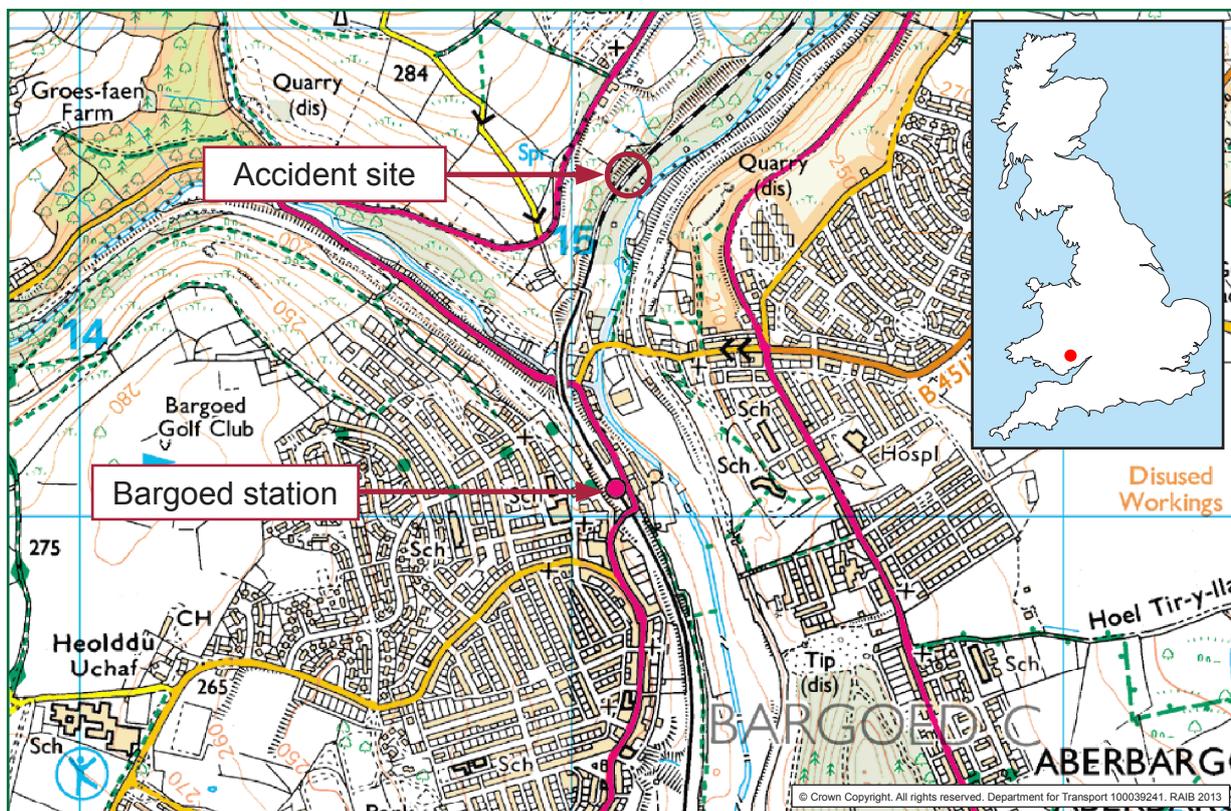
Figure 25: Bargoed: accident location

- 61 At approximately 06:20 hrs on Wednesday 30 January 2013, the 06:10 hrs Arriva Trains Wales service from Rhymney to Barry Island struck a tree which had been displaced onto the track by a landslide on the approach to Bargoed station (figure 25). The leading bogie derailed, the train suffered minor damage and a passenger was taken to hospital suffering from shock (figure 26).

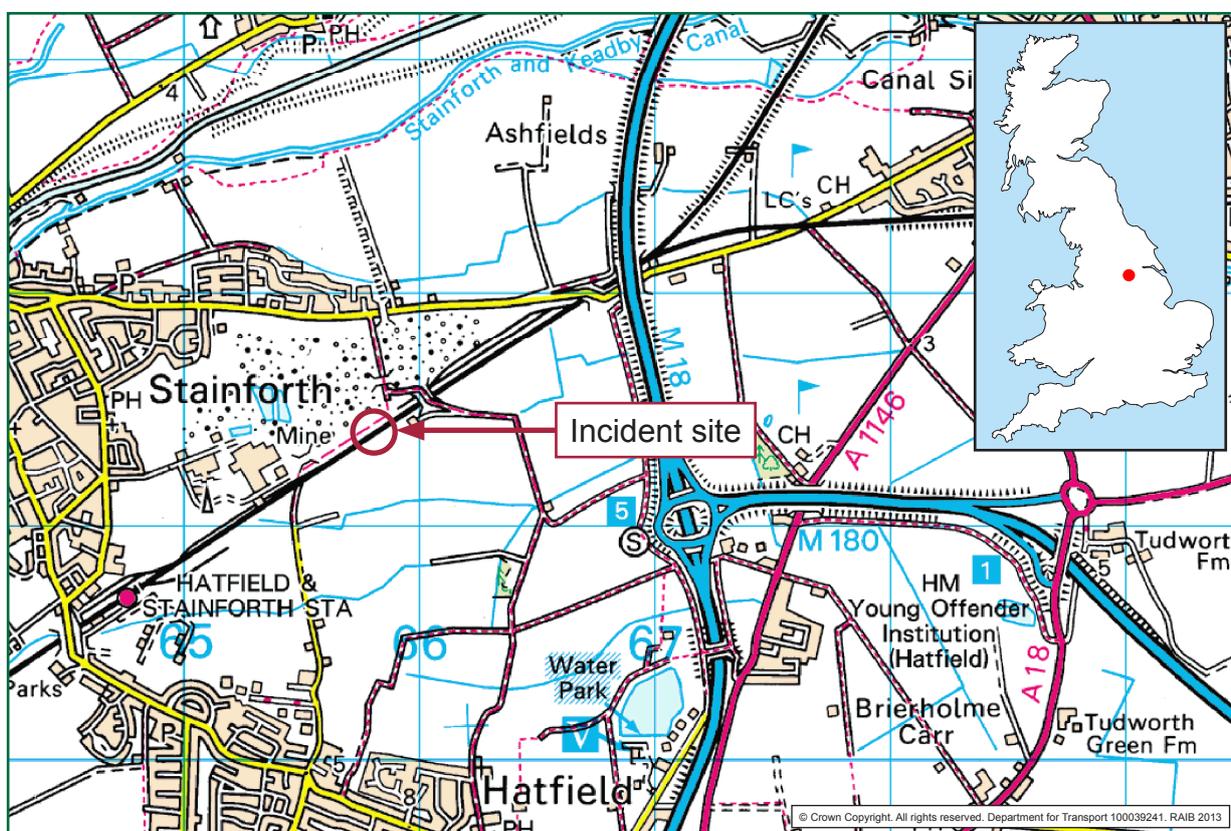
Figure 29: Hatfield Colliery: incident location

- 76 On 9 February 2013 a train driver noticed a track defect when passing Hatfield Colliery, near Stainforth, South Yorkshire at 7 miles 25 chains¹³ on the four track section of railway between Doncaster and Scunthorpe (figure 29). At this location, the maximum permissible speed is 40 mph (64 km/h) on the outermost lines and 60 mph (96 km/h) on the central pair of tracks. Network Rail staff attended site when the driver reported the defect and implemented progressively lower speed restrictions as on-going track movements became apparent (figure 30). Due to these movements, three of the lines were closed to traffic on 11 February and the fourth line was closed on 12 February.

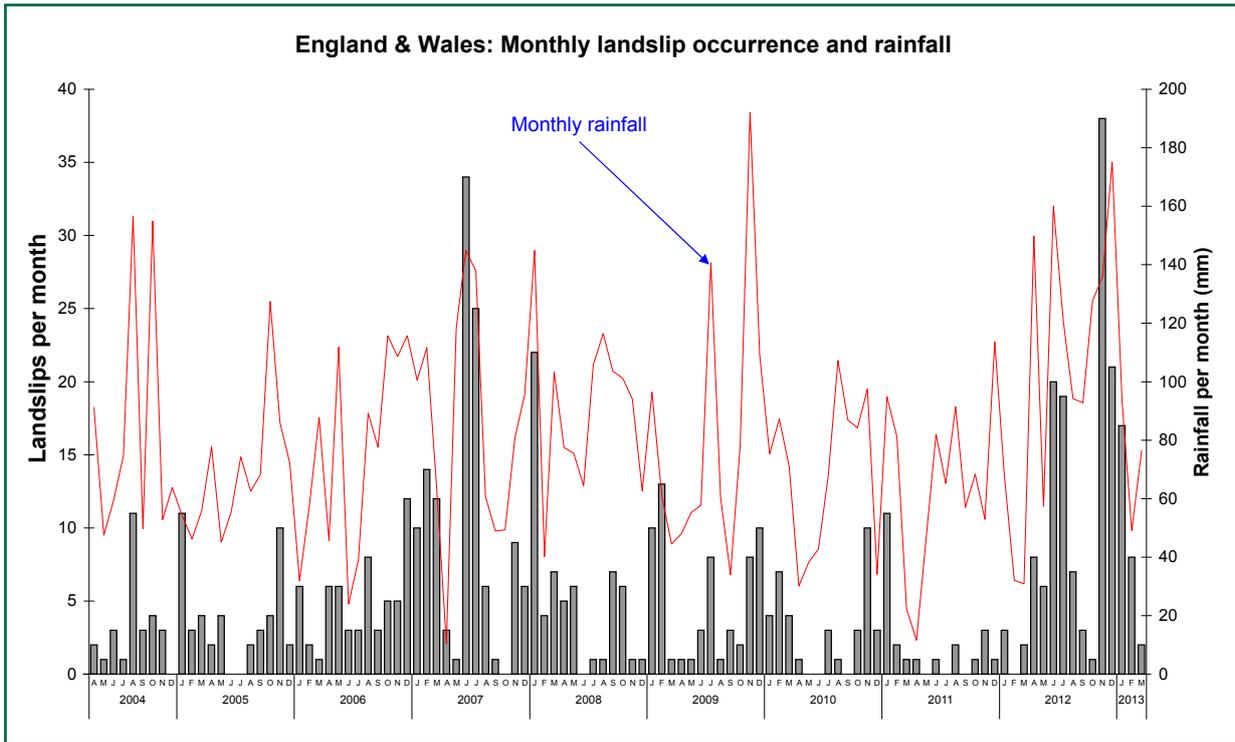
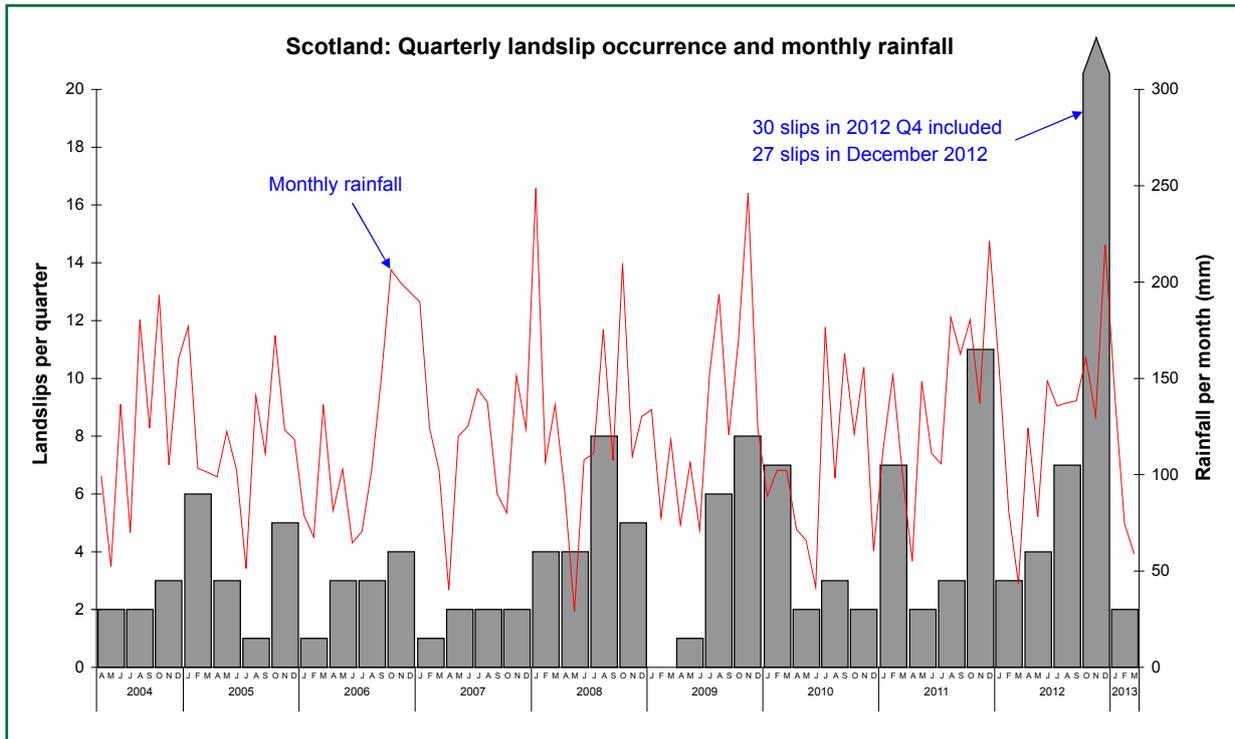
- water can increase the likelihood of a landslip by making parts of a slope heavier than in dry conditions.
- 86 The importance of rainfall is evidenced by the relationships between earthwork failures and rainfall shown in figures 33 and 34. Earthwork failure data is shown on a monthly basis for England and Wales (figure 33) and on a quarterly basis for Scotland where the length of railway is less and fewer failures occur (figure 34). Rainfall data is presented on a monthly basis on both figures and so does not include the following influences on landslips:

Figure 33: Rainfall and earthwork events on Network Rail infrastructure in England & Wales

Figure 34: Rainfall and earthwork events on Network Rail infrastructure in Scotland
