Rail Accident Report

**Tram running with doors open on London
Tramlink, Croydon
13 April 2013**

Report 05/2014
March 2014

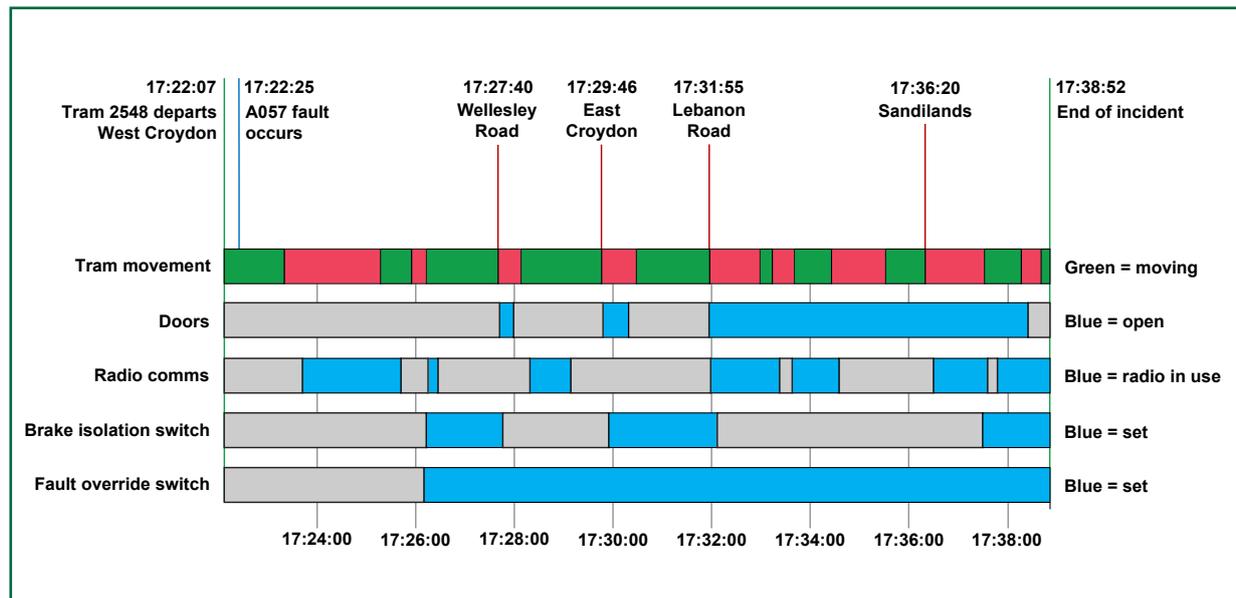
Figure 3: Timeline of the incident

- 25 At around 17:22 hrs, the driver of a tram that had just departed from West Croydon on its journey to Beckenham Junction received a fault message on his cab display: 'A057 Spring applied brake on B bogie will not release'. When the tram stopped at the next traffic signal, the driver informed the controller about the fault using the tram radio, and the controller instructed the driver to use the 'spring applied brake isolation' switch to see if this would clear the fault (figure 3).

- 26 The switch was sealed¹ and the driver found it difficult to break the seal, so he had to use two hands to operate the switch. During the period when he was attempting to operate the brake isolation switch, he inadvertently operated the adjacent switch at the same time (paragraph 58). The adjacent switch was the 'fault override' switch, which, amongst other things, had the effect of bypassing the interlock that prevented the tram from being moved with doors open (paragraph 20). Operating this switch also causes a status message to be presented on the cab display, reading '253 Fault override switch actuated'.
