Rail Accident Investigation Branch

Rail Accident Report

Partial failure of a structure inside Balcombe Tunnel, West Sussex 23 September 2011

Report 13/2013
August 2013

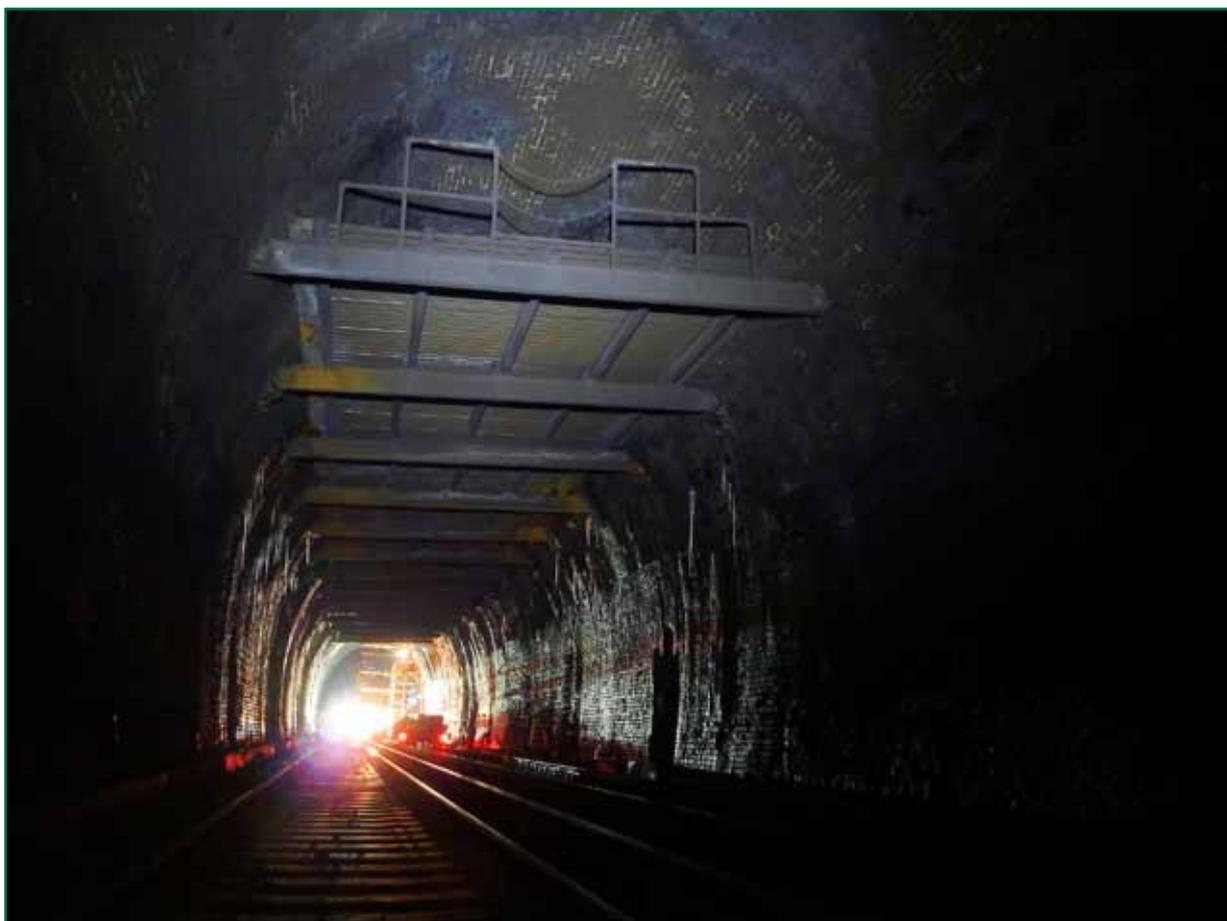
Figure 3: Water catchment tray 5 from north end in February 2012

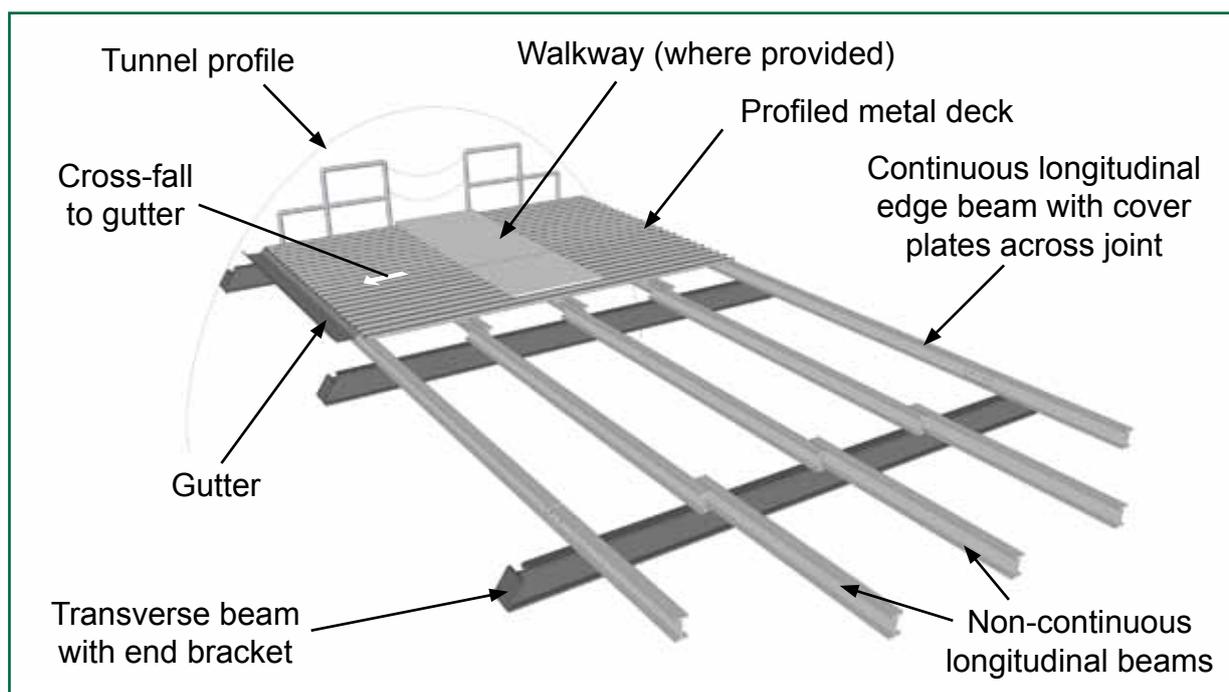
- 28 The trays, as designed by Scott Wilson, comprised a profiled metal deck supported by five longitudinal beams (ie parallel with the track) which in turn rested on transverse beams. The three central longitudinal beams spanned between transverse beams and were not continuous (ie a separate section of steel was used for each span, figure 4). The two outer longitudinal beams (ie one on each side) were continuous, with cover plates bolted across each joint. The transverse beams were approximately six metres long and spanned across the tunnel at four metre intervals (figures 3 and 4). The trays were inclined at a gradient of 1 in 40 so as to shed water towards a gutter above the down line. The design drawings showed that the trays were to be installed a minimum of 4.69 m above rail level.

Figure 4: Diagram of water catchment tray structure

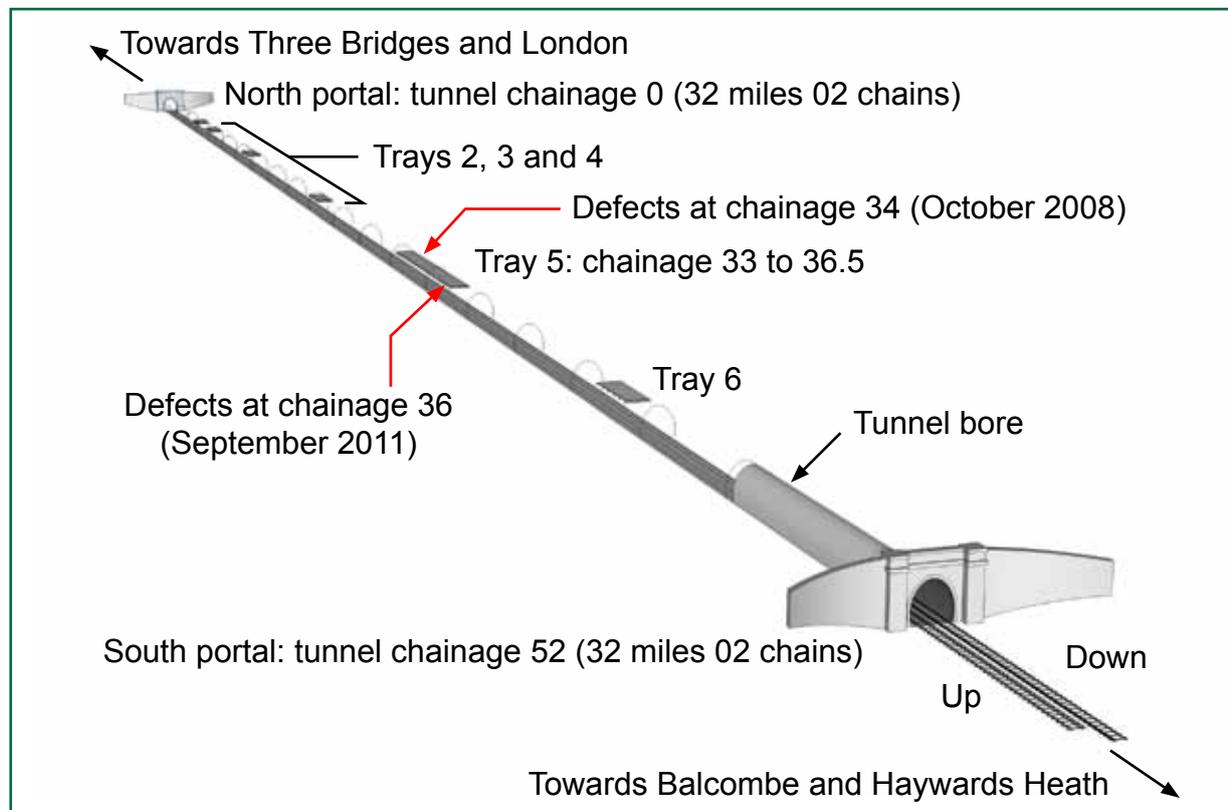
- 29 Four of the five trays (2, 3, 4 and 6) are 20 metres long, each supported by six transverse beams. Tray 5 is similar, but before being shortened following the incident, was 72 metres long and supported by 19 transverse beams, covering the area beneath shaft 4 (figure 5). The beams supporting tray 5 are numbered from 1 (at the north end) to 19.

Figure 5: Diagram of Balcombe tunnel showing location of water catchment trays and defects

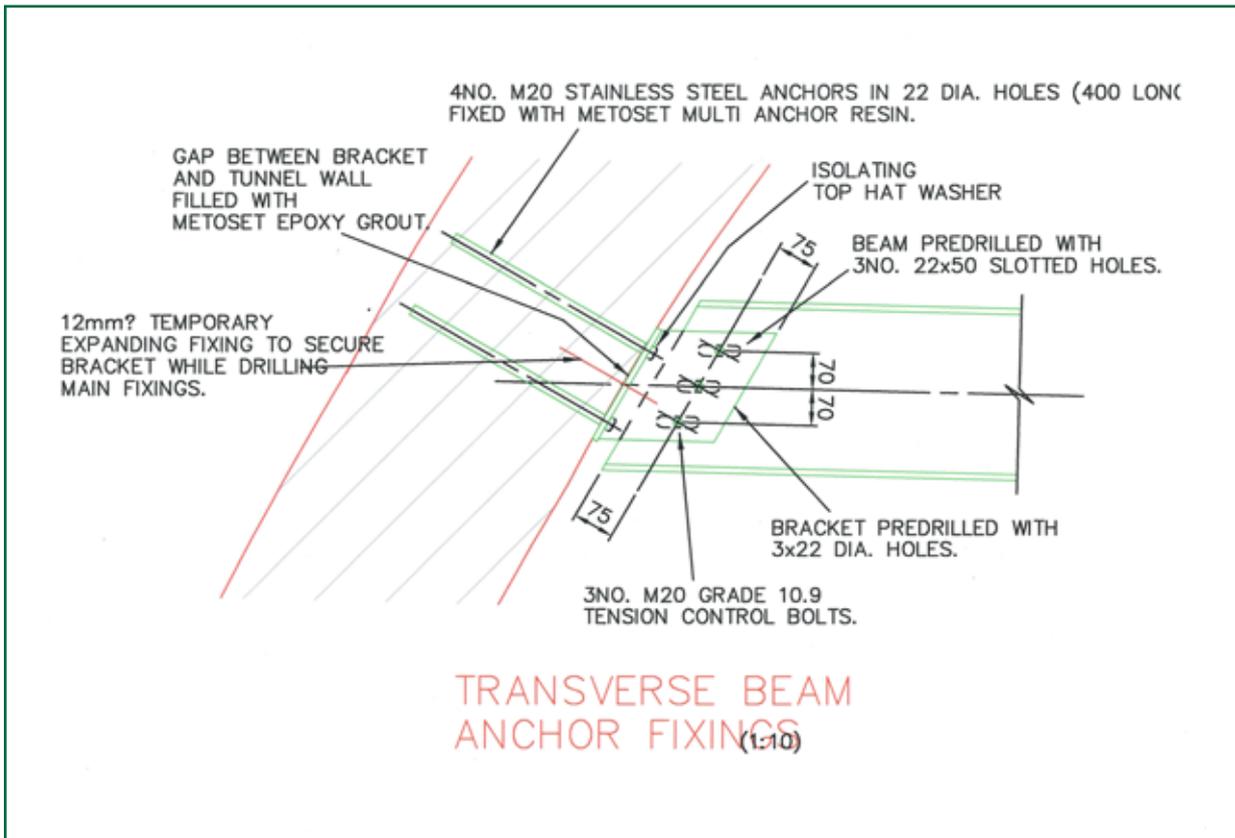
- 30 Atkins' outline design showed the ends of the transverse beams being inserted into holes cut in the tunnel lining and being directly supported by the brickwork. Scott Wilson's design did not adopt this arrangement, but instead the beams were connected to brackets which were attached to the tunnel lining by four 20 mm diameter threaded stainless steel rods (studs), two each side of the beam end. The studs were anchored into 22 mm diameter holes drilled into the tunnel brickwork at an angle of approximately 30° to the horizontal (figures 6 and 7) with a proprietary resin (Metoset multi-anchor resin is specified on Scott Wilson drawings). Once the bracket was in position, a washer and two nuts were added to each stud to secure it (figure 8).

Figure 6: Scott Wilson's design drawing showing transverse beam end fixing

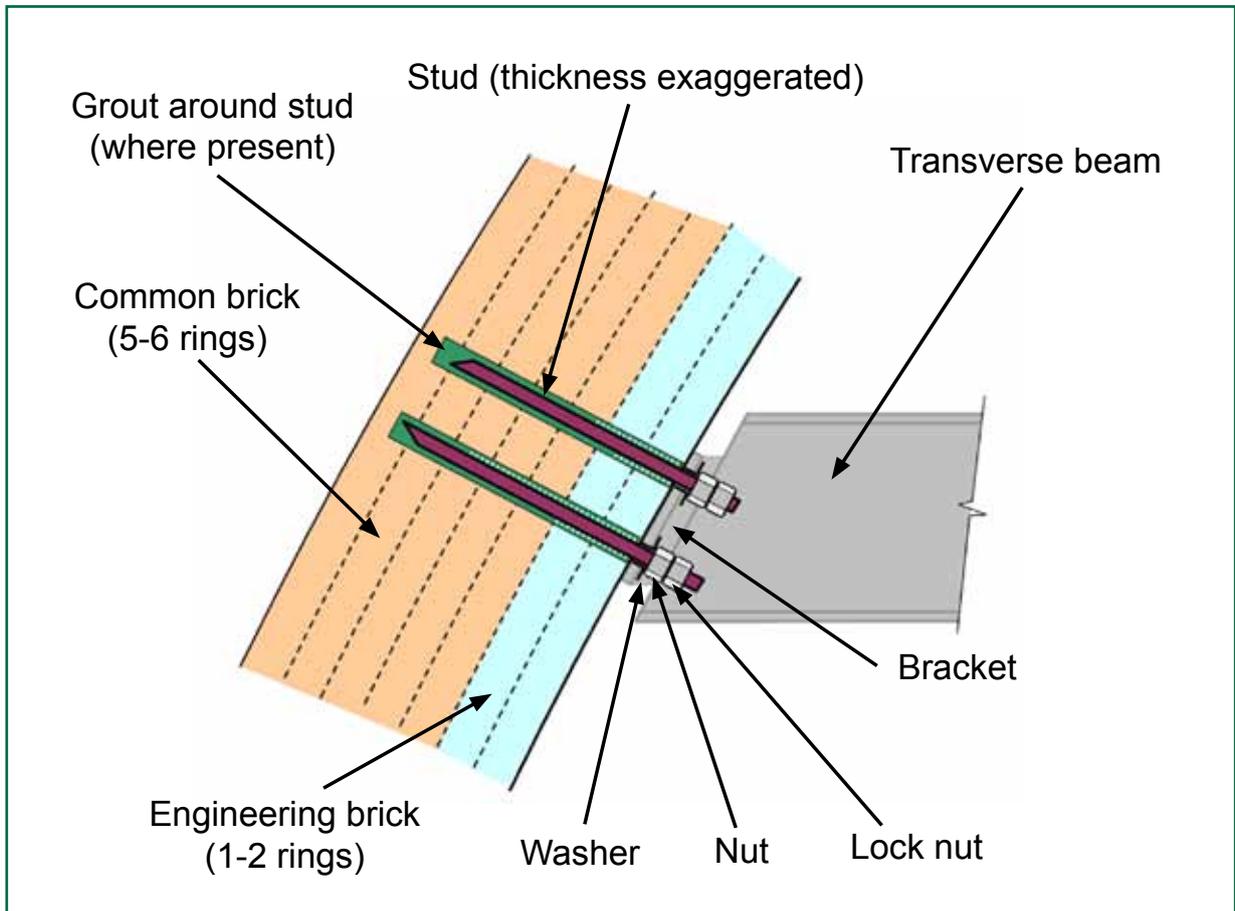
Figure 7: Simplified diagram of transverse beam end fixing

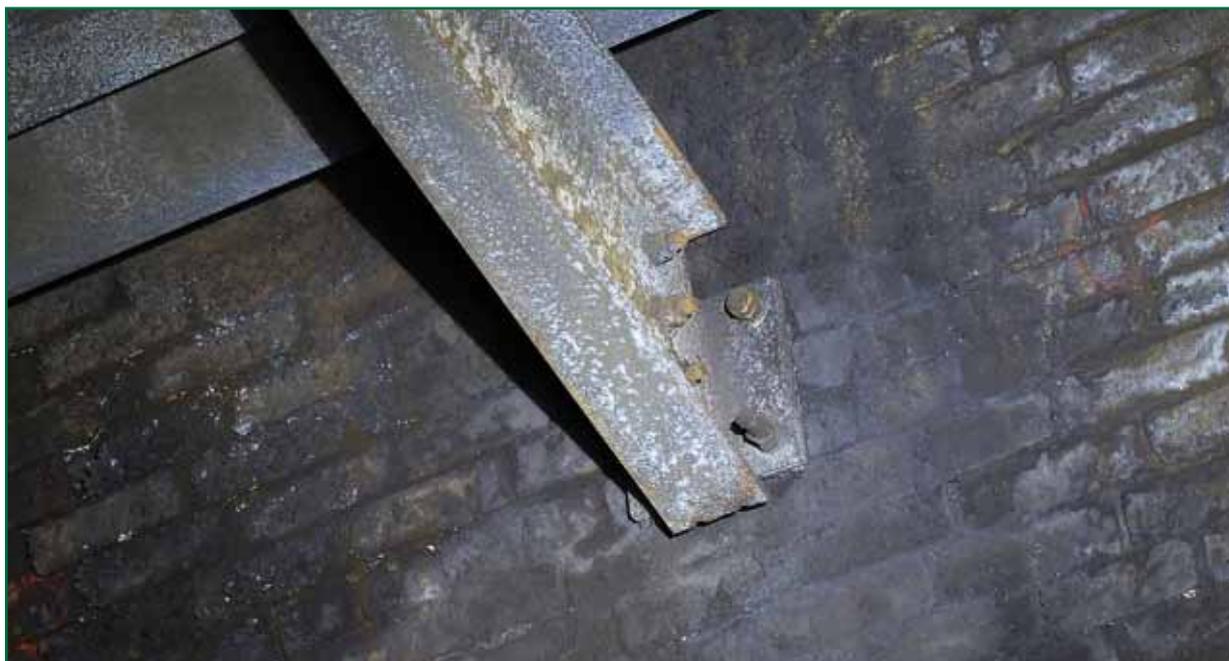
Figure 8: Transverse beam (as designed) supported by two studs on each side of the beam end
