Rail Accident Investigation Branch

# Rail Accident Report

## **Collision of a road-rail vehicle with a buffer stop at Bradford Interchange station 25 March 2012**

Report 09/2013  
July 2013

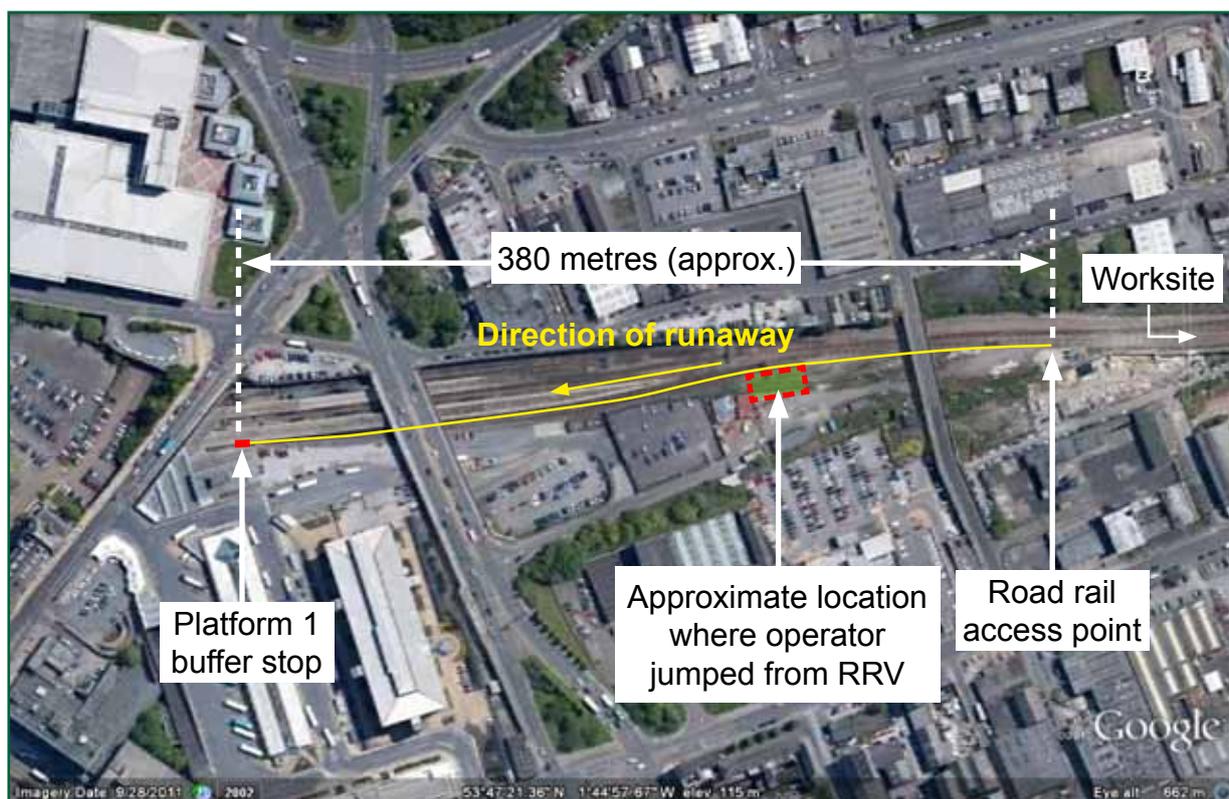
- 24 The dumper operator arrived at the site compound at around 22:00 hrs on Saturday 24 March. He started the dumper, moved it closer to the road-rail access point (RRAP) (figure 4), and checked the operation of the rail axles. This check was one of the functional checks prescribed by Quattro that an operator should undertake at the beginning of a work shift. While doing this he encountered a problem with raising and lowering the rail axles.

Figure 4: Location of accident at Bradford Interchange station

- 36 The operator remained on the machine for a distance of approximately 150 metres before jumping from it. This was before the dumper had reached the ramp at the end of platform 1 (figure 4). He landed on the ballast between the line on which the dumper was travelling and an adjacent line. The estimated speed when the operator jumped from the dumper was 18 mph (29 km/h) (paragraph 74).

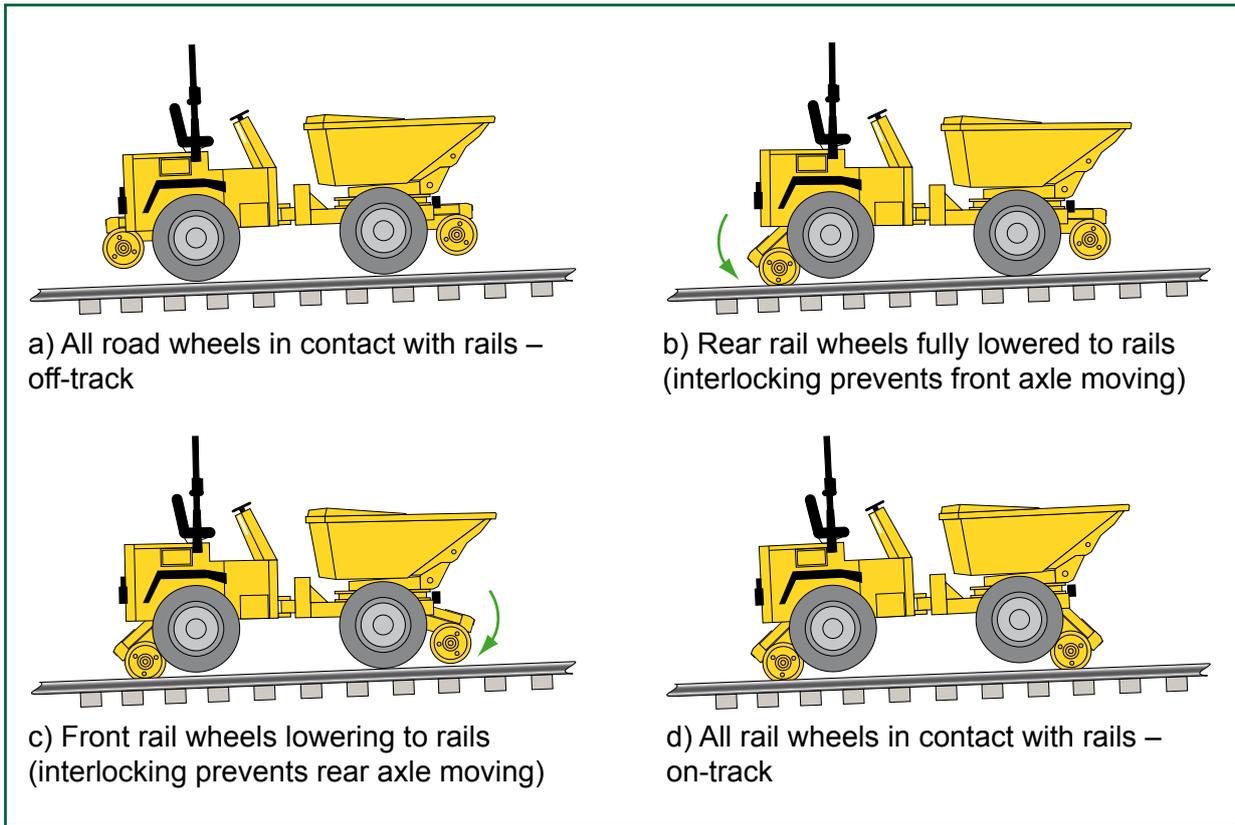
- 56 The dumpers' rail axle interlocking circuit forced the axles to move in a set sequence. When on-tracking (lowering the rail wheels into contact with the rails) the front rail axle was prevented from moving until the rear rail axle was detected to be fully lowered (figure 5). The rear end then became the holding end and the front rail axle could be lowered. When off-tracking, the front rail axle had to be detected as fully raised, before the rear axle could be raised (figure 6).

Figure 5: Rail axle movement sequence when on-tracking

- 86 When on-tracking, the correct sequence for deploying the rail axles was to fully lower the rear rail axle first followed by the front (figure 5). When off-tracking, the interlocking was designed to prevent the operator from raising the rear axle until the front rail axle had been fully raised (figure 6). This ensured that the rear road wheel tyres were in full contact with the rear rail wheels and therefore fully braked.

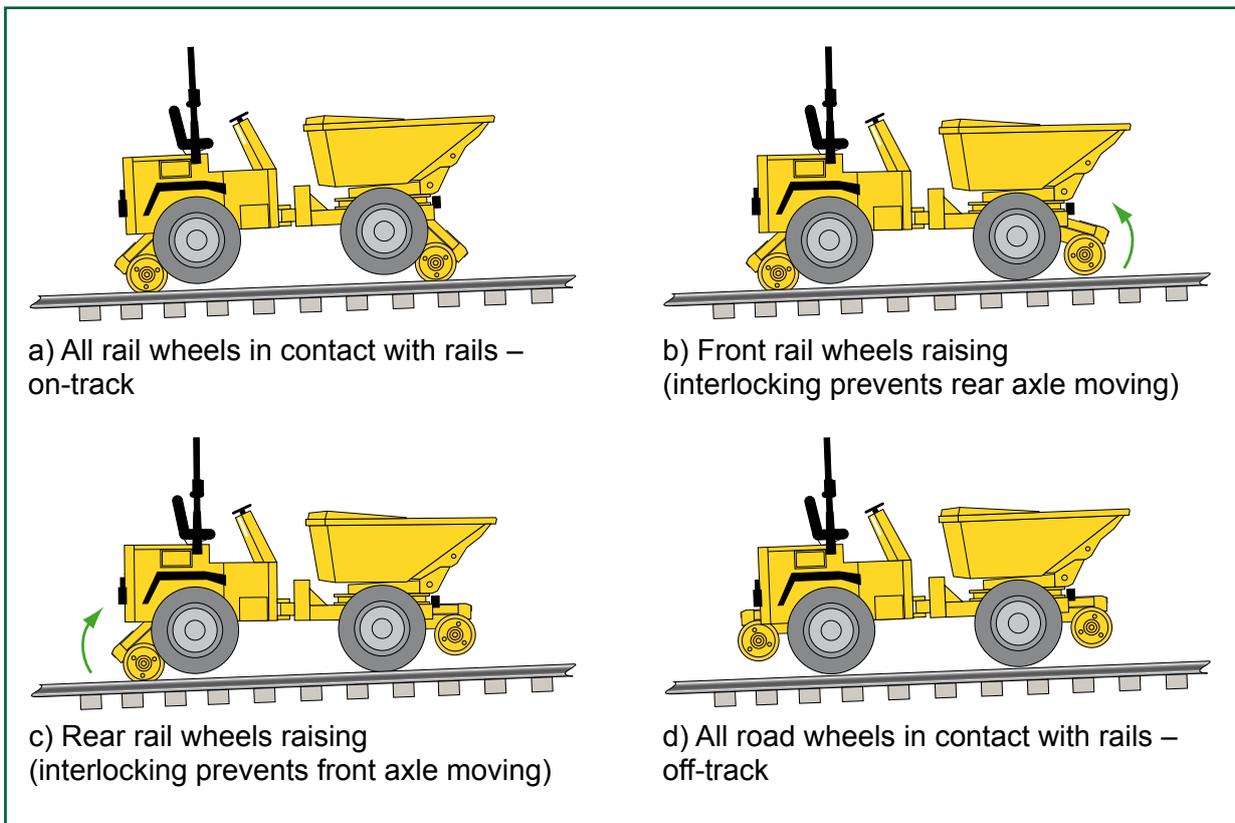
Figure 6: Rail axle movement sequence when off-tracking

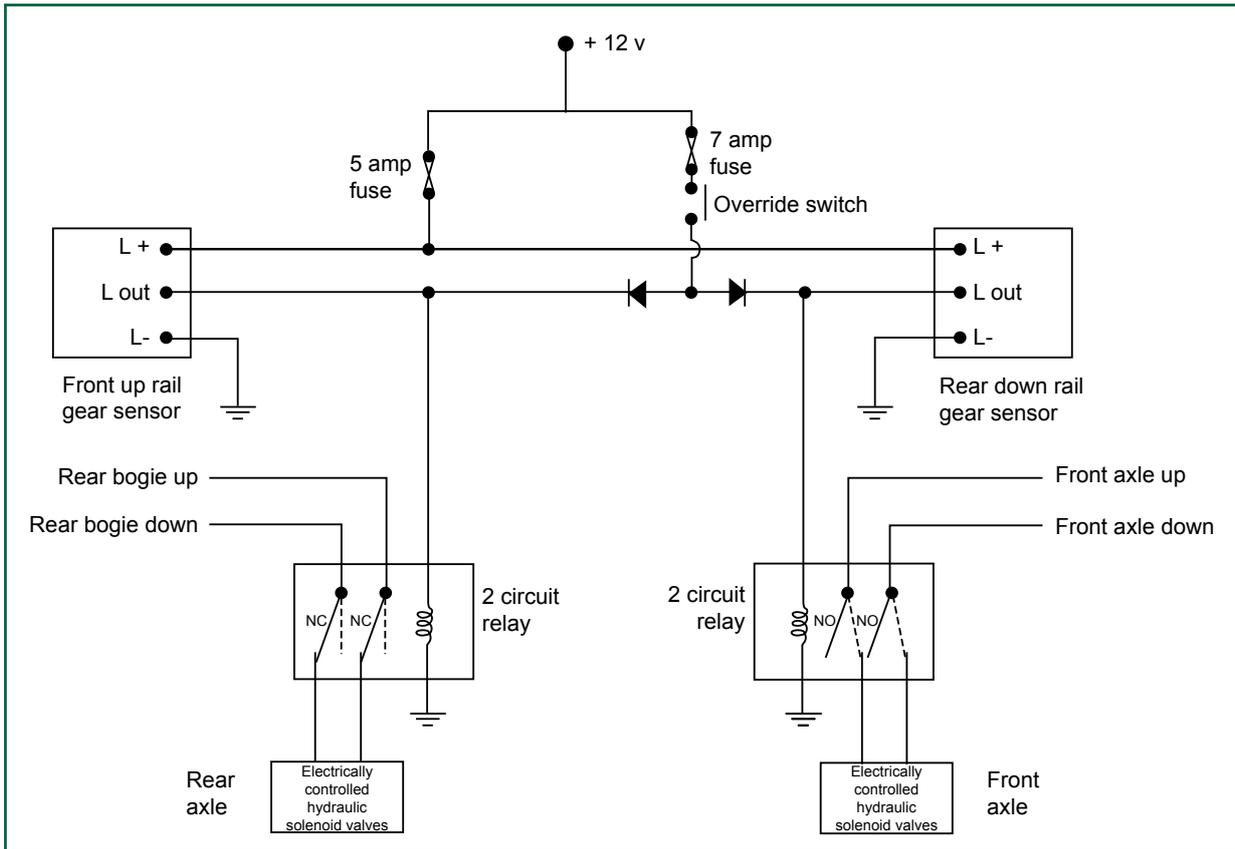
- h. **Electrical circuit diagram.** Quattro provided the RAIB with a hand-drawn circuit diagram (reproduced at figure 11). Although unreferenced and undated, Quattro confirmed that this was the interlocking circuit diagram for the dumpers.

- 66 An examination of the dumper's interlocking electrical circuit found that there was a wire connected between terminals of the two electrical relays controlling the movement of the front and rear rail axles (figure 9). This wire was not shown on the electrical circuit diagram (paragraph 61h and figures 11 and 12).

- 108 The hand-drawn circuit diagram (paragraph 61h) did not reflect the circuits fitted on either dumper 216 or 217 because some electrical components were not shown and others were shown incorrectly (figure 11). The RAIB has produced circuit diagrams representing the actual wiring on each dumper (figures 12 and 13).

Figure 11: Axle interlocking circuit diagram for dumpers 216 and 217, as designed (information from hand-drawn diagram supplied by Quattro)

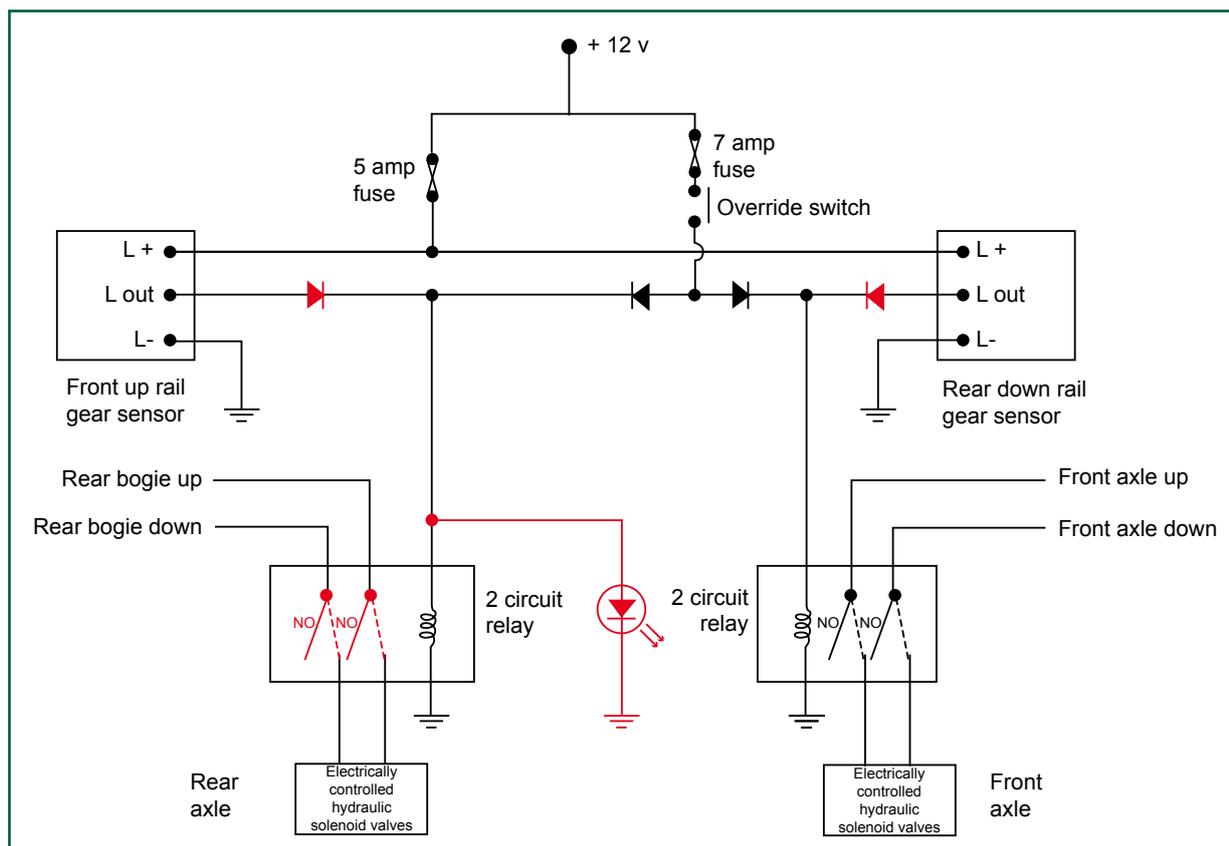
Figure 13: Actual axle interlocking circuit diagram for dumper 217

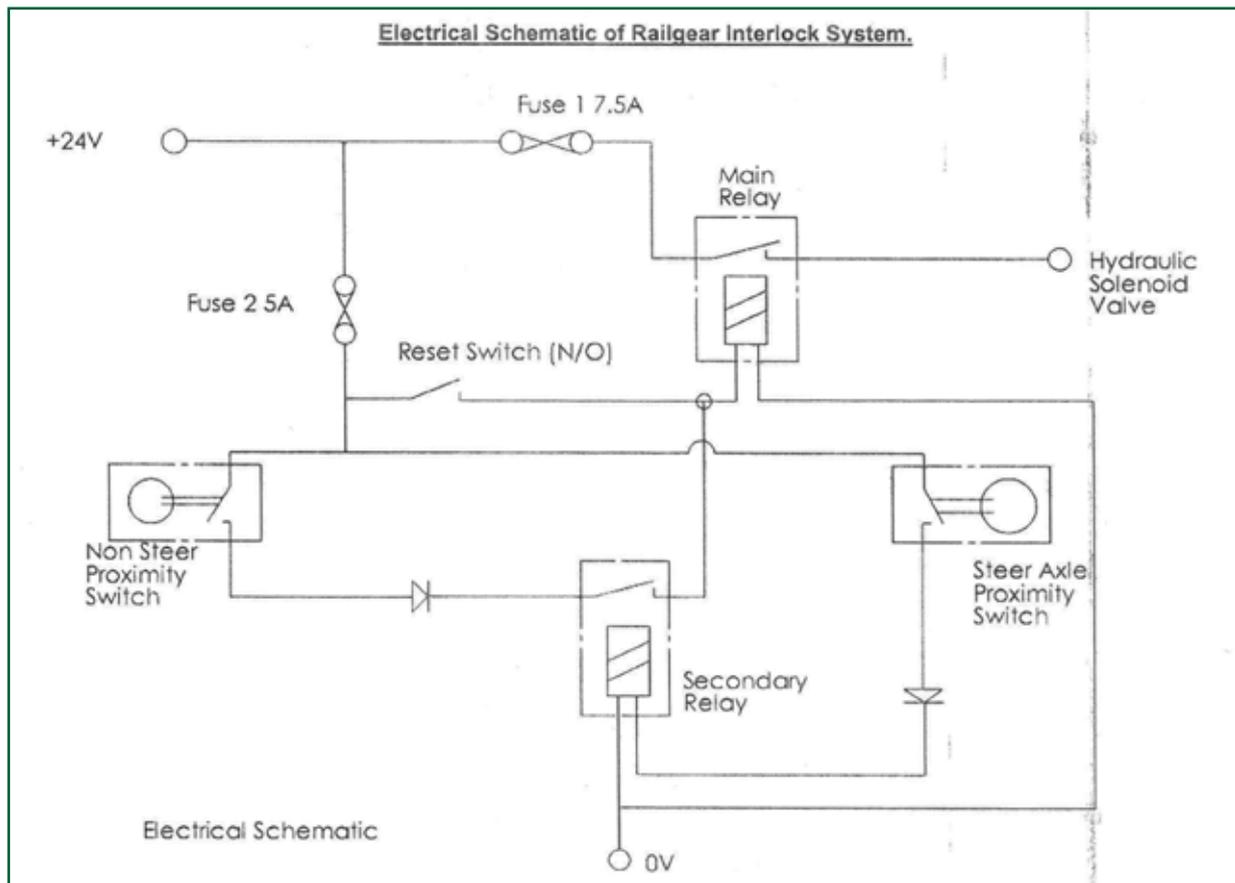
111 This form had a reference to the interlocking installation and test procedure document (paragraph 61d) which included a list of the RRVs to which it applied. This list did not include the dumpers and there was no other document specifically relating to the dumpers. The document contained an interlocking circuit diagram which did not represent those fitted to either dumper (figure 15), but was for other Quattro RRVs (paragraph 55). These discrepancies were not identified by the VAB. This is discussed further in the Observations section of this report (paragraph 150).

Figure 15: Interlocking circuit diagram referenced from modification declaration and submitted to the VAB by Quattro
