# Rail Accident Report

## Passenger accident at Brentwood station 28 January 2011

Report 19/2011  
November 2011

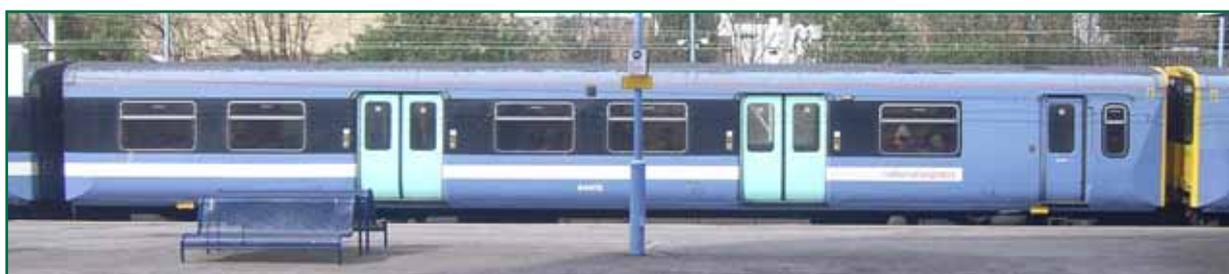
Figure 6: Class 315 EMU with doors at 1/3 and 2/3 positions.

- 18 Each passenger doorway is approximately 1.45 metres wide and is fitted with two sliding doors. Internal and external push-buttons are provided at each doorway to allow passengers to operate the doors once the train driver has released them using the controls in the driving cab. Audible alarms are provided at each doorway position to warn passengers when the doors are about to close. Warning signs above each doorway state that passengers should not attempt to leave the train when the doors are closing. An orange light illuminates on the outside of each carriage when the passenger doors are released.

- 20 A fixed step is provided at each passenger doorway. The step is approximately 1.57 metres long and extends 40 mm out from the carriage bodyside.
- 21 The RAIB has found no evidence that the condition of the train, including the maintenance and operation of the door system and the condition of the passenger door step at the passenger door used by the passenger who fell, contributed to the accident.

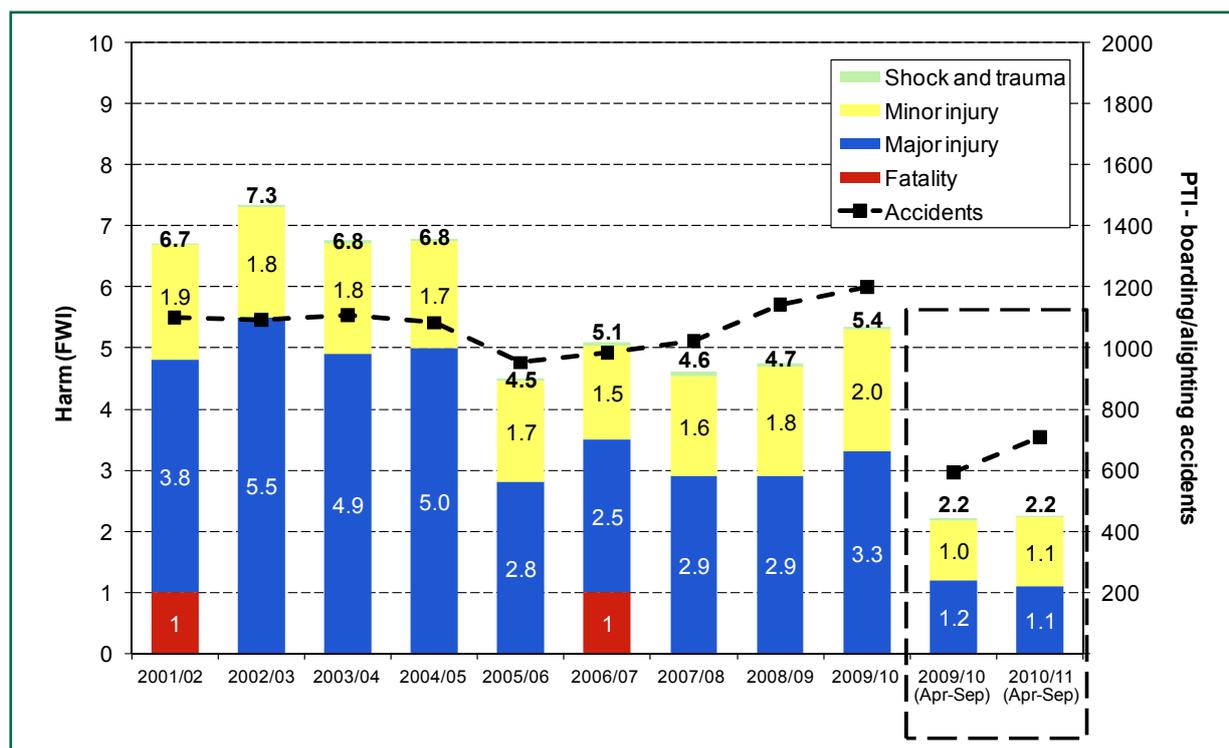
- 121 In June 2011, the RSSB published a special topic report on passenger risk at the platform-train interface<sup>25</sup>. The report identified that there were two passenger fatalities attributed to getting on and off trains on the national rail network between 2001 and 2010, with the last one recorded in 2007. During this same period the figure for *fatalities and weighted injuries* (FWI) arising from accidents at the platform-train interface had varied between its highest value of 7.3 FWI/year in 2002/2003 to its lowest value of 4.5 FWI/year in 2005/2006. In 2009/2010 the value was 5.4 FWI/year (figure 16).

Figure 16: RSSB data on harm to passengers while boarding or alighting trains at the platform-train interface (PTI). The hatched box contains data from two half-financial years to allow comparison with data up to September 2010.
