Rail Accident Report

Runaway and derailment of wagons at Ashburys 4 May 2010

Runaway and derailment of wagons at Ashburys, 4 May 2010

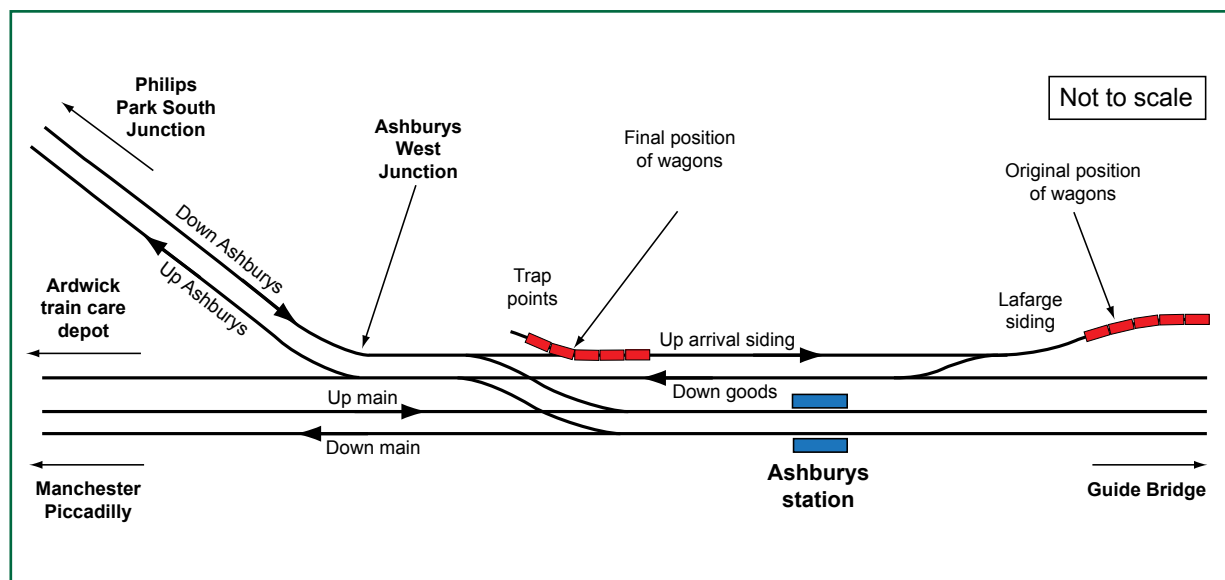
Figure 2: Plan of the area

- 14 The derailment occurred at Ashburys West Junction. The wagons ran down a 1:173 gradient towards Manchester on the *up* arrival siding. This siding joins the Down Ashburys line at Ashburys West Junction. The railway at this location consists of four tracks; the up arrival siding, *down* goods, up main and down main (figure 2).
- 15 The exit from the up arrival siding onto the Down Ashburys line was protected by a set of trap points which was set to derail any runaway vehicles. The first two wagons in the set of five were derailed at these trap points.

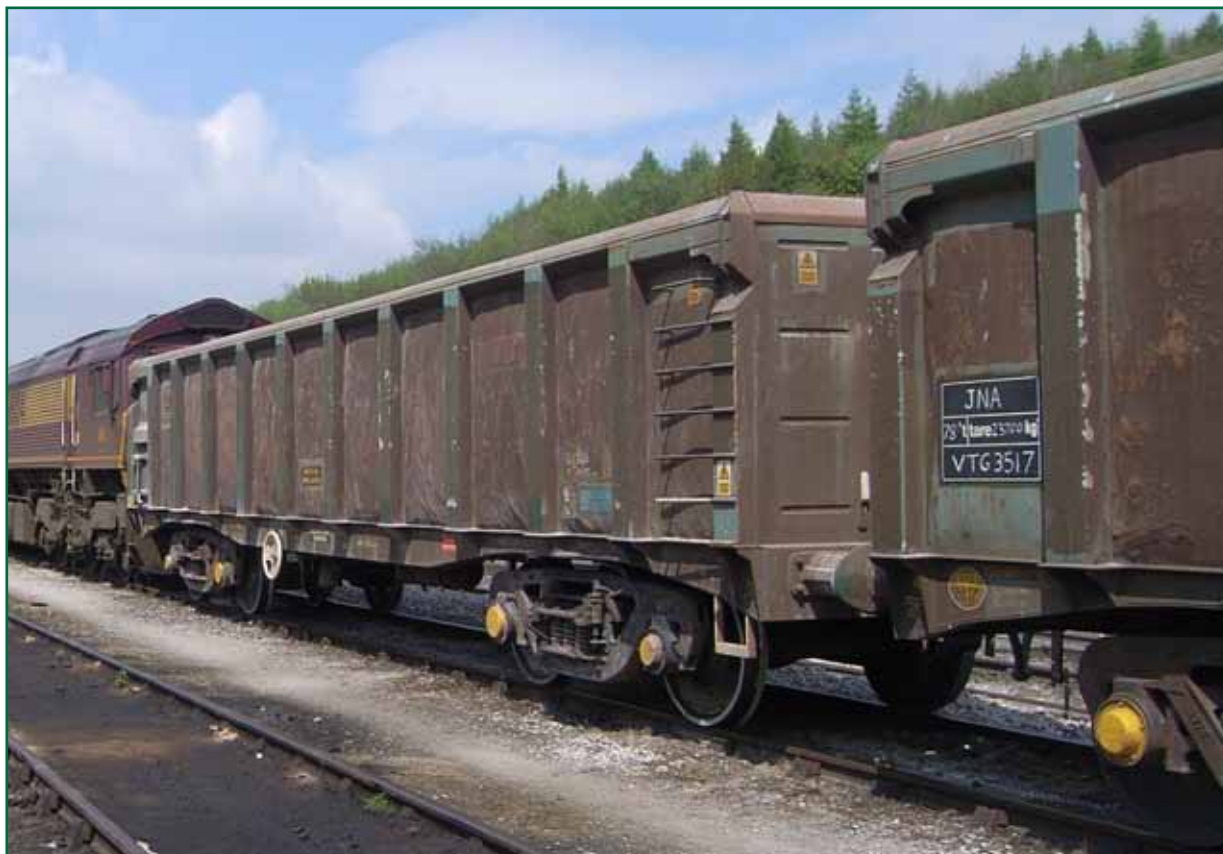
Figure 3: Typical JNA wagon

- 16 The five wagons involved were 102 tonne *gross laden weight* open box wagons of type JNA (figure 3). They were designed to carry ballast and spoil from track renewal projects and latterly were redeployed to carry construction aggregate. The wagons are listed in table 1.
