Rail Accident Investigation Branch

Rail Accident Report

Passenger train struck by object at Washwood Heath 6 March 2010

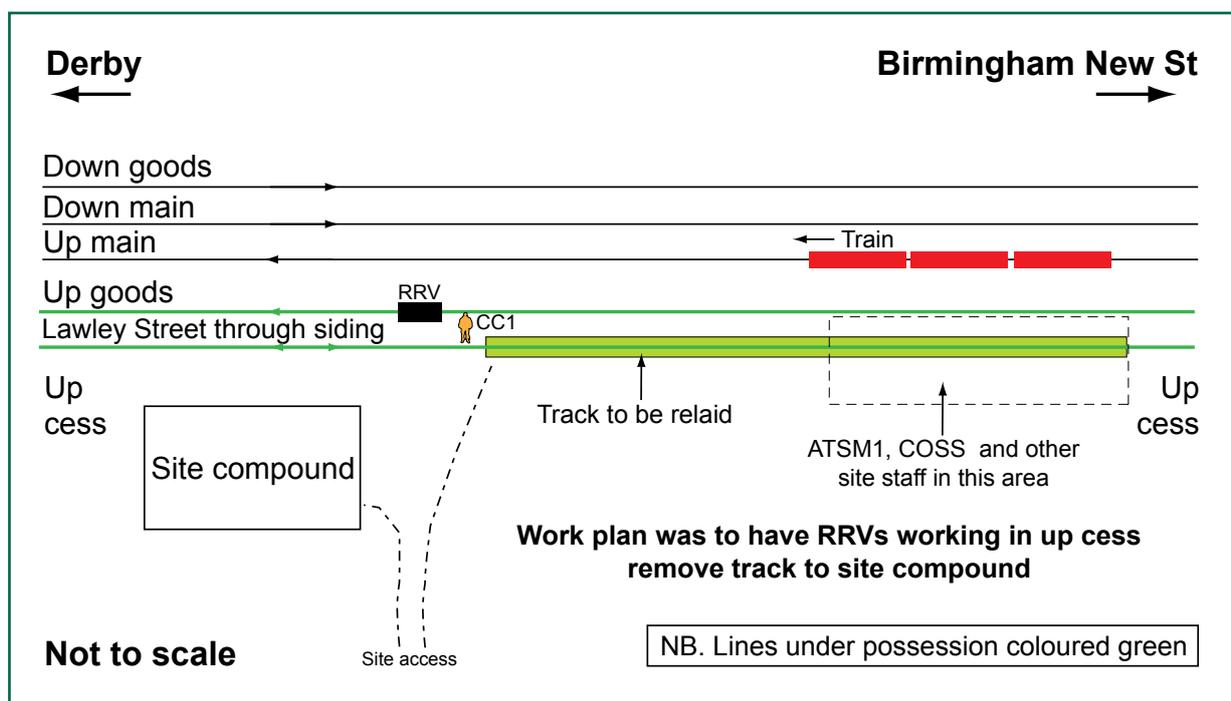
Figure 2: Plan of the site

- 19 The accident occurred close to Washwood Heath no.1 signal box, which was not manned at the time. The railway at this location consists of five tracks (figure 2):
 - Lawley Street through siding (which was being relaid at the time);
 - up goods;
 - up main;
 - *down* main; and
 - down goods.

The train was passing on the up main at the time of the accident. The Lawley Street through siding and the up goods were under *possession* for track relaying work. All the other lines were open to traffic at normal *line speed*. The line speed on the up main was 75 mph (120 km/h), though a 40 mph (64 km/h) speed restriction ended 973 m (1065 yds) before the site of the accident.

- 40 After the track that was being relaid had been removed, one of the RRVs and its crane controller, CC1, moved away from the main site of the track renewal and travelled to the site access area (figure 2). Working under the control of CC1, the RRV then started to pick up some rails that were required later in the shift and to move them closer to where they were to be installed. During one of these lifts the rail swung out and was struck by the passing train.
