Rail Accident Investigation Branch

Rail Accident Report

Derailment at St Peter's Square, Manchester 29 June 2008

Report 25/2009
February 2011

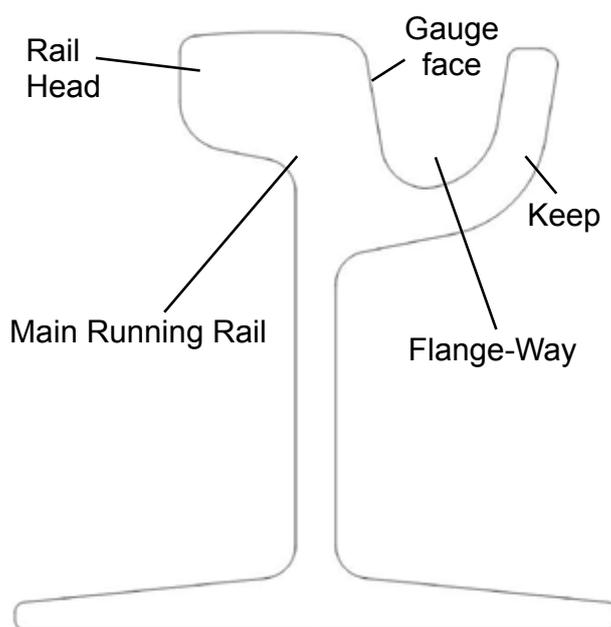
Figure 3: Ri 59 grooved rail cross section

- 26 In the *city zone* the track construction consists of rail embedded in a polymer block with no specific gauge retention other than that provided by the polymer and the road surface. The track consists of Ri 59 *grooved rail*; the cross section of which is shown in Figure 3. It consists of a main running rail and a keep, between which is the *flange-way*.

- 27 The Manchester system design was for tram wheels to be guided by the rail gauge face only; the wheels were not intended to contact the keep at any time as it was only to act as a barrier between the flange-way and the road. Other tram system designs have their wheels guided by the keep (or 'check') and gauge face. Both methods of wheel guidance require planned inspection, maintenance and worn rail repair or replacement. In Manchester, contrary to the design, uncorrected sidewear led to tram wheels being guided by both gauge face and keep.
