Rail Accident Investigation Branch

Rail Accident Report

Collision near New Southgate 27 July 2008

Report 17/2009
June 2009

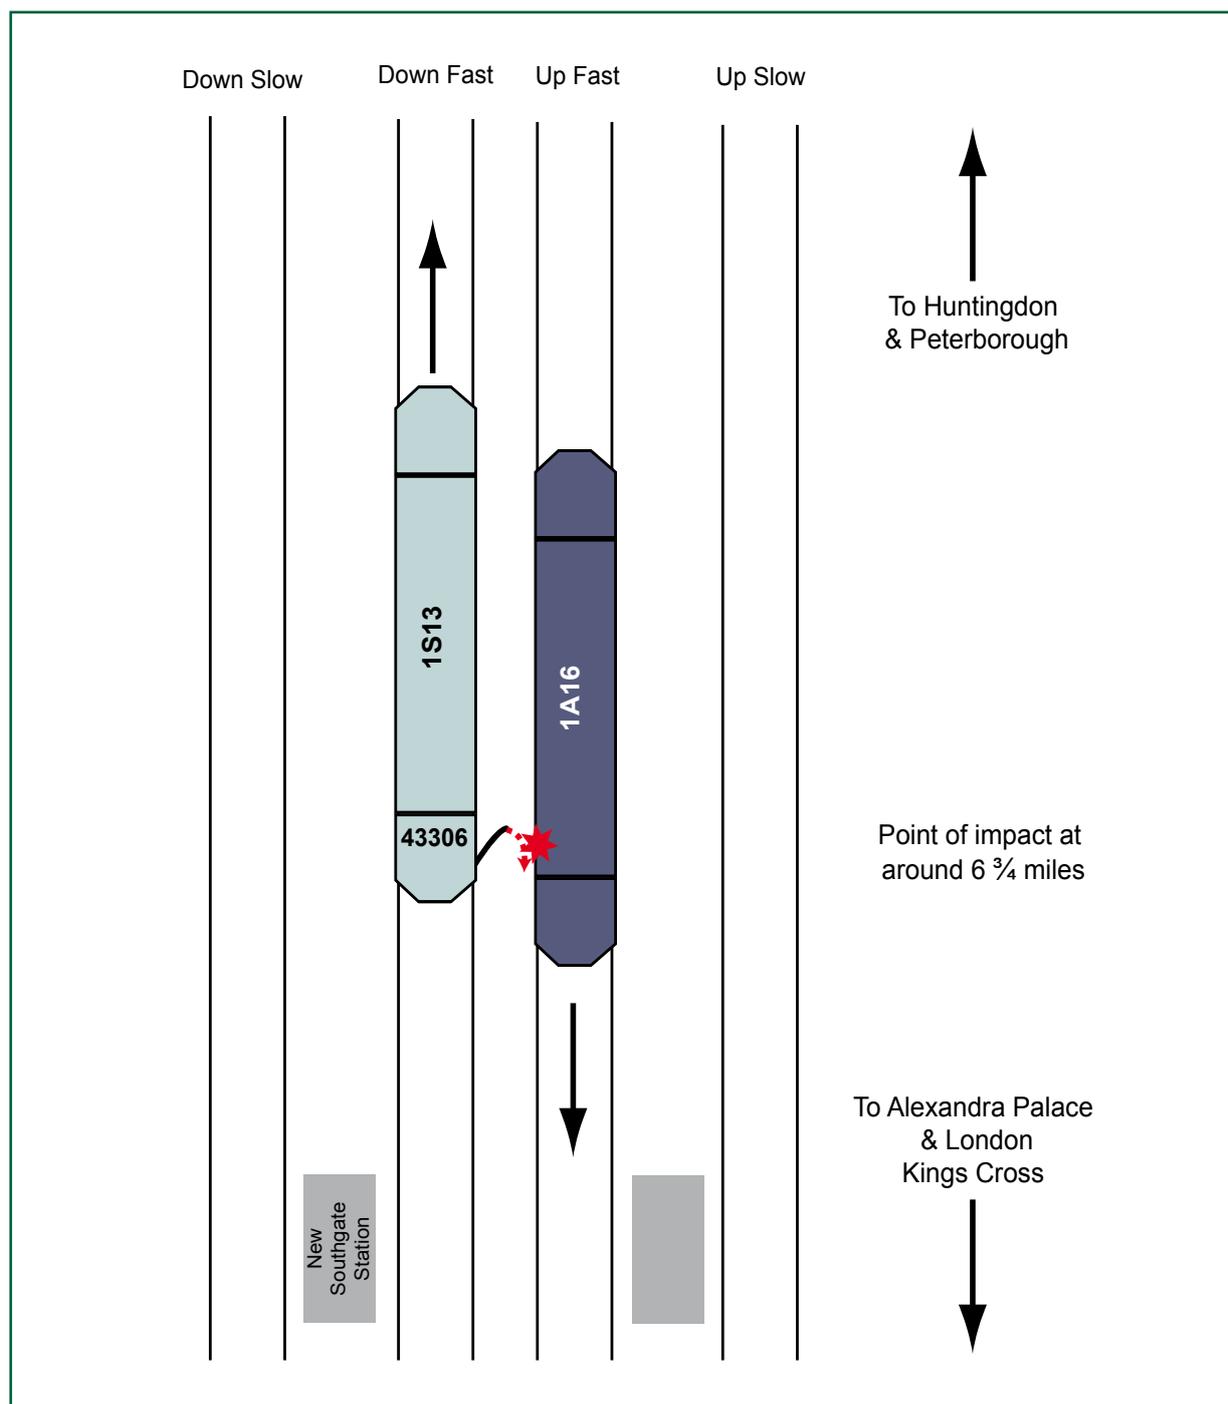
Figure 2: Detailed location of incident (not to scale)

- 12 The incident occurred on the East Coast Main Line. At this location (Figure 2), the four-track line is broadly straight. The up and down fast lines, on which the trains were travelling, are adjacent to each other and both have line speed limits of 100 mph (160 km/h).

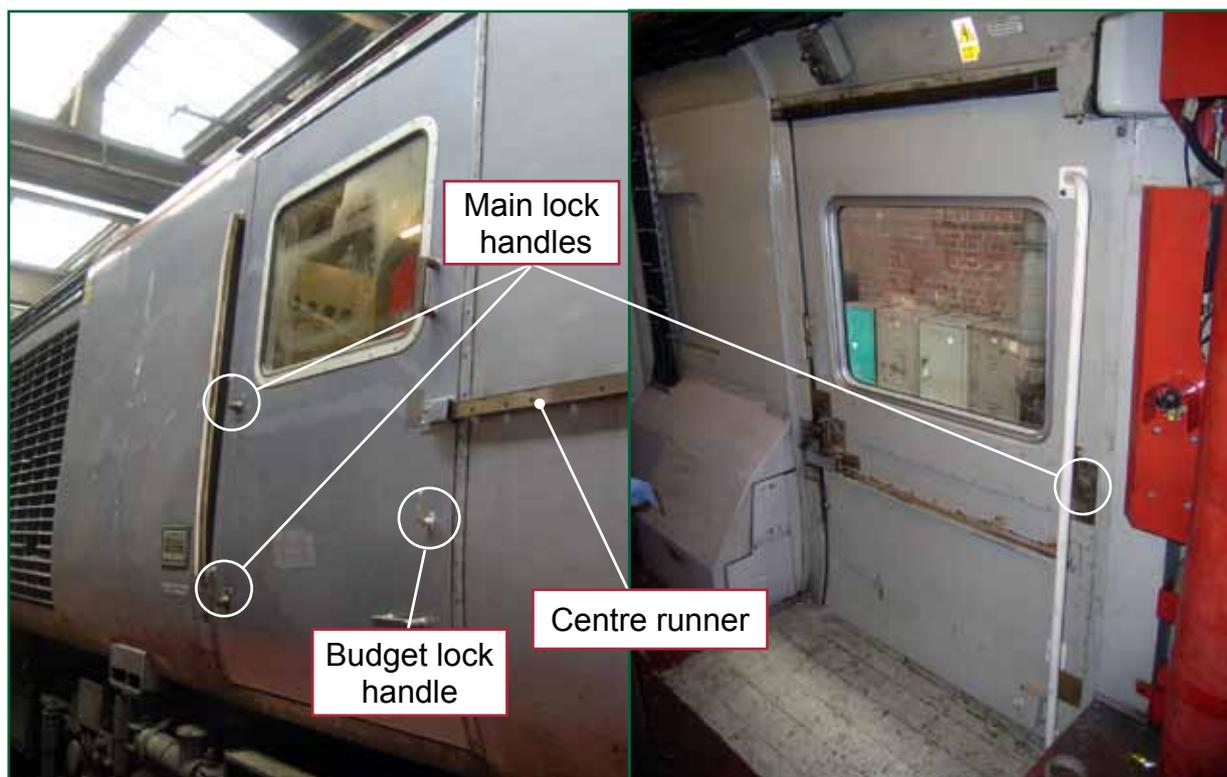
Figure 4: High Speed Train luggage van right-hand door (outside/inside)

- 15 Both the northbound and southbound trains were formed of class 43 High Speed Trains (HSTs), designed to run at up to 125 mph (200 km/h). These trains comprised a power car at each end and nine coaches. The power cars have a single sliding-plug door on each side, giving access to the luggage compartment (Figure 4). The working of this type of door is described in paragraphs 33 to 37.

- 36 As well as the main lock, the door is fitted with a budget lock. This is a simple rotating lock tongue that engages with a single catch striker plate in the door frame. On National Express East Coast HST sets, the budget lock is operated from the outside with a handle (Figure 4) and from the inside with a key. This is unlike most other HST sets on which a key is used both inside and outside.

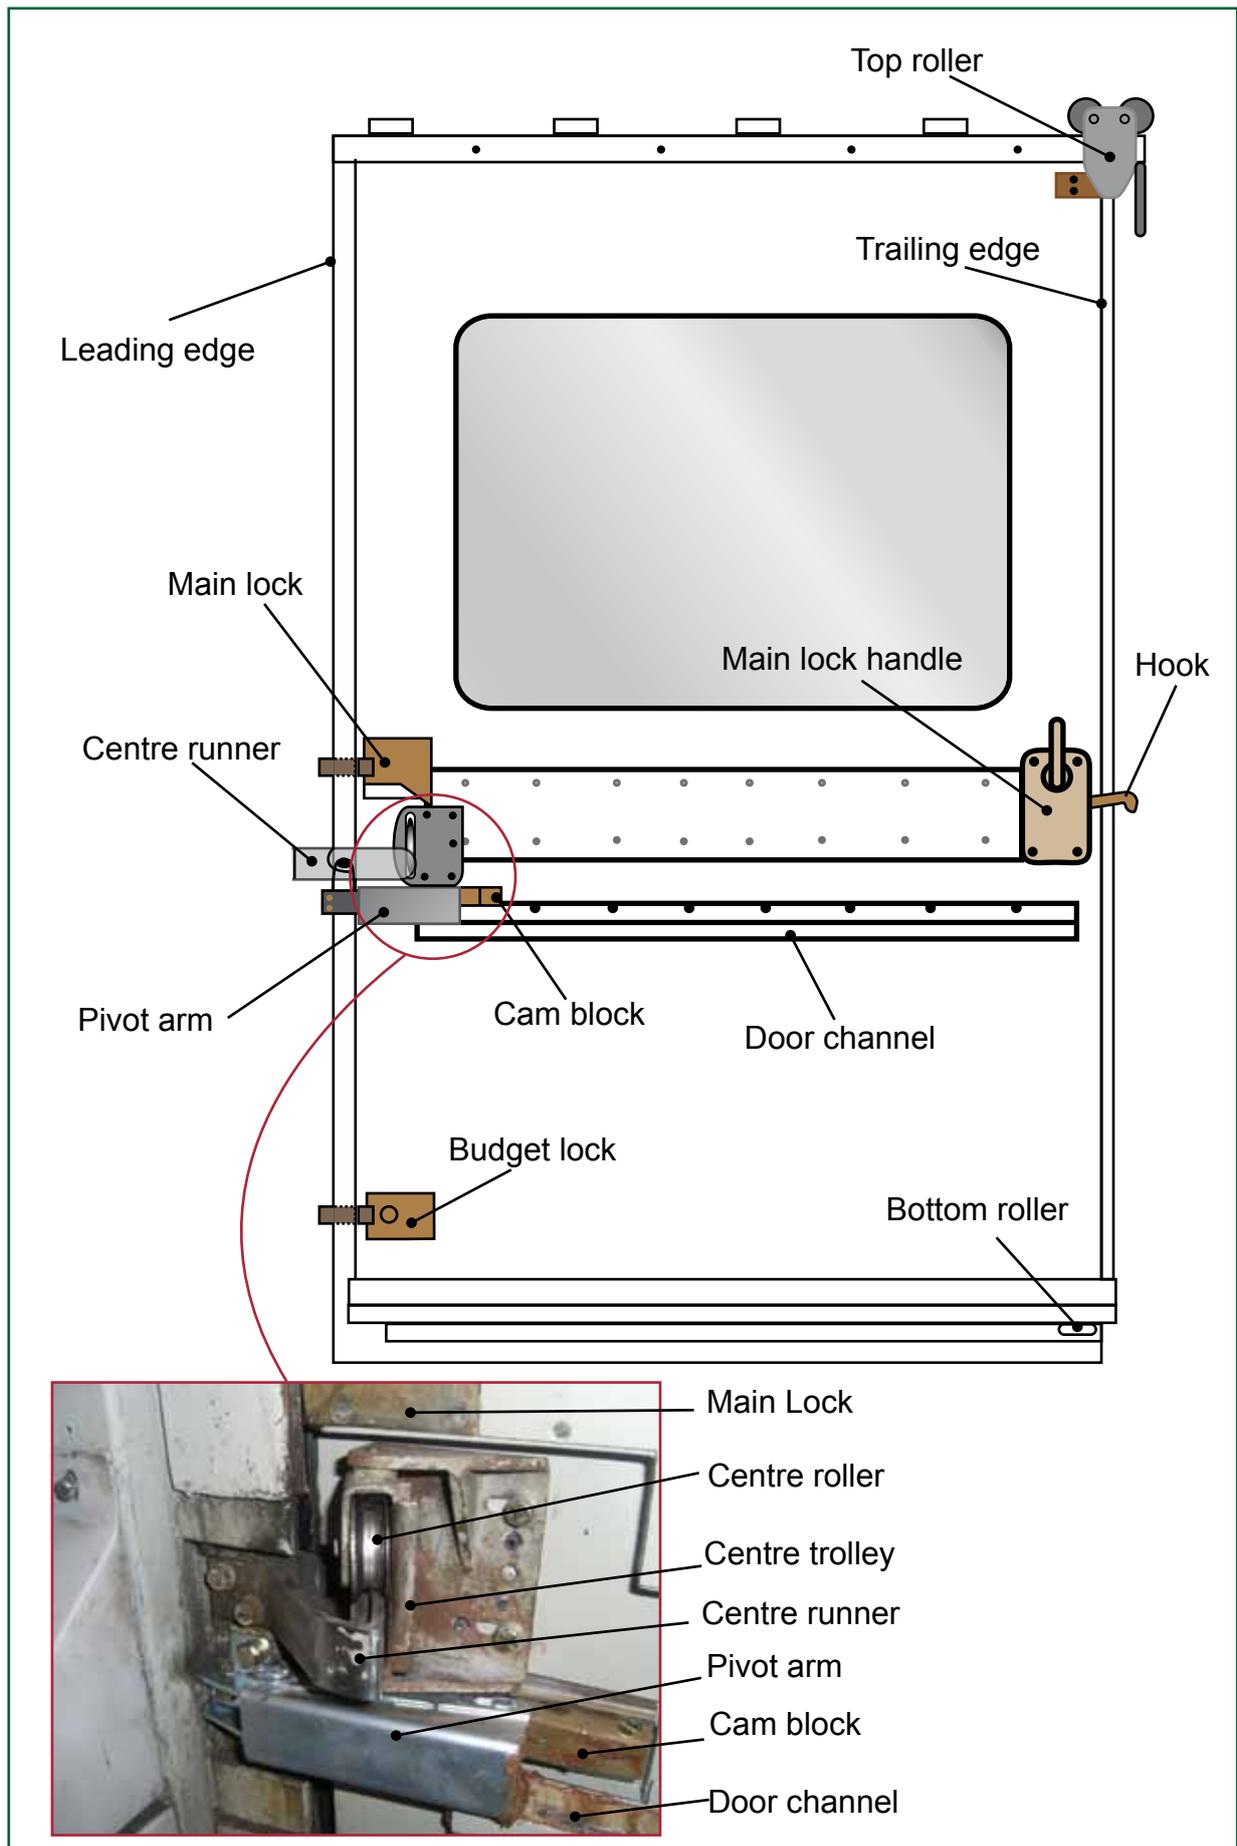
Figure 5: The relevant components of a High Speed Train luggage van door

- 34 When the door is being opened or closed its weight is taken by a top roller at the trailing end of the door and a centre roller at the leading end. There is also a bottom roller at the trailing end which provides guidance and retention but does not bear weight. The top and bottom rollers run in tracks on the vehicle body directly above and below the door opening. The centre roller runs on a track that guides the leading edge of the door along the outside of the vehicle body and into or out of the door opening, depending upon whether the door is being closed or opened. The centre pin holds the centre roller into a trolley attached to the door (Figures 4 and 5).
