Rail Accident Investigation Branch

# Rail Accident Report

**Fatal accident to a track worker east of Reading station**

**29 November 2007**

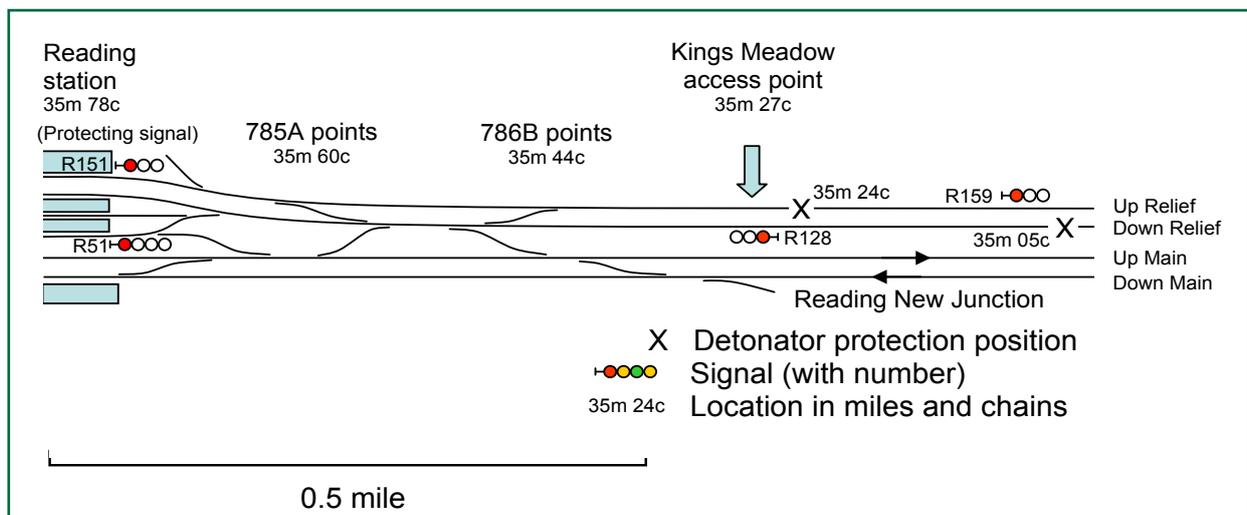
Figure 4: Schematic diagram of site prior to end of possession

- 20 Reading station is located 36 miles from London Paddington. The up direction is towards London. Signalling is by the *track circuit block* system with three and four-aspect colour light signals controlled from the signal box at Reading.
- 21 The accident occurred 60 metres (66 yards) west of signal R159, and 1000 metres (1090 yards) east of Reading station on a four-track section of the Great Western main line. In this area, the up and down relief lines are located to the north of, and separated by more than three metres from, the up and down main lines, with the up relief line on the northernmost side of the formation (Figure 4). None of the lines are electrified.

- 26 Network Rail's track layout plans show four access points on the north side of the railway within the first mile east of Reading station. Of these, Kings Meadow pedestrian access at 35 miles 27 chains, is closest to the detonator protection position for the up relief line (Figure 4).

- 37 The Reading BRM accessed the track via the Kings Meadow access point and, after unlocking and passing through the railway boundary gate, carried his equipment up a flight of steps to track level. He then had to walk along the track to the locations where the detonator protection was required. The nearest detonator protection position to the access point was situated on the up relief line at 35 miles 24 chains, approximately 60 metres (66 yards) to the east and close to signal R128. The corresponding down relief detonator protection position was a further 382 metres (418 yards) to the east at 35 miles 05 chains (refer to Figure 4).

96 The detailed arrangements for the possession were listed in the WON, including the lines to be blocked, the start and finish times and the location where detonator protection was to be placed (ie 400 metres (440 yards) east of 786B points and signal R128 on the up and down relief lines respectively as indicated in Figure 4).
