Rail Accident Investigation Branch

# Rail Accident Report

## Collision with the gates at Lydney Town level crossing 15 August 2007

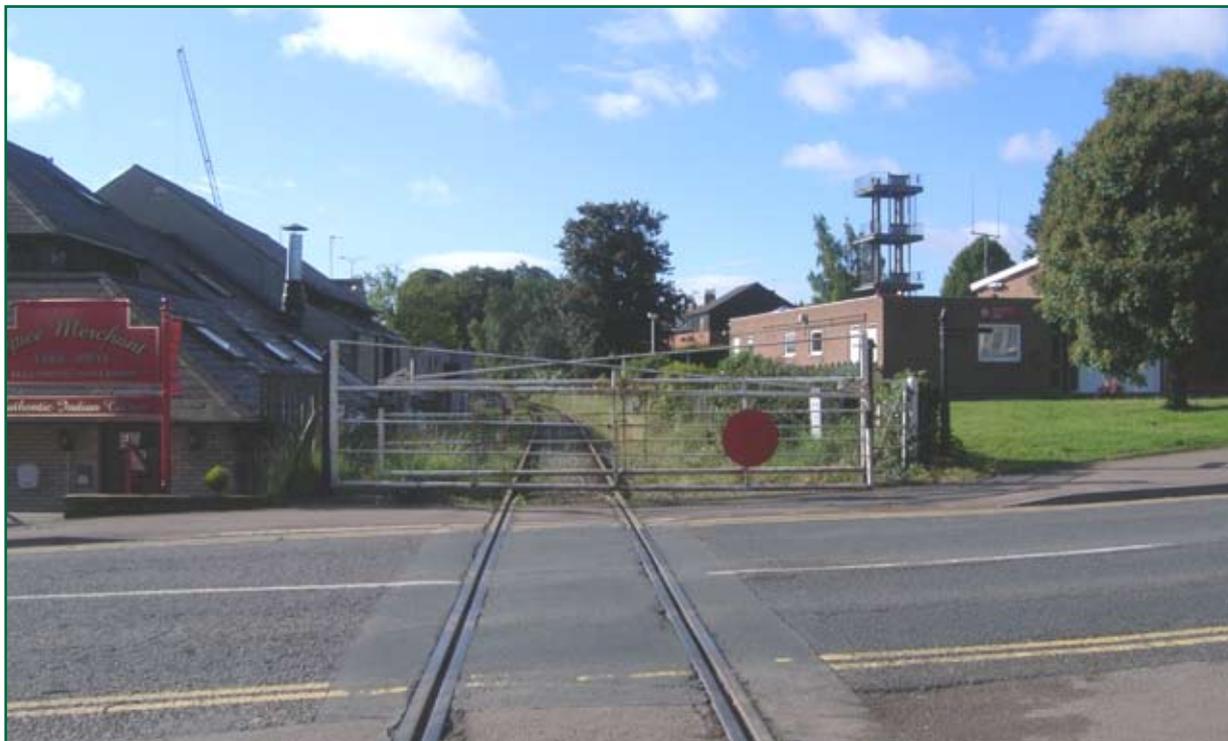
Figure 3: Lydney town crossing looking south

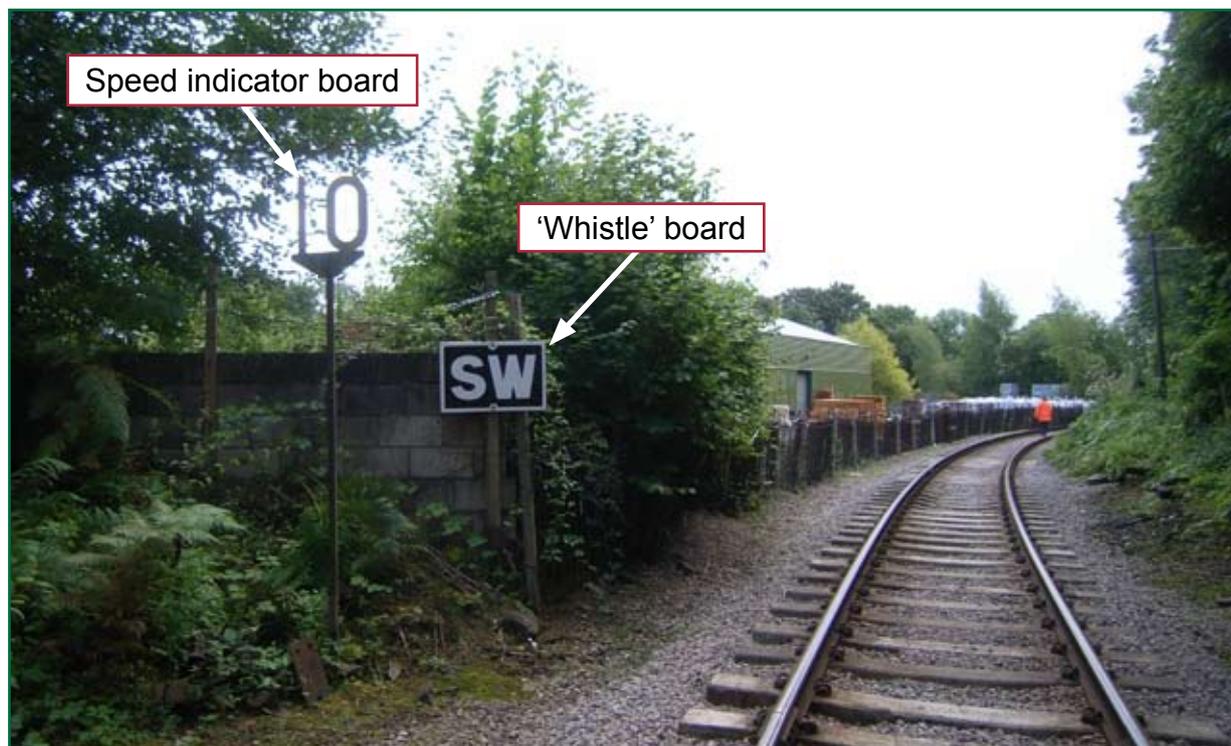
- Reduce speed to 10 mph (16 km/h) at a speed indicator board. This is located to the left of the line, as seen by a train driver, 183 metres (200 yards) from the crossing (Figure 7).

- Sound a warning at a 'Whistle' board (denoted by the letters 'SW') located close to the speed indicator board (Figure 7).
  - Look out for the crossing gates and any hand signal from the crossing keepers. The gates come into the driver's view when the train is 119 metres from the crossing.

Figure 7: Speed indicator board and 'Whistle' board

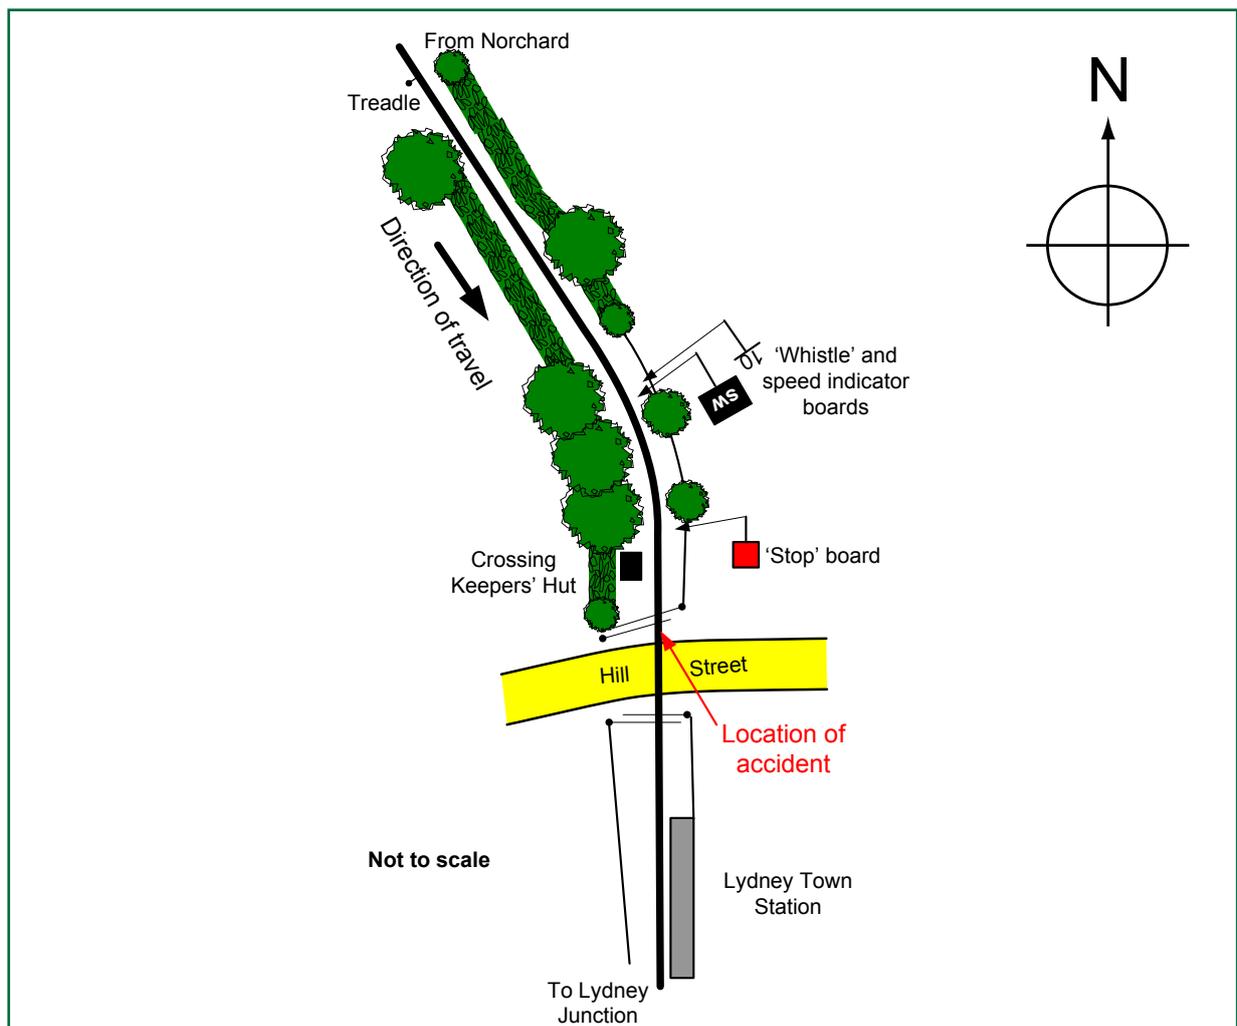
- 34 Vegetation to the left of the line obstructs the view of the stop board until the driver is some 40 metres from it, but for a train travelling at 10 mph on a dry rail this provides sufficient stopping distance.
- 35 Figure 9 shows schematically the position of the features in relation to the crossing gates.

Figure 9: Plan of approach to Lydney town crossing

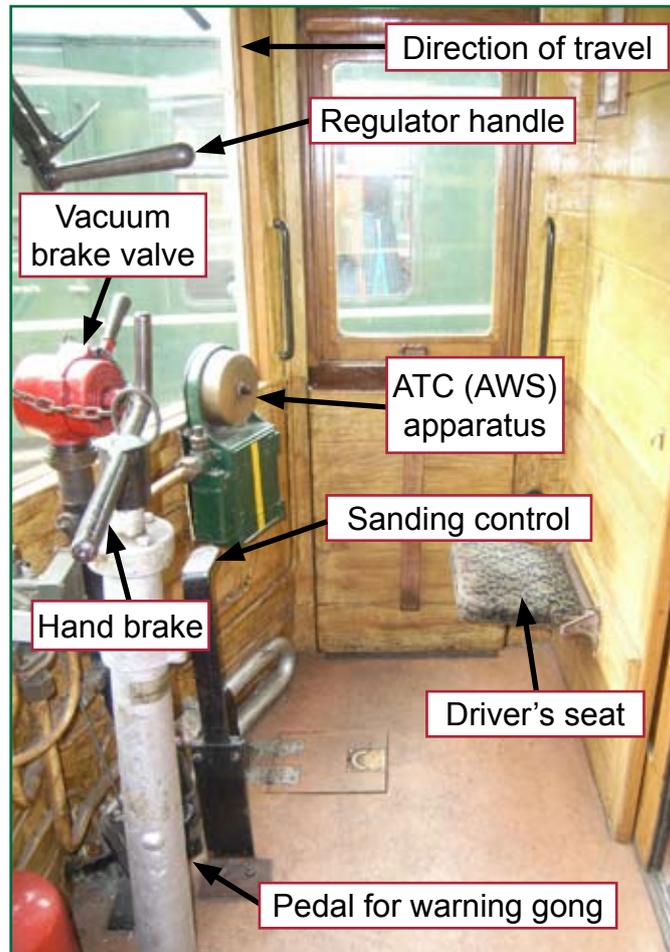
- 45 When the driver wishes the fireman to release the brakes by creating vacuum, he should give two rings on the electric bell between the autococh and locomotive to tell the fireman to release the brakes. The bell was not in working order on the day of the accident, so the engine whistle (operated by a wire from the cab of the autococh) was being used for communication instead.

Figure 13: Driver's position in Autococh. Bell and whistle controls are above front window, to left of picture

101 The autococh driving cab arrangement is shown in Figure 13. The driver is normally standing or seated towards the right hand side of the cab, looking forward. The views from the cab on the day of the accident were reported as being good with no observable windscreen contamination.
