Rail Accident Report

**Two trains in the same section at Aylesbury
27 August 2007**

Two trains in the same section at Aylesbury

27 August 2007

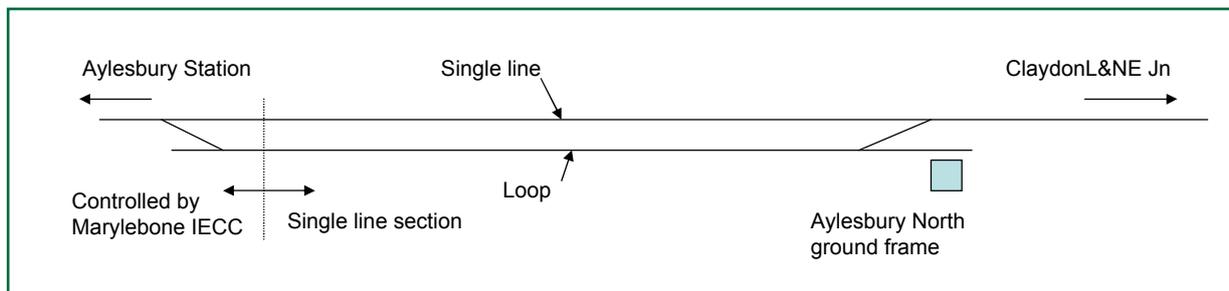
Figure 2: Schematic plan of the Aylesbury north loop

7 The train crew consisted of a driver and a shunter. The shunter obtained a *single line token* from the *token machine* at Aylesbury North *ground frame* (Figures 2 and 3), used it to unlock the ground frame, reversed the points and called the locomotive from the loop onto the running line. The shunter then returned the points to the normal position and returned the token to the token machine.

- 17 The Marylebone IECC control area extends to milepost 38 ½ (measured from Baker Street), a point north of Aylesbury station where there is a single running line and a goods loop, Aylesbury North loop (Figure 2). The crossover at the Aylesbury end of the loop is controlled from Marylebone IECC. The crossover at the north end of the loop is controlled from a ground frame at Aylesbury North.

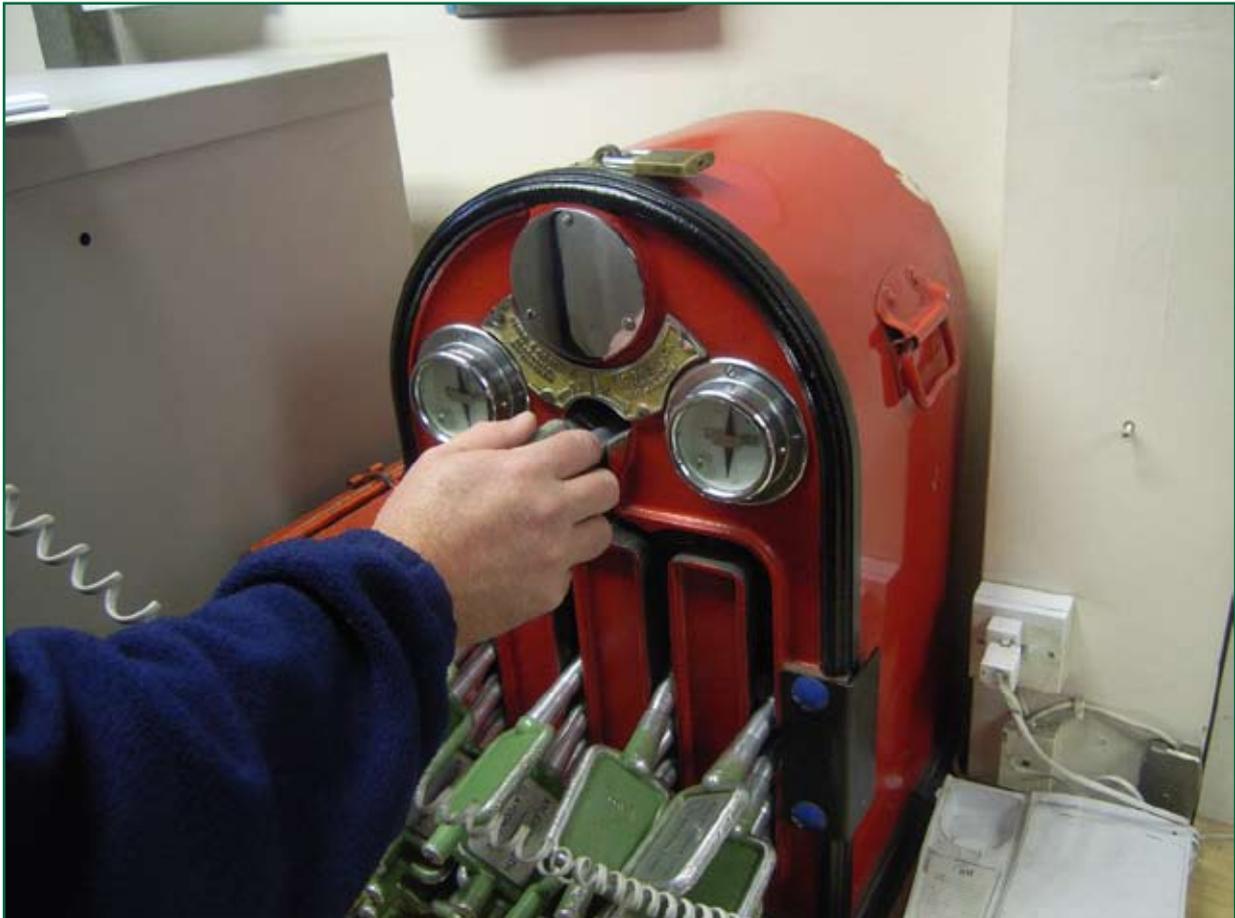
Figure 6: Token being taken from the machine

- 29 A further complication arises as there are sidings off the single line where a train can be stabled clear of the line. A train running into one of these sidings needs to be able to return the token in order to release the token machines for other trains to pass. There are two such locations on the Aylesbury to Claydon L&NE Junction line, at Aylesbury North loop and at Calvert. At each of these intermediate locations, an additional token machine is provided. These intermediate locations do not have token release switches but have indicators on the machines to show when the machine is unlocked for token issue.

- 30 The release switch that the signallers operate to issue a token releases all of the token machines; at Aylesbury station, Aylesbury North groundframe, Calvert sidings and Claydon L&NE Junction. When the signallers at Marylebone and Claydon L&NE Junction have operated their release controls, a token can be withdrawn from any one of the four machines. All of the machines are fitted with indicator needles to show when the release has been given.
