Rail Accident Investigation Branch

Rail Accident Report

**Fatal accident at Bronwydd Arms station,
Gwili Railway
19 July 2006**

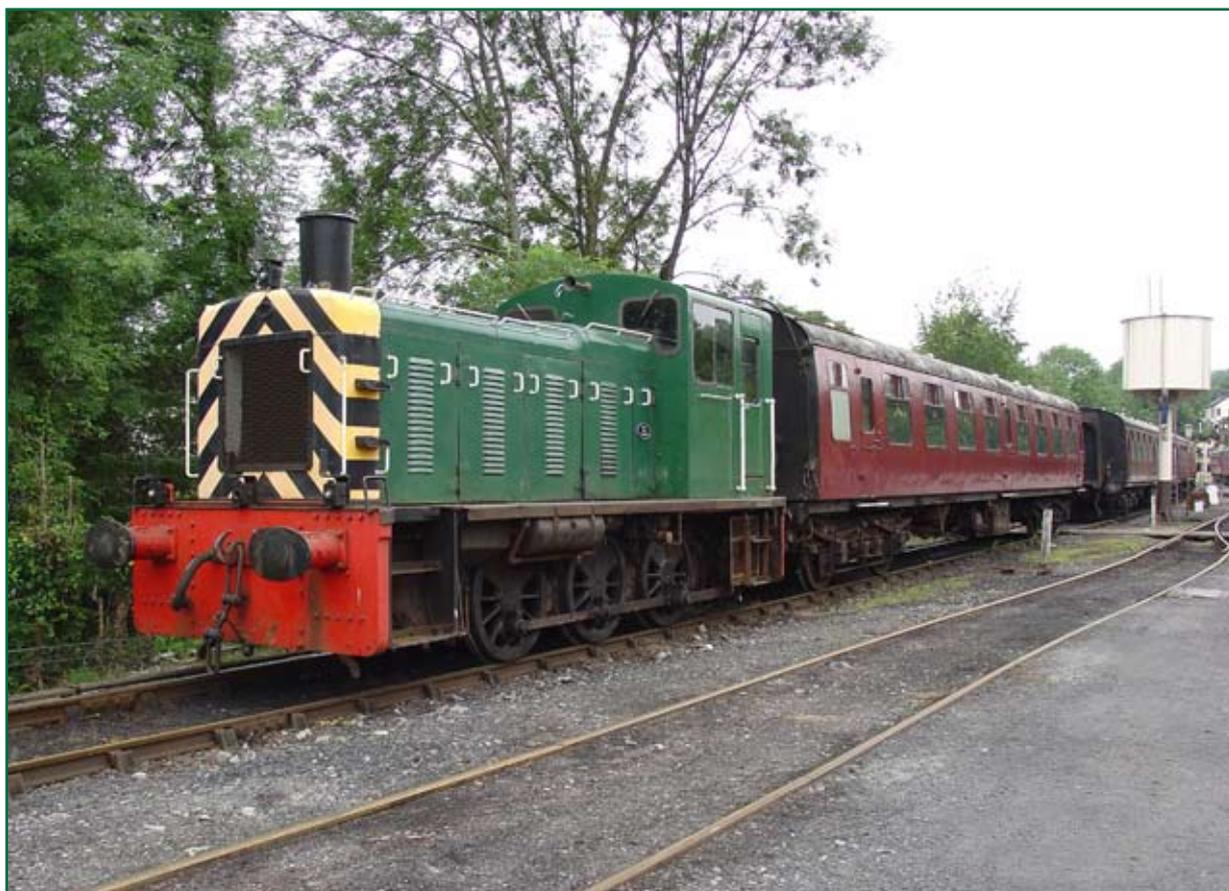
Figure 2: Class 03 locomotive and carriage

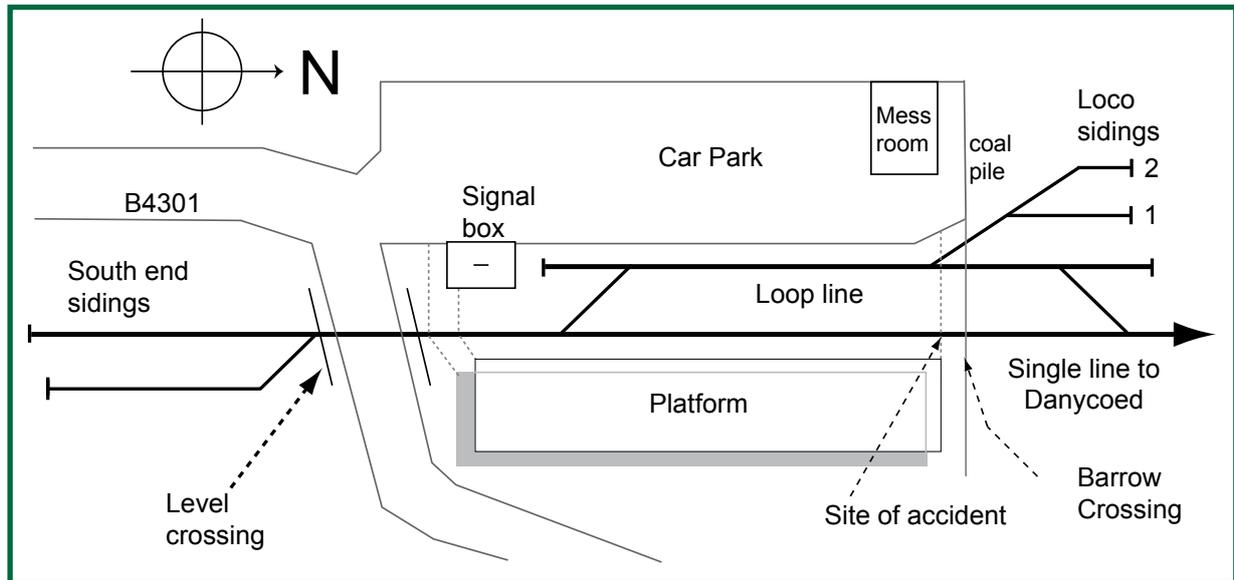
- 15 The Gwili Railway Company Ltd was incorporated in 1975, with the aim of recreating a passenger operation over part of the route of the closed railway, along the picturesque valley of the Afon Gwili. In July 2006, the operational line consisted of the 2 miles 20 chains (3.6 km) from Bronwydd Arms northwards to Danycoed Halt, and 18 ch (0.36 km) of sidings to the south of Bronwydd Arms station.

Figure 3: The track layout at Bronwydd Arms station

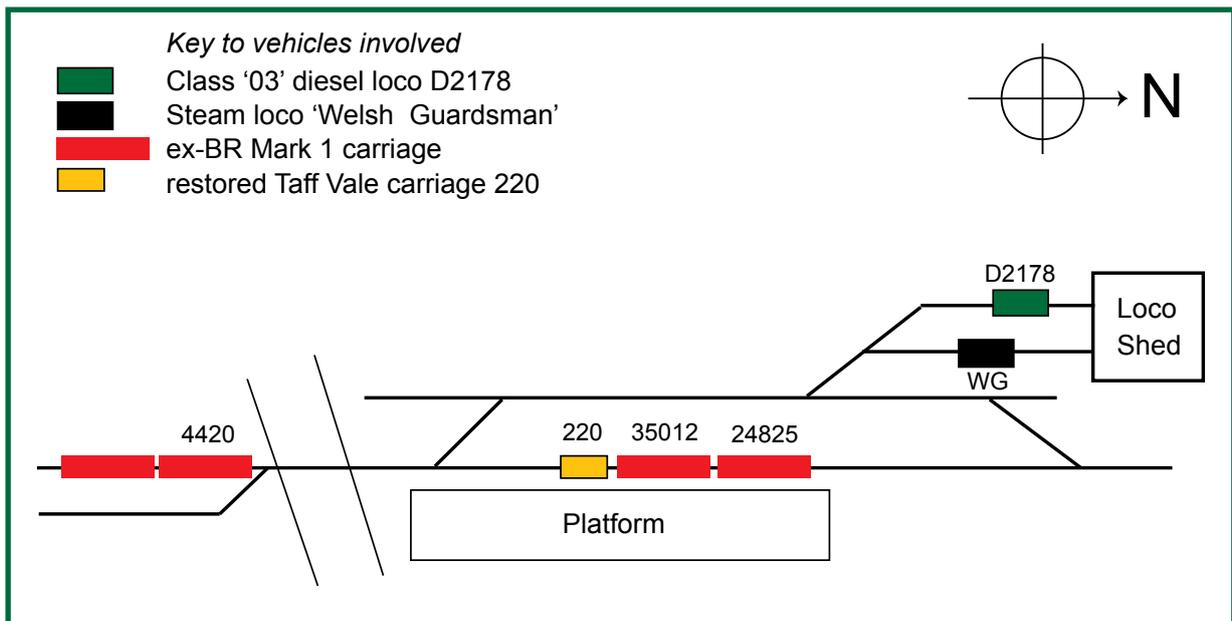
27 The location of the above vehicles are shown in Figure 5.

Figure 5: Location of relevant rail vehicles prior to the shunting manoeuvre

- 30 On the morning of the accident the driver on duty decided to strengthen the train back to three carriages and the 'Taff Vale' carriage, in the knowledge that there was a school party booking that day. This strengthening was to be achieved by using the diesel locomotive to collect carriage 4420 from the south siding, hauling it to the north end of the station via the loop line and propelling it back towards the platform (Figure 5).

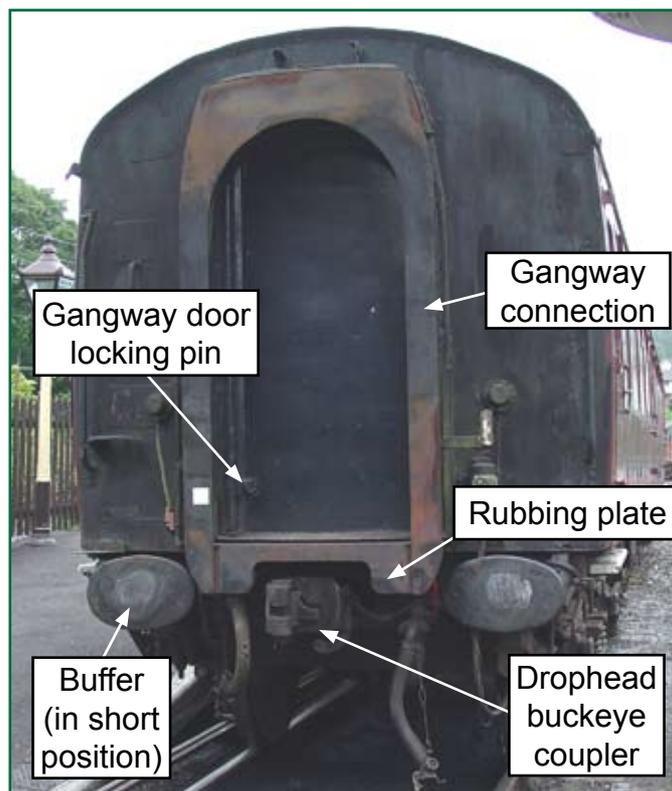
There are several actions required to convert a stationary Mark 1 carriage from the configuration of being attached to a locomotive, to that of attaching to another carriage. A typical sequence of preparation is as follows:

- ensure that the vehicle will not be moved and that it is safe to go onto the track;
- raise the drophead buckeye coupler and insert the locking pin;
- retract the buffers to the short position;
- open the buckeye horizontal hook;
- remove the retaining pin from the external gangway door lock;
- remove vacuum or air brake pipes from dummy housings / receptors;
- remove train heat connectors pipes / cables from receptors;
- check there is no equipment or foreign object present that would prevent a coupling being made;
- return to a position of safety.

Figure 10: The carriage end showing the external features

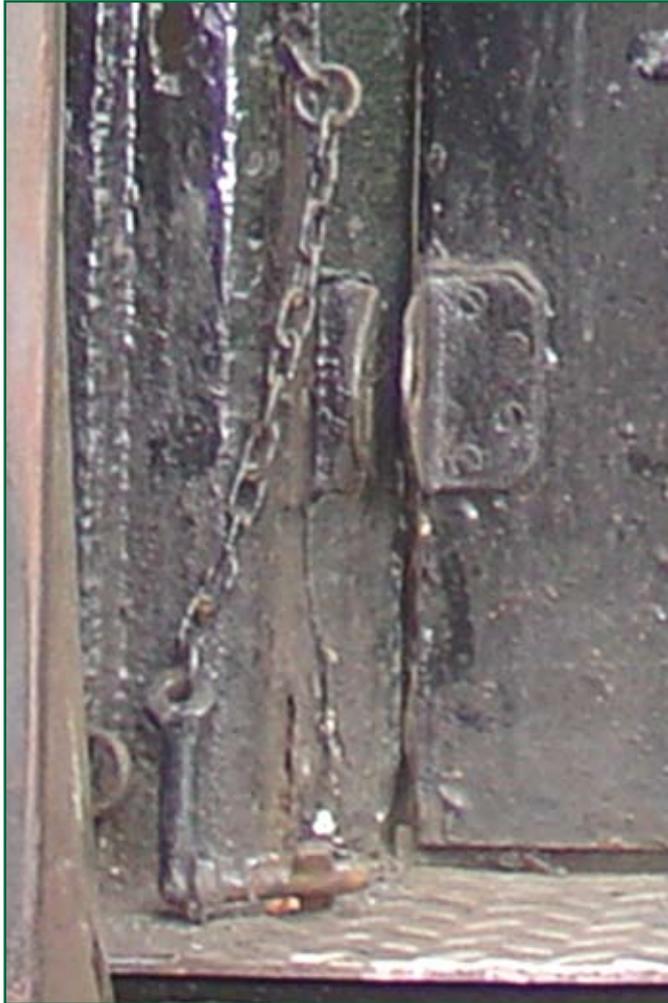
Figure 11: the carriage end door locking pin in the unlocked position
