Rail Accident Investigation Branch

Rail Accident Report

Unauthorised train movement at High Street Kensington 29 April 2006

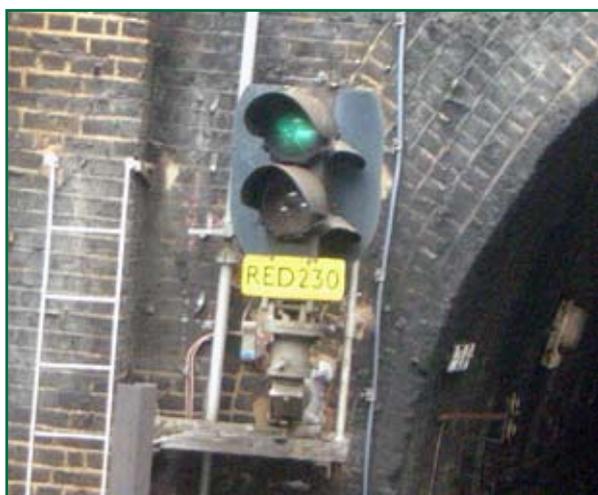
Figure 7: Signal RED230

- 49 The following signal is RED230 (yellow – green aspects) (see Figure 7) mounted to the left of the train on the tunnel headwall at the exit to Triangle Sidings. It is a repeater signal that gives advance warning of the aspect being displayed by ED230. It is not fitted with a *trainstop*.

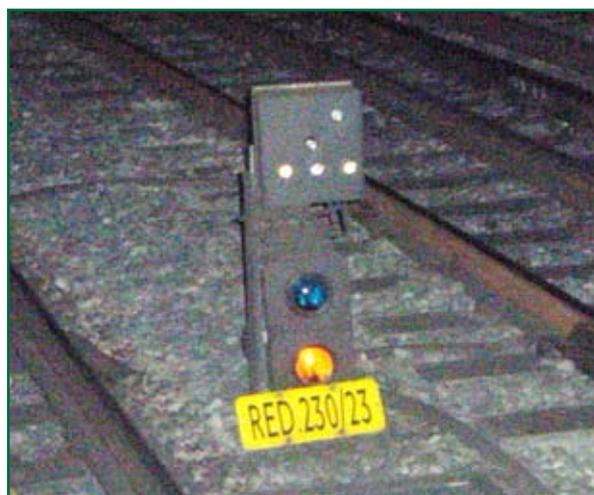
Figure 8: Signal RED230/23

- 50 The next signal is RED230/23 (yellow – green aspects) (see Figure 8) mounted to the right of the train near ground level. It is fitted with an *arbour lights* junction indicator that indicates the route set at High Street Kensington. Three horizontal white lights are displayed for the route to platform 2, three lights at 45° for the route to platform 3, and no lights illuminated for the route to platform 4 (see Figure 13 for the similar arbour lights route indicator fitted to ED23). This signal is a repeater for ED230 and ED23; it gives advance warning of the aspect being displayed by both these signals. It is not fitted with a *trainstop*.

105 The first junction indicator that the train passed is fitted to RED230/23 signal (Figure 8) a short distance inside the tunnel beyond Triangle Sidings. This displayed three horizontal lights indicating that the route was set for platform 2. Although the Train Operator knew that the train was booked to terminate at High Street Kensington a possible scenario why the route indication did not register with him was the train's normal destination being to Edgware Road and the green PROCEED aspect being displayed. The low line speed of 20 mph (32 km/h) on the approach to High Street Kensington meant that there would be adequate time to brake for ED23 when it was first sighted. There is also a slight possibility that the indicator could have been mistaken for the three lights inclined at 45° indicating the correct route for platform 3. Similar route indications would have been received on ED23 signal. No firm evidence exists why the Train Operator failed to respond to these incorrect route indications.

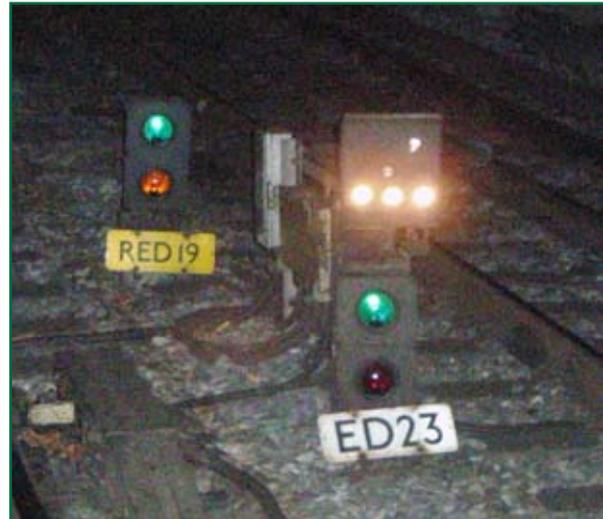
Figure 10: Signal ED23 showing route to Circle Line Platform 2

- 51 ED230 is the first stop signal encountered after Triangle Sidings. It is followed by ED23 (Figures 10 and 11) which acts as the *outer home signal* for High Street Kensington station; it also protects the facing junction for the terminal or through platforms. It is mounted near ground level in the 6 foot and is thus on the right hand side of the driving cab, it is fitted with an arbour lights junction indicator (see Figure 13) and has an associated train stop.

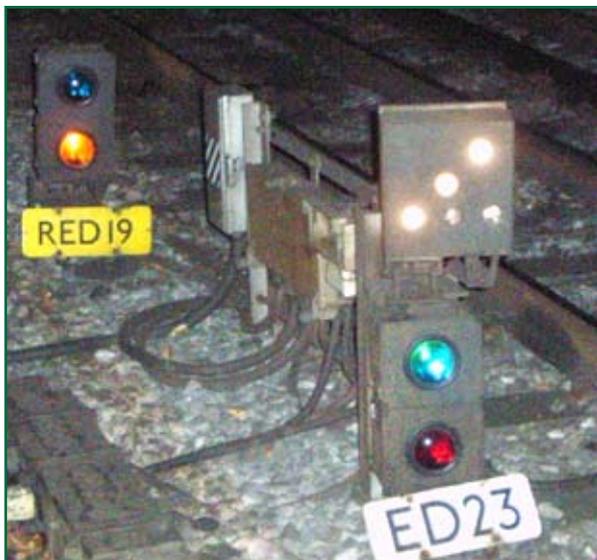
Figure 11: Signal ED23 showing route to terminal Platform 3

- 52 Facing in the opposite direction to the above three signals is ED171 (See Figure 11). This is a halogen lamp, fibre optic shunt signal. Unlike the main signals described above it does not show a red STOP, or green PROCEED aspect; instead it displays a horizontal red bar for STOP, and a 45° red inclined bar for PROCEED. The illumination projected from the face is brighter than other signals in the area. It controls movements from the eastbound track back into Triangle Sidings. It has a train stop fitted and is mounted near ground level next to the right hand side tunnel wall. It is therefore remote from the left hand driving position in the train cab.
