Rail Accident Report

Two near misses at Crofton Old Station No.1 Level Crossing, near Wakefield, West Yorkshire 1 and 18 May 2006

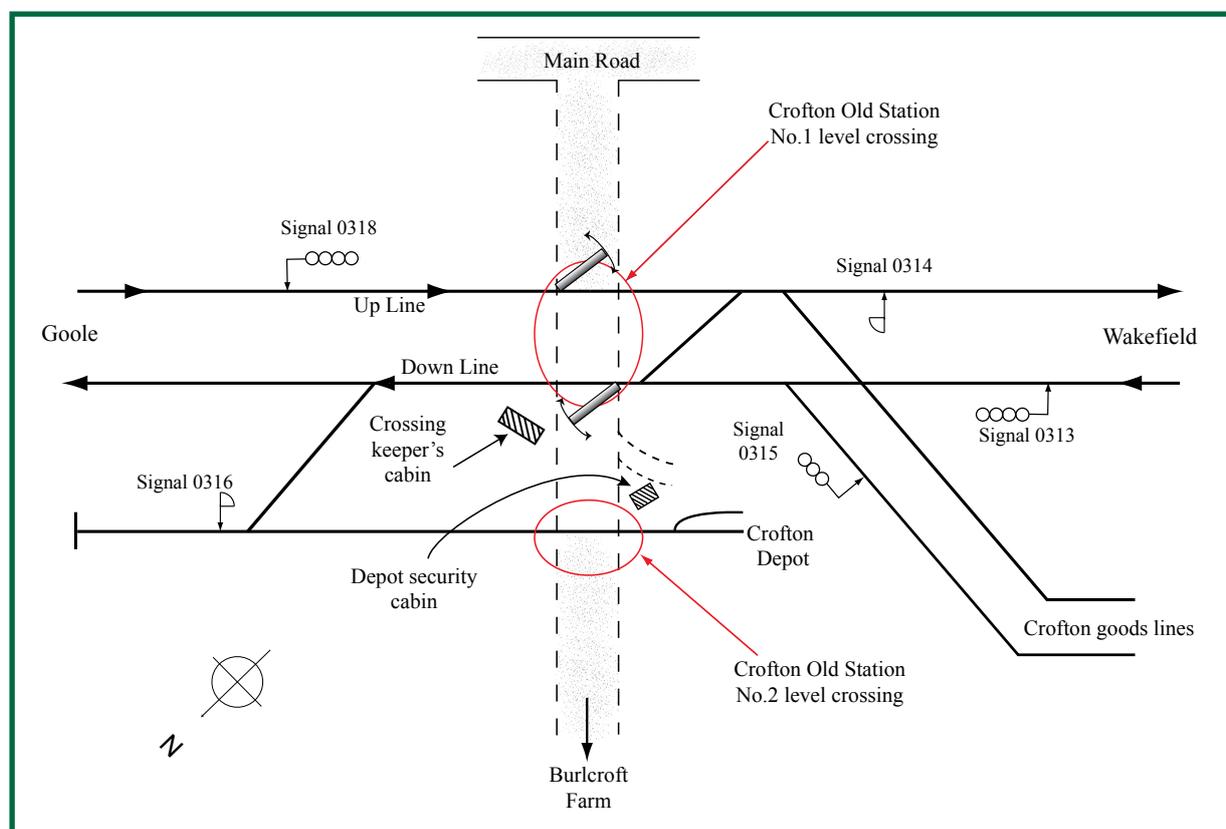
Figure 2: Simplified diagram of crossing layout and signals

- 30 The *protecting signals* for Crofton Old Station No.1 level crossing on the up and down Goole lines are O318 and O313 respectively (Figure 2).

- 35 Crofton Old Station No.2 level crossing is situated approximately 40 metres from No.1 level crossing and forms the rail access to and from the Bombardier train maintenance depot. It is connected to the main lines via a headshunt (Figure 2).

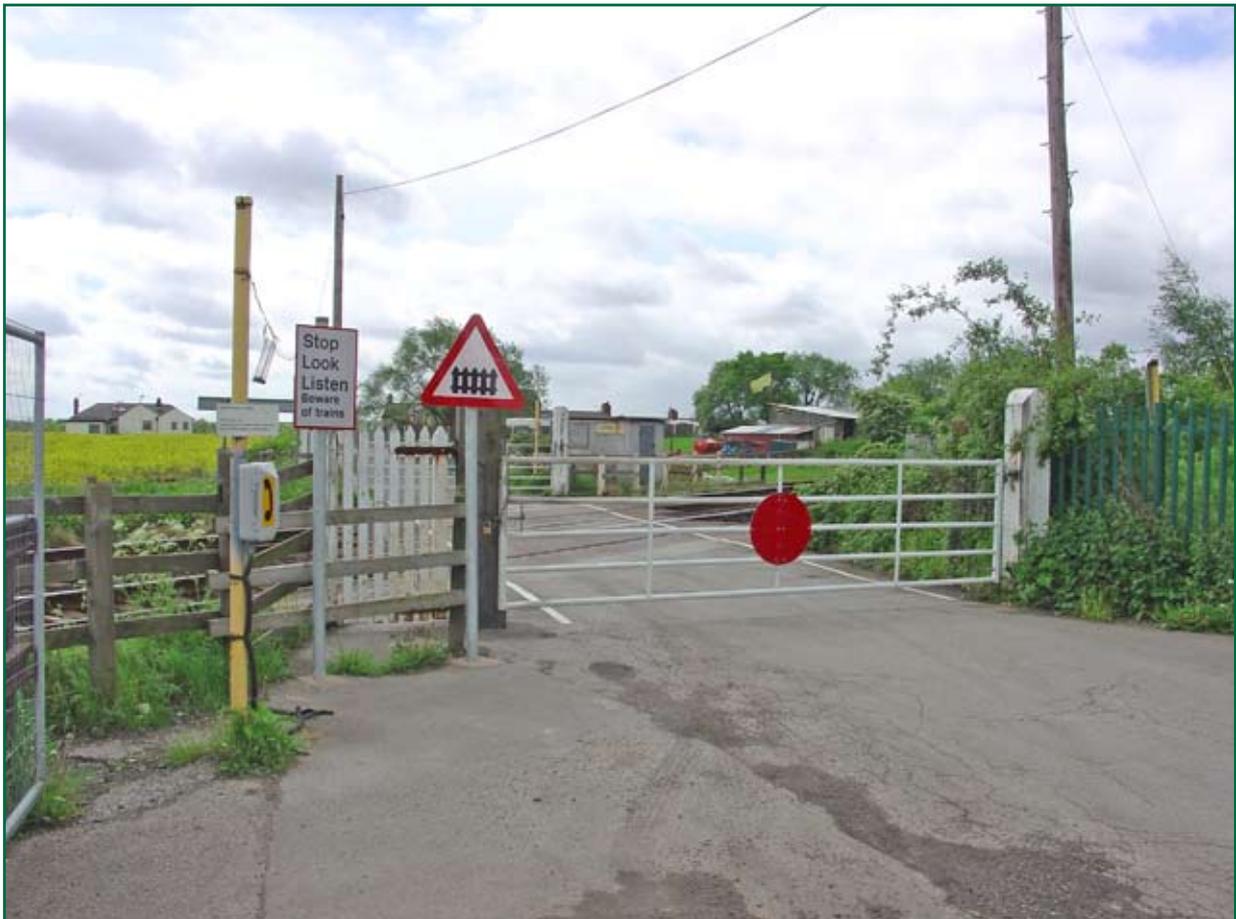
Figure 3: Crofton Old Station No.1 crossing

- 31 Crofton Old Station No.1 level crossing consists of hinged, full road gates which are normally open to road traffic. The gates open outwards to the road, away from the railway. Adjacent to each road gate is a wicket gate for use by pedestrians (Figure 3).
- 32 Rail traffic use over Crofton Old Station No.1 crossing at the time of both incidents consisted of an hourly passenger train in each direction during service times and up to twenty freight trains and light locomotives per day. This typically gave fifty operations of the level crossing gates per day. There could be up to six full operations of the crossing gates per hour during peak times, and the gates were often closed for more than one train to pass.
