Rail Accident Investigation Branch

Rail Accident Report

**Collision at New Addington on
Croydon Tramlink,
23 November 2005.**

Report 11/2006
July 2006

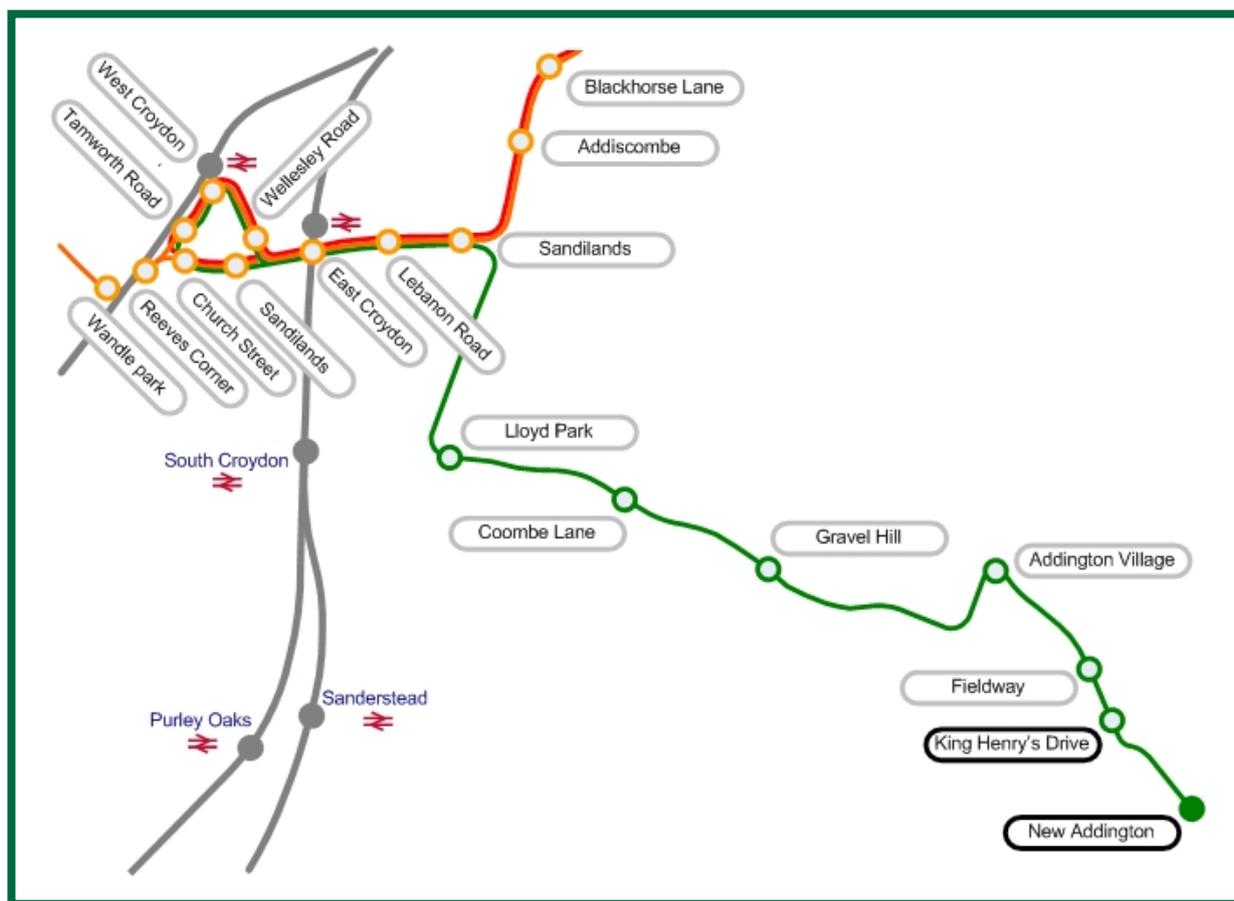
Figure 3: Diagram showing the south eastern part of Croydon Tramlink Line 3 between Croydon and New Addington is shown in green

- 29 On the morning of 23 November, trams 2533 and 2538 were operating on the Line 3 service from Croydon to New Addington (Figure 3). Thick fog had descended during the night and remained in the area until late morning reducing visibility to approximately 70 m (this is estimated from witness commentaries and CCTV records). Rail conditions were very damp and the southbound line adjacent to KHD02 signal was visibly contaminated with a rusty sludge or paste. There is no evidence of poor wheel-to-rail adhesion which would have adversely affected the braking capability of the tram. Consequently the presence of this sludge does not appear to have had any bearing upon the accident.

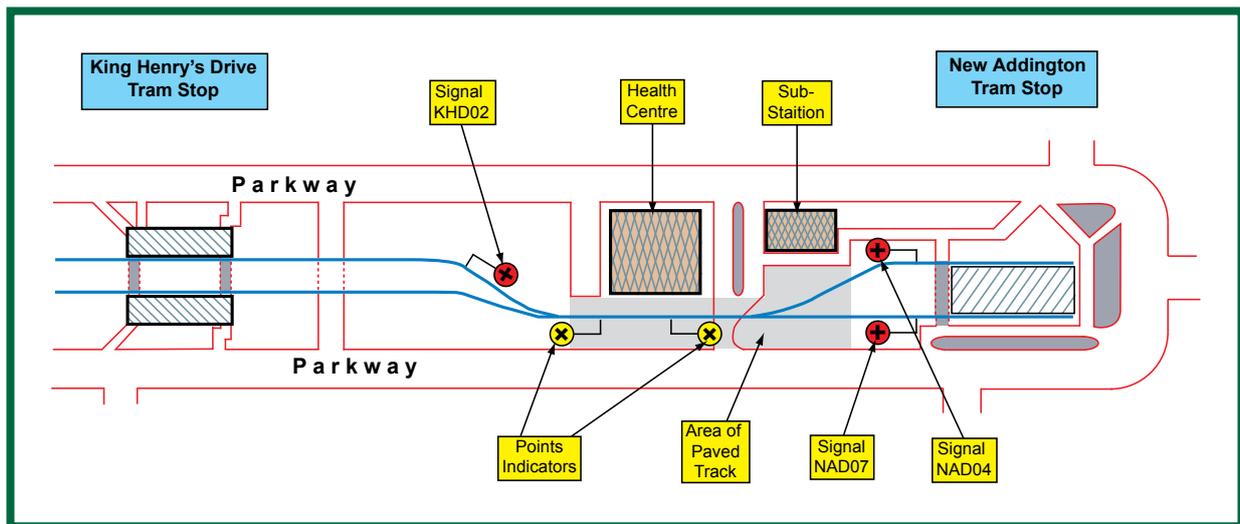
Figure 4: Diagrammatic representation of the line between King Henry's Drive and New Addington

- 21 The single track section is located immediately north-west of the New Addington terminus; the reason for this is its proximity to a building (used as a Health Centre) where there is inadequate room for double track. It is located on the apex of 0.68% and 0.63% rising gradients from New Addington and King Henry's Drive respectively. A shallow right hand curve is apparent on departure from New Addington. The entry to the single line is controlled by a motorised point and NAD04 and NAD07 signals at New Addington and a *spring point* and KHD02 signal from King Henry's Drive. *Points Indicators* are provided at both ends of the single line. Good sighting of the collision point is possible from at least 50 m distance under conditions of moderate visibility.

- 22 The entry to the single line at New Addington is controlled by signals at each end. The controls are triggered by track-located sensors, one at King Henry's Drive tramstop and one adjacent to KHD02 signal. Similar sensors are provided at New Addington. Apart from the sensor at King Henry's Drive tramstop which operates automatically, a proceed request is activated by the driver initiating a 'Ready-to-Start' signal from the cab. The system normally operates on an automatic first come – first served basis, although manual over-ride from the control centre at Therapia Lane Depot is possible.

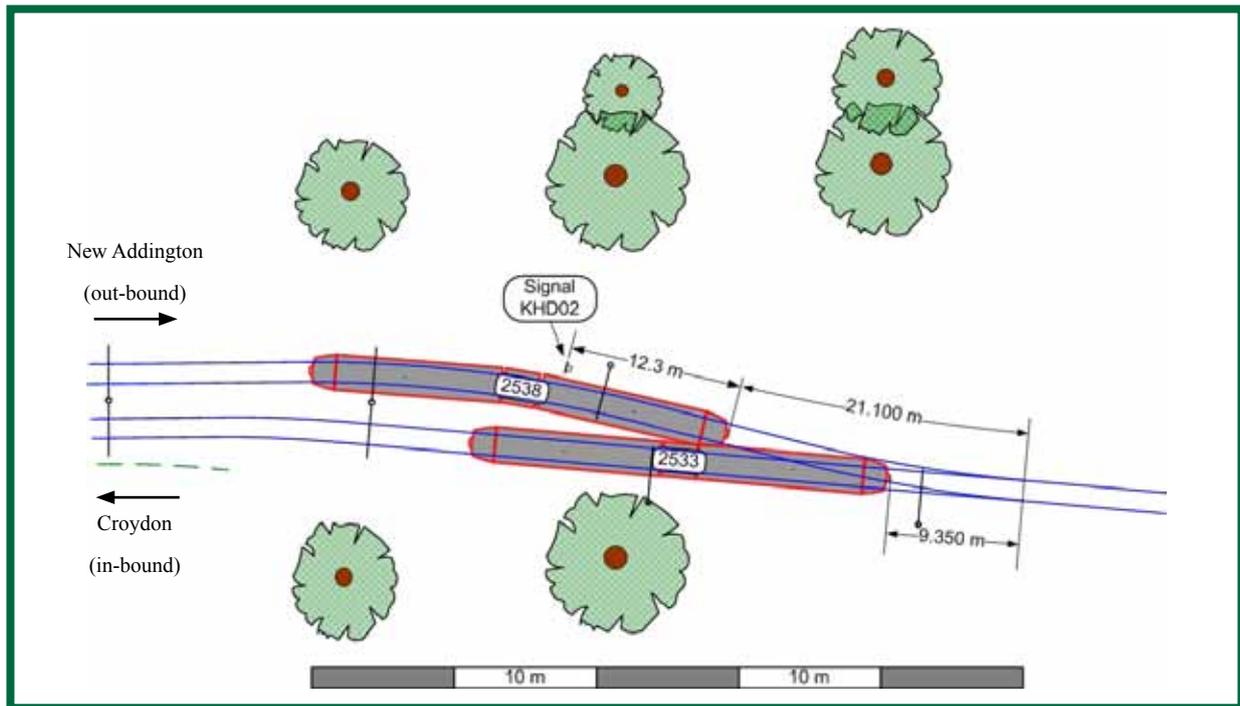
Figure 14: Diagram showing final positions of trams 2533 and 2538 in relation to toe of points

- 27 On 23 November 2005 at 08:16 hrs, tram 2538, a three-section articulated unit, was travelling southbound with about ten passengers from Croydon towards the New Addington terminus on the 'out-bound' line in conditions of thick fog. The tram passed KHD02 signal, which was displaying a STOP aspect. This signal, positioned near the end of the double track section from King Henry's Drive tramstop, protects the entry into the short single line section just before New Addington. The tram came to a stand 12.3 m beyond the signal partially blocking the adjacent 'in-bound' line, see Figure 14 following Paragraph 46.

- 40 At 08:16:33 hrs a service brake was applied on tram 2533 when it was only 1.5 m from tram 2538. It took about 1 second before the demand from the traction brake controller became effective in beginning to slow the tram, by which time the collision had occurred. The driver did not apply the hazard brake prior or subsequent to the collision.
- 41 The collision occurred when tram 2533 was travelling at 26.1 km/h. It caused damage to the offside of both cabs and further damage to the offside of 2533 whilst it travelled a further 18 m before coming to a stand.
