Rail Accident Report

**Runaway and subsequent collision near to
Loughborough Central station, Great Central
Railway
12 May 2014**

Report 04/2015
May 2015

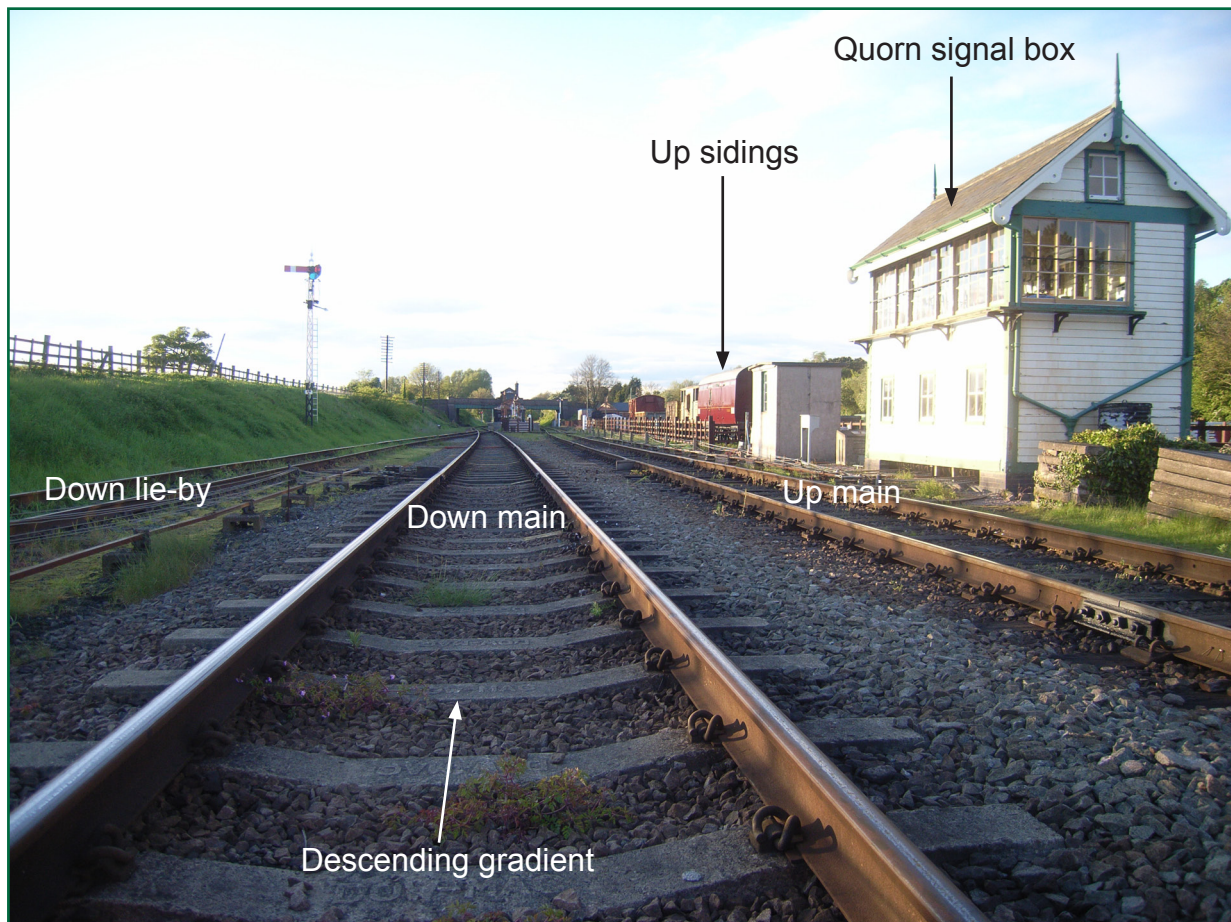
Figure 2: Layout of the track opposite Quorn signal box.

- 9 The train which ran away (referred to as the 'incident train' throughout this report) had been left unattended on the *down* main line opposite Quorn signal box (95 miles 16 *chains*); this is situated just to the south of Quorn and Woodhouse station (95 miles 6 *chains*) (figure 2). The railway at this location is double-tracked and consists of the down main line (for trains travelling northwards towards Loughborough Central at 93 miles 2 *chains*) and an *up* main line (for trains travelling southwards to Swithland and Rothley). The lines within the *station limits* of Quorn signal box are not equipped with *track circuits*.

- 10 A single-track siding known as the 'down lie-by' is situated to the west of the down main line. This siding is around 300 metres long and can only be accessed from the down main line by trains making a shunting movement over *points* located to the north of the signal box, which controls it. The down main line is protected from unauthorised movements originating from the down lie-by by *trap points*. Quorn North and Quorn South sidings are situated to the east of the up main line and are also under the control of the signal box (figure 2). These sidings can be accessed from the up main line using points located to the north of Quorn and Woodhouse station and to the south of Quorn signal box respectively.

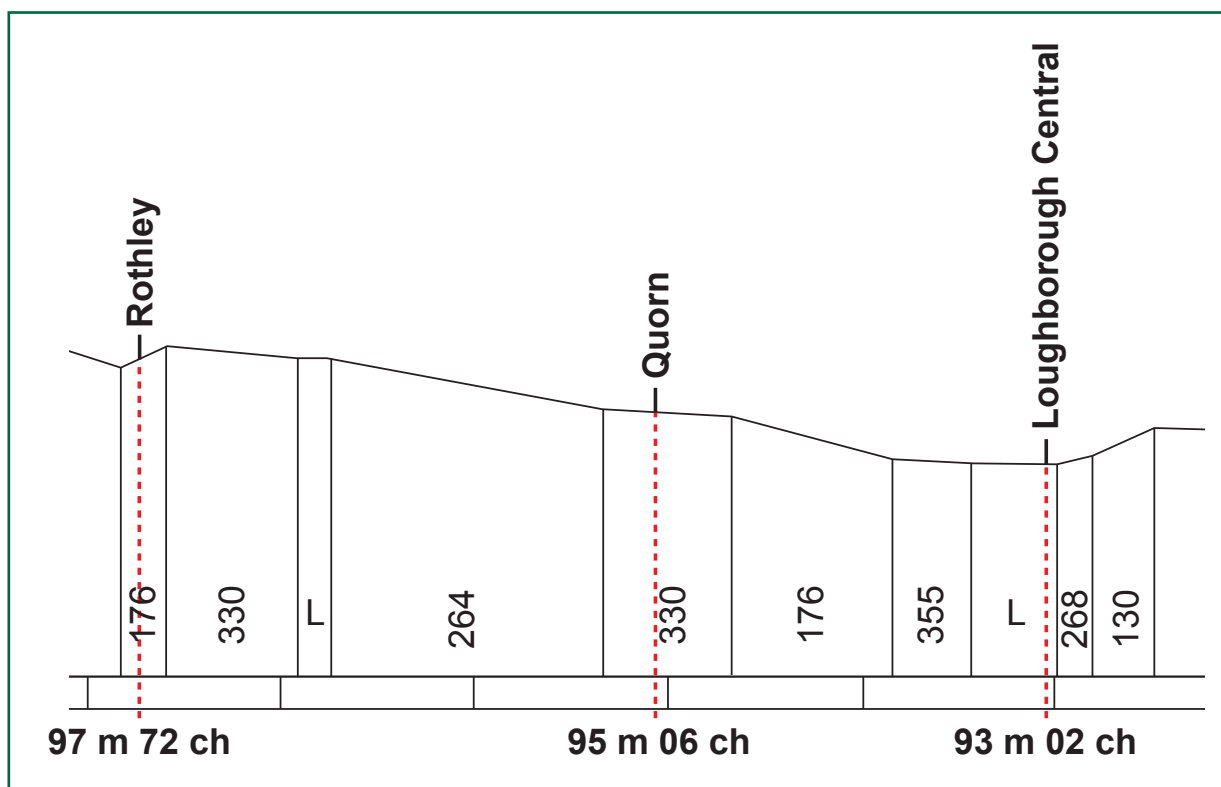
Figure 3: Diagram of line gradients between Rothley, Quorn and Woodhouse and Loughborough Central

- 11 Historical gradient tables record an average gradient of 1 in 330 for the railway at Quorn and Woodhouse, descending towards Loughborough (northwards). A survey undertaken by the RAIB showed that the location where the incident train was stabled (paragraph 57) was slightly steeper than this average, at around 1 in 212. The recorded average gradient increases in steepness to around 1 in 176 around 775 metres to the north of Quorn and Woodhouse. It then decreases before levelling out around 75 metres on the approach to the point where the collision occurred (figure 3); this was within the station limits of Loughborough North signal box. The down main line at the point of collision is equipped with track circuits which can be monitored from this signal box.

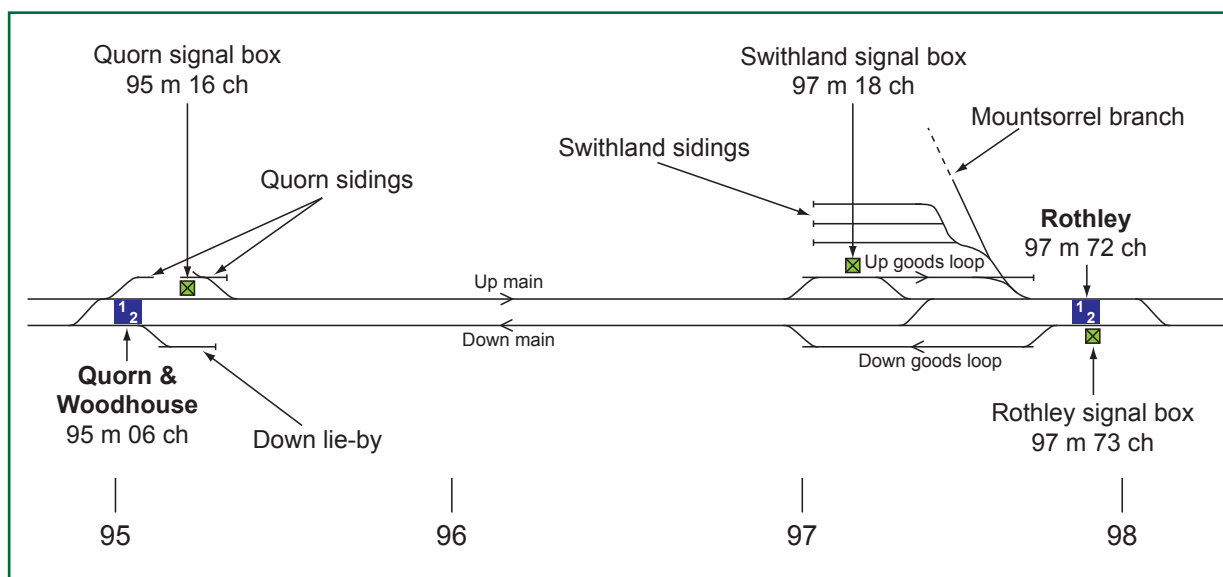
Figure 5: Line diagram of key locations within the possession of 12 May 2014

- 49 While waiting for the air pressure to build, the PICOP and the five staff making up the permanent way team discussed their plans for the day. These were to undertake shunting at Quorn sidings and then to re-arrange vehicles within the Swithland sidings and the Mountsorrel branch (figure 5). This latter activity was required following the previous weekend's gala and to accommodate the requirements of the upcoming photographic charter. The operations department had also requested that the permanent way team move the POS coach from Swithland to Loughborough.
