# ***AAIB Bulletin***

***7/2015***

<b>Aircraft Type and Registration:</b>	Hawker Sea Fury T Mk 20, G-RNHF	
<b>No &amp; Type of Engines:</b>	1 Bristol Centaurus XVIII piston engine	
<b>Year of Manufacture:</b>	1949 (Serial no: ES3615)	
<b>Date &amp; Time (UTC):</b>	31 July 2014 at 1601 hrs	
<b>Location:</b>	RNAS Culdrose, Cornwall	
<b>Type of Flight:</b>	Private	
<b>Persons on Board:</b>	Crew - 1	Passengers - None
<b>Injuries:</b>	Crew - None	Passengers - N/A
<b>Nature of Damage:</b>	Engine internal disruption, right wingtip, flap and minor fuselage abrasion damage	
<b>Commander's Licence:</b>	Military	
<b>Commander's Age:</b>	44 years	
<b>Commander's Flying Experience:</b>	3,545 hours (of which 232 were on type) Last 90 days - 54 hours Last 28 days - 35 hours	
<b>Information Source:</b>	AAIB Field Investigation

<b>Aircraft Type and Registration:</b>	Jetstream 3102 31, G-GAVA
<b>No &amp; Type of Engines:</b>	2 Garrett Airesearch TPE331-10UGR-516H turboprop engines
<b>Year of Manufacture:</b>	1987 (Serial no: 785)
<b>Date &amp; Time (UTC):</b>	15 August 2014 at 1836 hrs
<b>Location:</b>	Doncaster Sheffield Airport, Yorkshire
<b>Type of Flight:</b>	Commercial Air Transport (Passeng

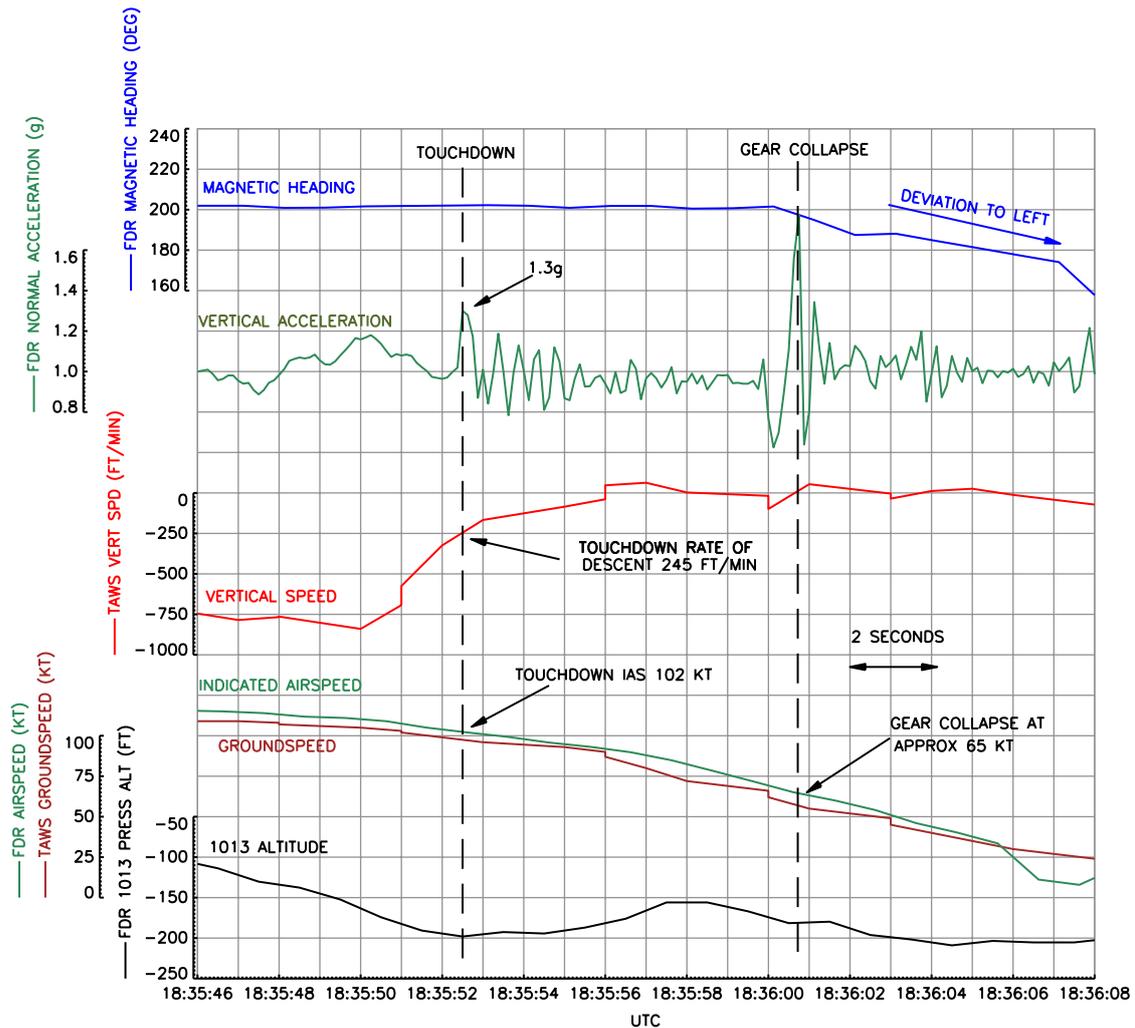
**Figure 2**

The aircraft touched down at 1835:52 hrs at an IAS of 102 kt and normal acceleration of 1.3g (Figure 2). Recorded rate of descent was approximately 245 ft/min (4 ft/sec) which was within the touchdown landing gear load limit which is defined as a rate of descent of 10 ft/sec at a maximum landing weight of 14,900 lb (6,758 kg).

While decelerating through a groundspeed of 65 kt, a normal acceleration spike was recorded, indicating the point at which the left main landing gear failed.

Flight data recorded during the landing

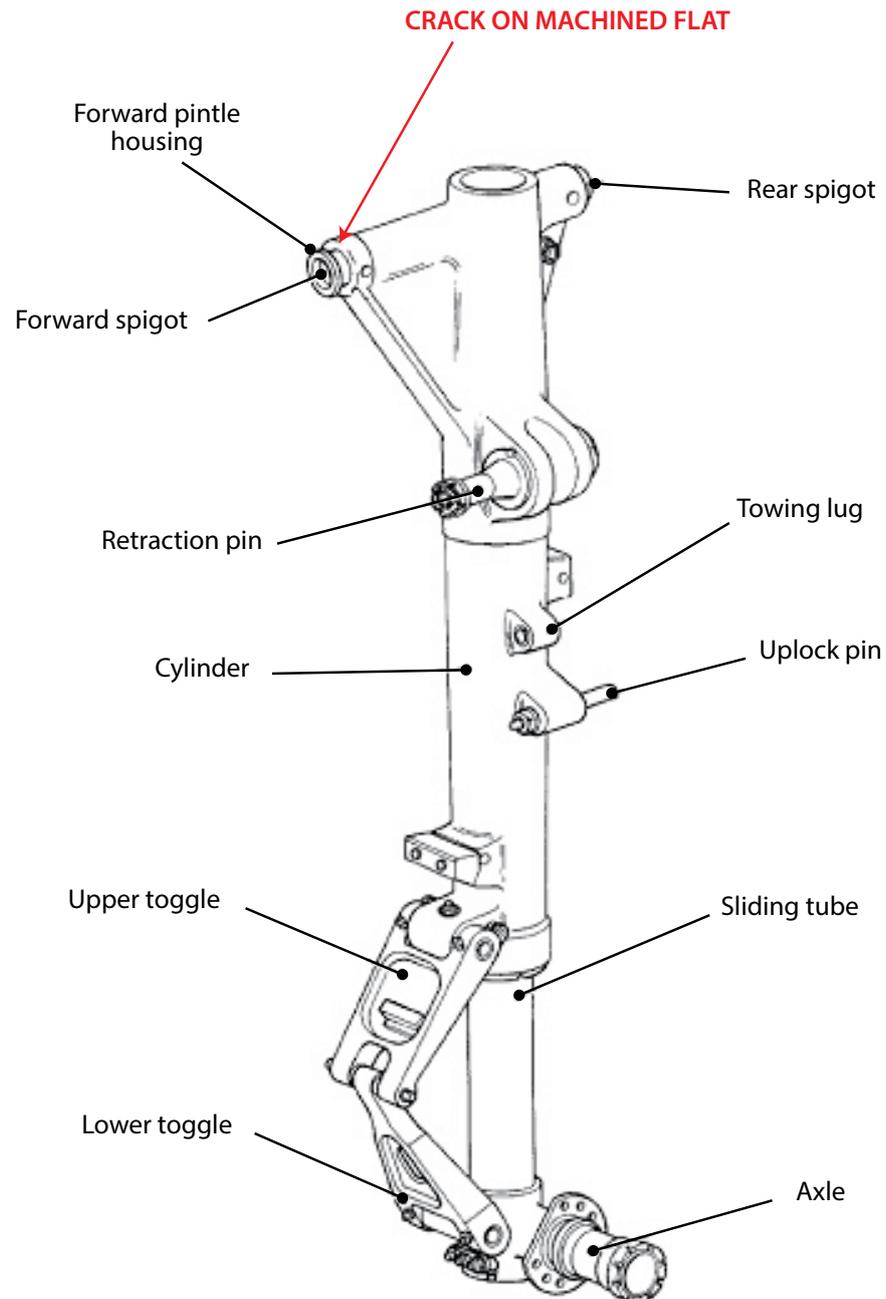
**Figure 4**  
Jetstream 31 main landing gear leg

The Jetstream 31 main landing gear leg consists of a cylinder, manufactured from DTD 5094 aluminium alloy, and an inner sliding tube on which the single wheel and brake assembly are mounted. The landing gear cylinder is attached to the airframe by a yoke which fits onto steel spigots, which are bolted through the pintle housings. The upper surfaces on the forward and rear pintle housings are machined flat to introduce a weak link which will fail, allowing the landing gear to detach from the airframe without damaging the fuel tanks, if it is subjected to a force outside its design limits. During the accident, the forward pintle housing failed along the machined flat (Figure 4).

The DTD 5094 landing gear cylinder is known to be susceptible to stress corrosion cracking (SCC) and similar landing gear failures have occurred on other Jetstream 31 aircraft. In particular, SCC has occurred in the forward pintle housing as a result of the forward face rotating against the spigot bearing during extension and retraction of the landing gear. The resulting abrasion causes degradation of the protective surface treatment, the consequent formation of corrosion pits and, ultimately, cracking. The Jetstream 32 main landing gear cylinder and later versions of the Jetstream 31 main landing gear cylinder are manufactured from L161 alloy and are not susceptible to SCC.
